Qualitative analysis of daylight photoluminescence imaging compared to daylight electroluminescence imaging

A. Moreton, *GdS-Optronlab group, Dept. Física de la Materia Condensada, University of Valladolid, Valladolid, Spain; angel.moreton@uva.es*

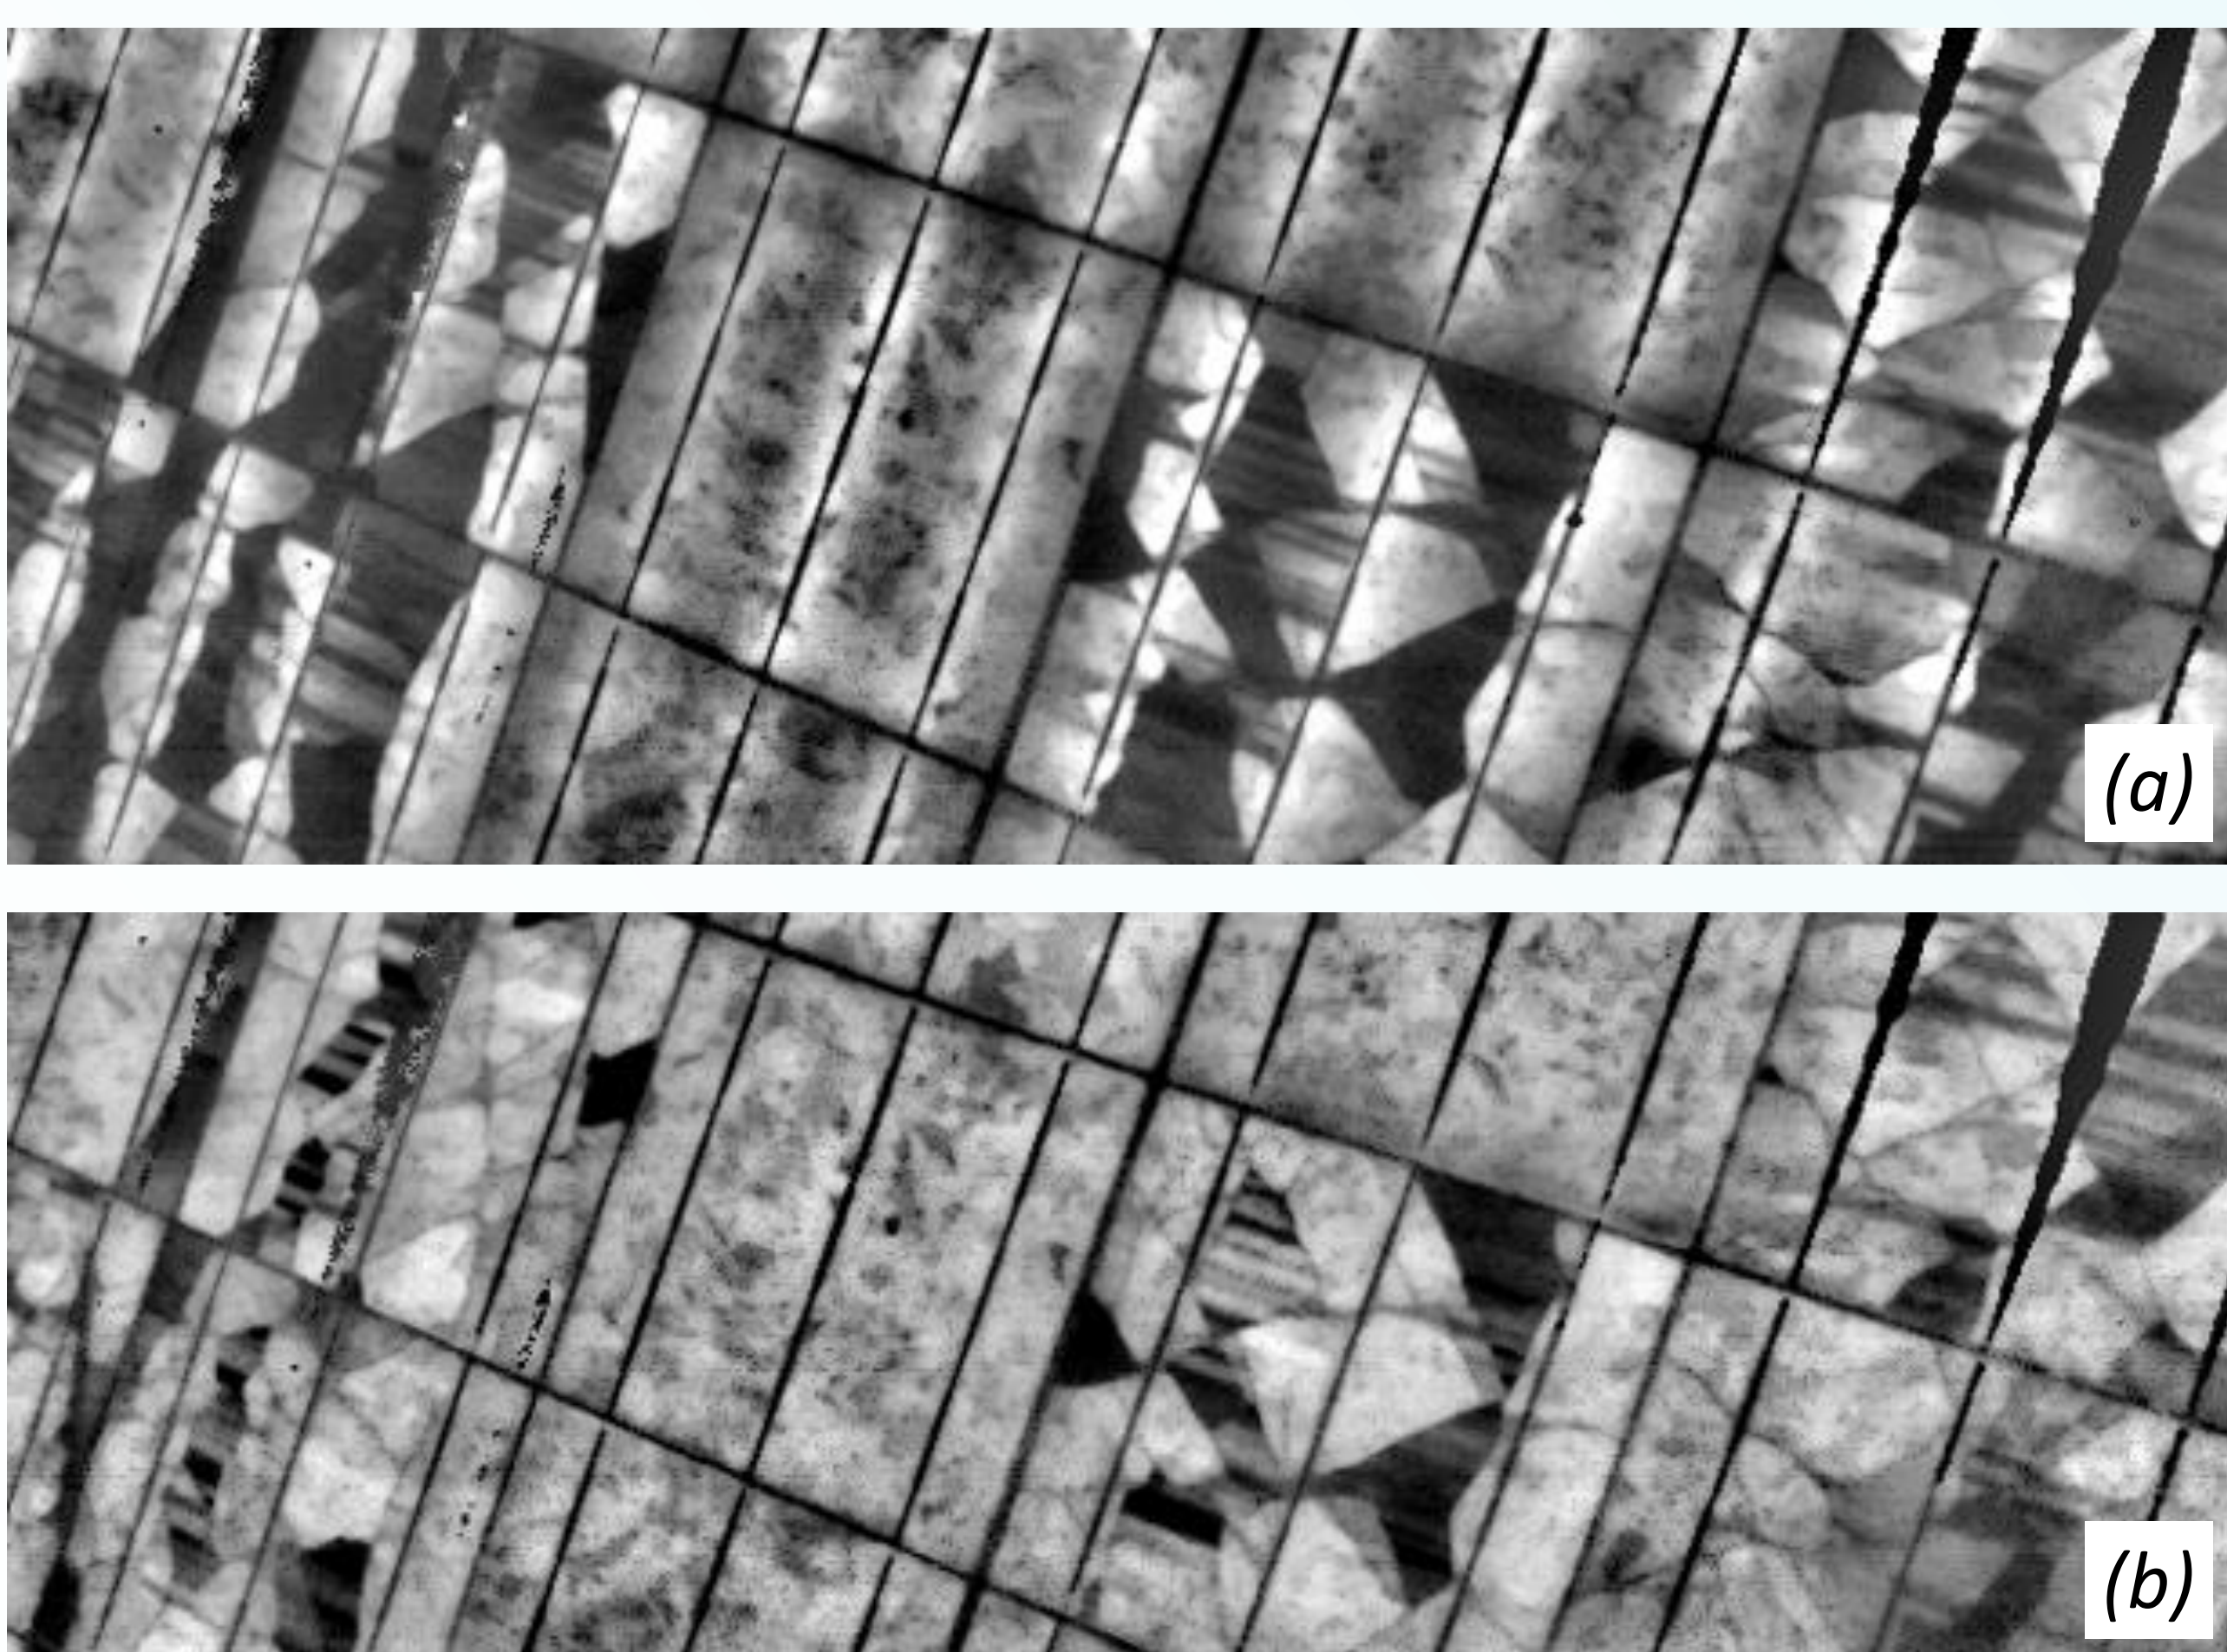
Figure 4. Daylight EL (a) and PL (b) images of some solar cells of a damage module.

EL image, figure 4a, shows some parts of the cells with dark contrast, associated with defective areas.

The PL image, figure 4b, presents contrast differences with respect to the EL image.

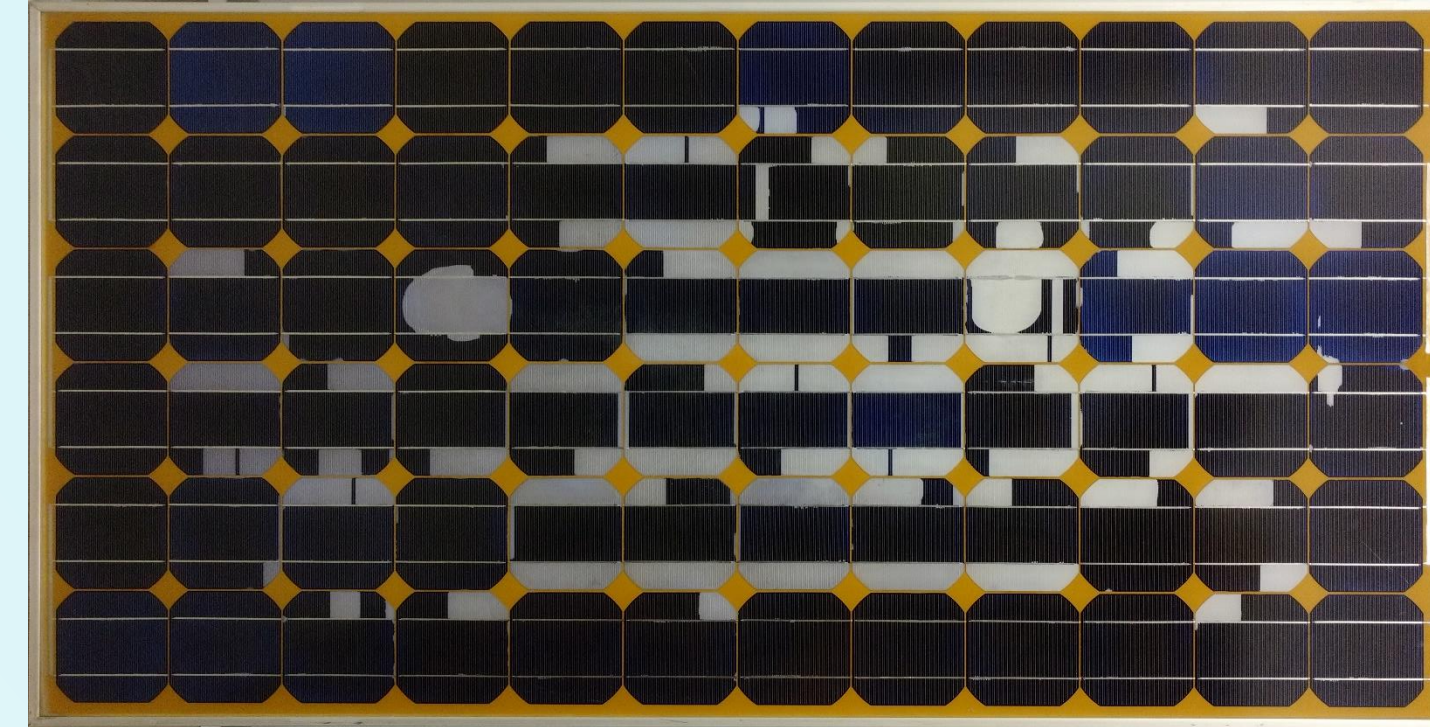
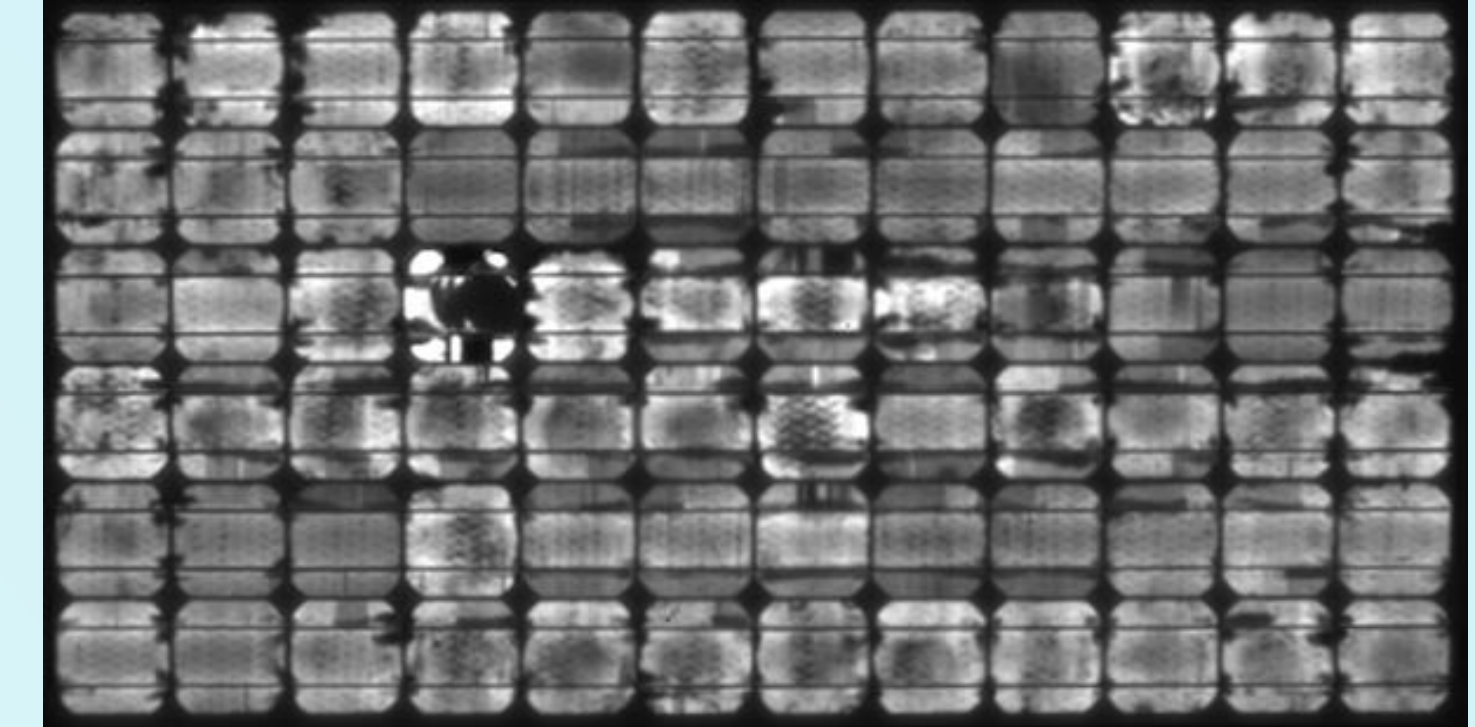
Figure 1. VIS image of a damage tested module (left). Indoor ELi measurement of same module (right).

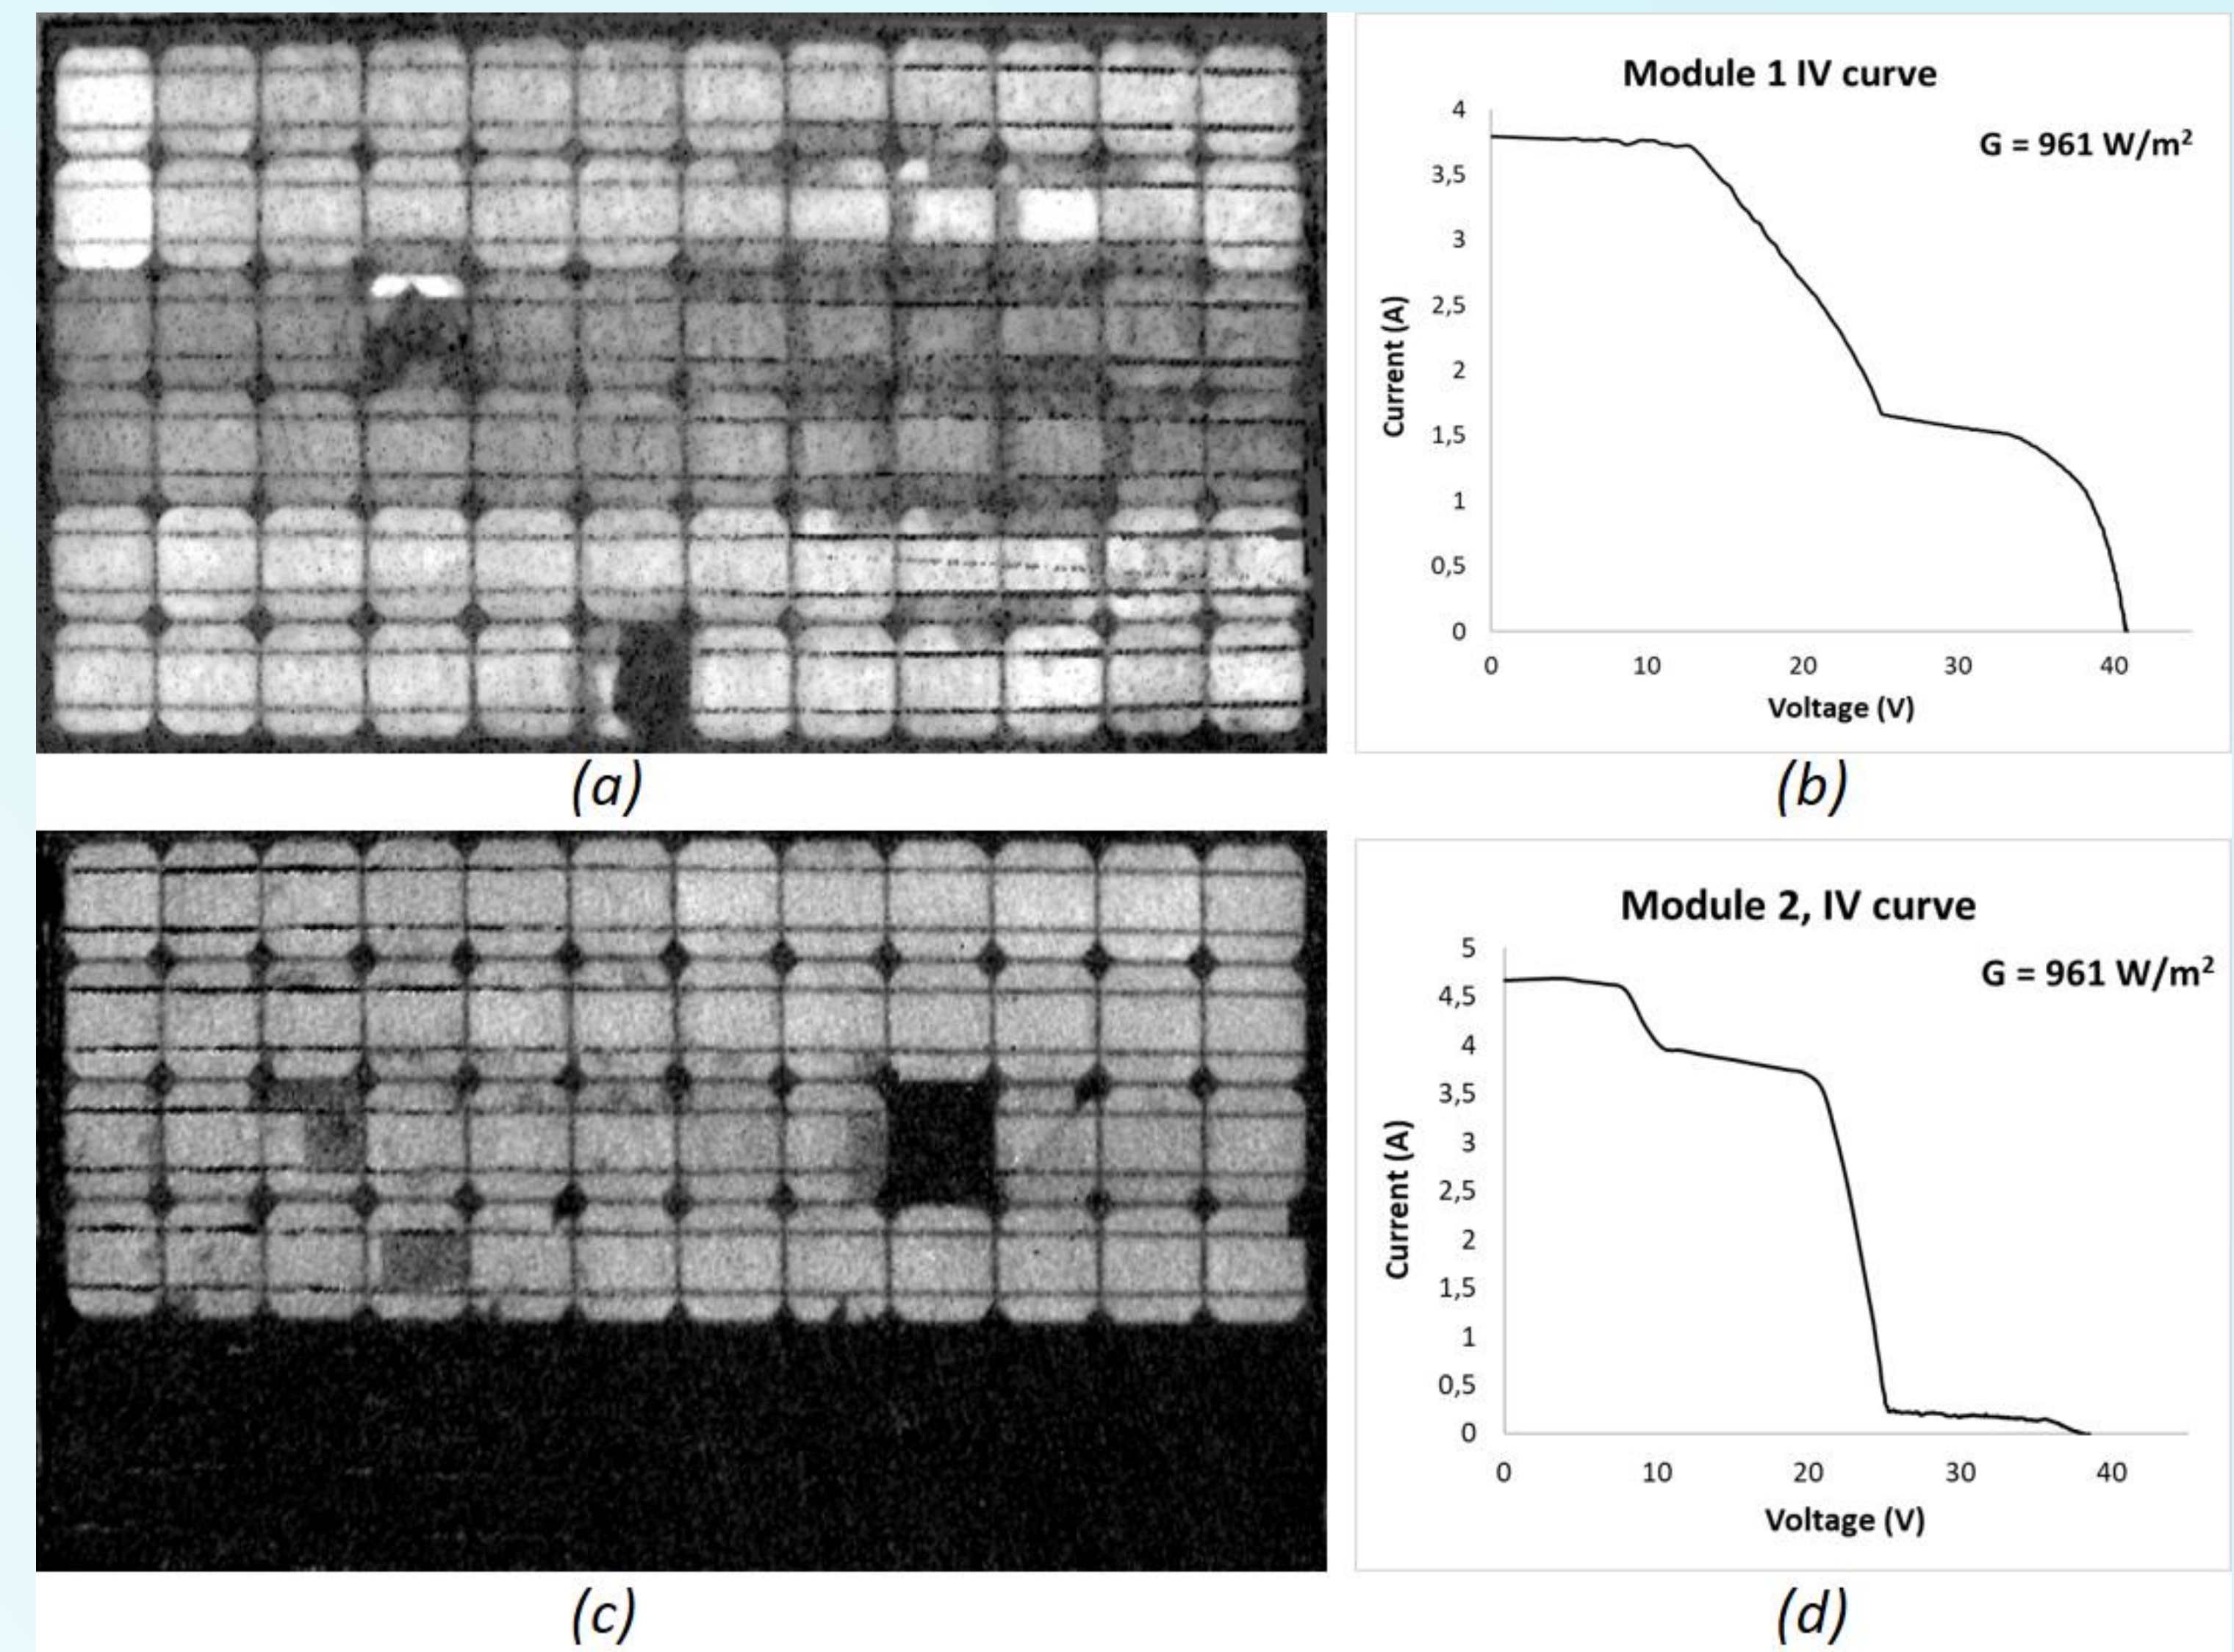
Typically, failed modules give a step in the I-V plot, which can be due to either a malfunction of the bypass diode, or the presence of damaged cells in the module (Fig. 3b and 3d)

Figure 3. Daylight PL images of two damage modules (a, c), and corresponding I-V curves (b, d).

The partial darkening of the central cell array in Figure 3 corresponds to low performance of these cells. in Figure 3c, the darkening is total, and it means that these cells do not produce energy.
