Sara Gallardo-Saavedra^{1*}, Ángel Moretón-Fernández², Marta María Jiménez-Martín², Víctor Alonso-Gómez¹, Luis Hernández-Callejo¹, Óscar Martínez-Sacristán², Miguel Ángel González-Rebollo², José Ignacio Morales-Aragón¹

Keywords: photovoltaic inspection, faults diagnosis, photovoltaic thermography, photovoltaic electroluminescence, IV curve.

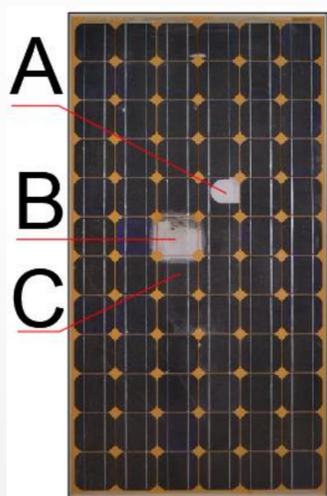
Figure 2: S-E1 module RGB appearance

- **Visual (fig. 2):** An EVA delamination failure in the cell labelled as A, and a burn area in cell B. Apparently, cell C does not present important failures detected visually, but failure B apparently is extended in the upper area of cell C. However, these three cells are inactive, as it can be seen in the EL images (fig. 4), appearing completely black, as they do not emit. These cells are short-circuited, allowing the current passing but not producing energy.

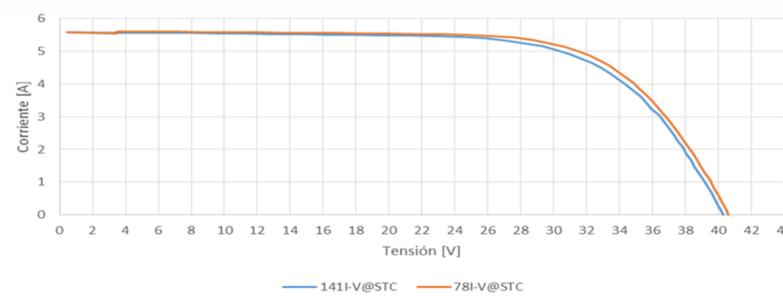
Figure 3: IV Curve of the S-E1 module in STC.

- **IV Curve (fig. 3):** Open circuit voltage (Voc) drop of 3,45V, which correspond with the contribution of the three inactive cells in addition to other partial inactive cells. Short circuit current (Isc) does not fall, since the same current continues circulating throughout the circuit as damaged cells are short circuited.

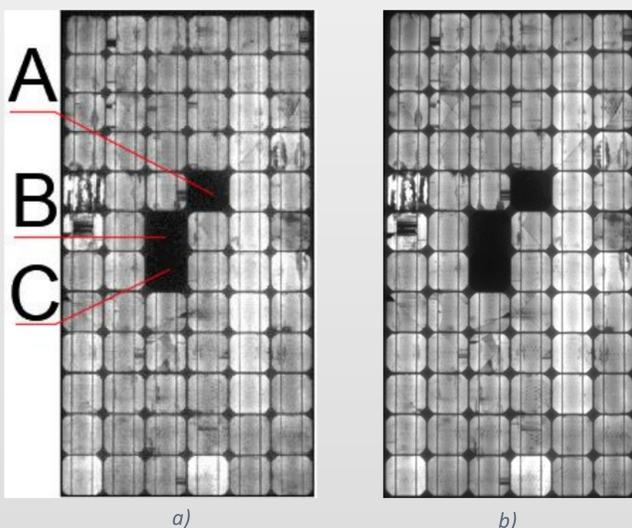
- **EL (fig. 4):** No significant change between the IV curves shape before and after the EL test. Continuously fed short circuit current injection (72 hours) does not affect considerably the performance.

Figure 4: First (a) and last (b) EL images of S-E1 module

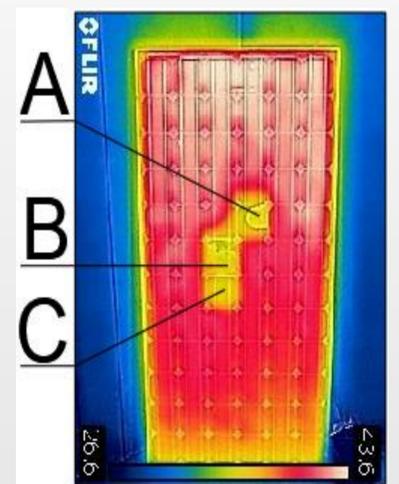
- **Thermography fourth quadrant (fig. 5):** Total inactive cells remains cooler than active areas during the current injection for the EL test. Additionally, it has been observed that when there is an inactive area within a cell partially active, the active area is revealed as an overheated area.
- **Thermography ordinary operation (fig. 6):** These Failures are also revealed in operation, as hot spots working in the second quadrant. However, the delamination in A and B, produces a change in the material emissivity value responsible of covering up the hot spots, as the delaminated areas appear cooler than their actual temperature.

Figure 5: Thermographic image of S-E1 in the fourth quadrant during the EL test.

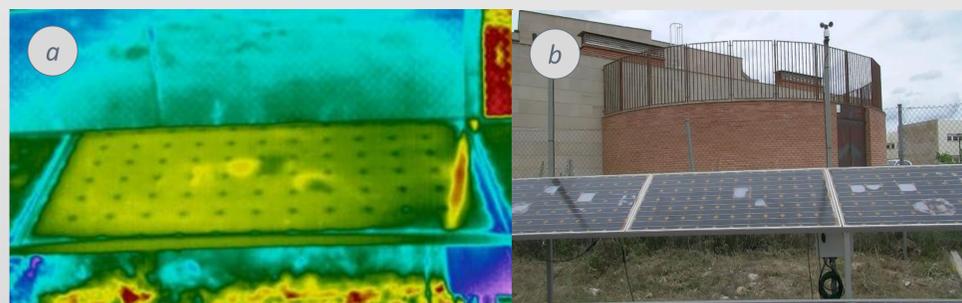
Figure 6: Thermographic (a) and visual (b) images of S-E1 outdoor in ordinary module operation.
