## FAILURE DIAGNOSIS ON PHOTOVOLTAIC MODULES USING THERMOGRAPHY, ELECTROLUMINESCENCE, RGB AND I-V TECHNIQUES

**ABSTRACT:** Different techniques can be used to detect and quantify PV modules anomalies, as visual inspections, electrical tests like the I-V curve test, infrared thermography (IRT) or electroluminescence (EL). PV plants operators usually apply only one or two of them within the Operation and Maintenance (O&M) activities. Additionally, researchers usually studied them separately. However, these methods provide complementary results, glimpsing interesting information about the PV site state. The main strength of the research performed is the simultaneous study of all these inspection techniques, studying the correlation between them. Results confirm that, EL and IRT under current injection on modules are closely correlated, while IRT under normal operation (sun exposure) reveals complementary information not detected in EL but existing in the visible spectrum. In conclusion, it is advisable using as many techniques as possible to characterize the actual state of the module and to explain its I-V curve.

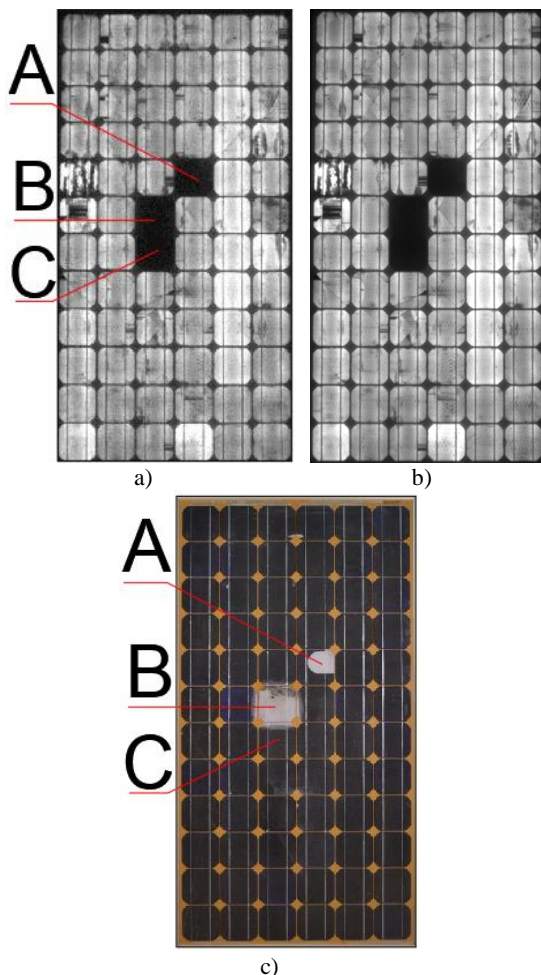
**Figure 4:** First (a) and last (b) EL images of S-E1 module and its RGB appearance (c).

Some relevant results achieved in the research will be discussed along this section. Regarding the PV module S-E1, which main nominal characteristics have been described in the previous section, results show that there is not any significant change between the IV curves shape before and after the EL test. The first and the last EL images of the stack are presented in Figure 4 a) and b), respectively. This means that the continuously fed short circuit current injection during 72 hours does not affect considerably the modules performance. It is important to consider that it has been an EL test to evaluate the modules behaviour during prolonged periods of current feeding them. However, during an ordinary EL test on-site, the modules are exposed during a minimum period of time, just in the moment the EL images are going to be taken. The same module captured with a visual camera is presented in Figure 4, c).

In this visual image, it can be seen an EVA delamination failure in the cell labelled as A, and a burn area, combined with delamination, in cell B. Apparently, cell C does not present important failures detected visually, but failure B apparently is extended in the upper

area of cell C. However, these three cells are inactive, as it can be seen in the EL images, appearing completely black, as they do not emit. Therefore, it can be concluded that these cells are short-circuited, allowing the current passing but not producing energy. Although cell C visually does not present any relevant defect, the failure B has extended affecting likewise cell C. This fact is also revealed in the IV Curve, which can be seen in Figure 5. In this figure are showed two different test performed at different irradiance and temperature conditions and extrapolated to Standard Test Conditions (STC). Its main parameters are compared with the nominal data of the module in Table 2. It can be seen an open circuit voltage (Voc) drop of 3,45V, which correspond with the contribution of the three inactive cells in addition to other partial inactive cells, as it can be seen in the EL images in Figure 4. The short circuit current (Isc) does not significantly fall because the rest of cells are almost fully active (in the sense of cell area working).

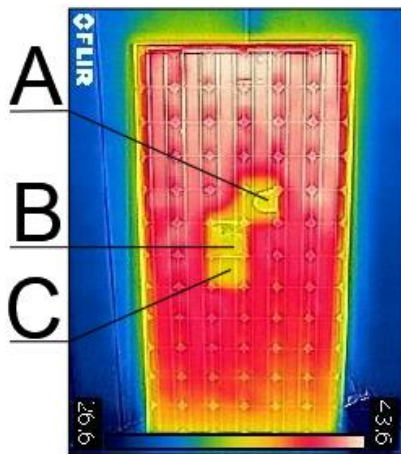
**Figure 6:** Thermographic image of S-E1 in the fourth quadrant during the EL test.

Results presented in Figure 6 show how total inactive cells remains cooler than active areas during the current injection for the EL test. Additionally, it has been observed that when there is an inactive area within a cell partially active, the active area is revealed as an overheated area. Therefore, it can be concluded that thermographic images during the EL tests also gives complementary information. In Figure 7, the module S-E1 is in landscape mounting mode, with its connection box in the right side of the image. The long hotter area in the right part of the module is the reflection of the anemometer post, which can be seen in the RGB image (Figure 7 b). The three Failures A, B, and C that have been analysed during this paper are also revealed in operation, as hot spots whose defects make them work in the second quadrant. However, the delamination that the module present in A and B, produces a change in the material emissivity value with respect the rest of the glass, responsible of covering up the hot spots, as the delaminated areas appear cooler than their actual temperature.
