DAYLIGHT ELECTROLUMINESCENCE INSPECTION OF PV PANELS ON-SITE VS. TRADITIONAL EL INSPECTION WITH SILICON CAMERAS

ABSTRACT: This paper presents a comparative study of electroluminescence (EL) imaging of silicon photovoltaic (PV) panels in three currently operating PV plants. EL images were acquired using two methods: in a darkroom with a silicon sensor reflex camera after dismantling the panels; and during daylight without dismantling the panels using an InGaAs sensor camera (dEL). The results demonstrate that dEL can detect the same important defects in the PV panels while being not only less costly in terms of time and money but also able to prevent the production of new defects resulting from disassembly, transportation and reassembly of the modules. This way, dEL provides a more efficient and reliable procedure for quality control and maintenance.

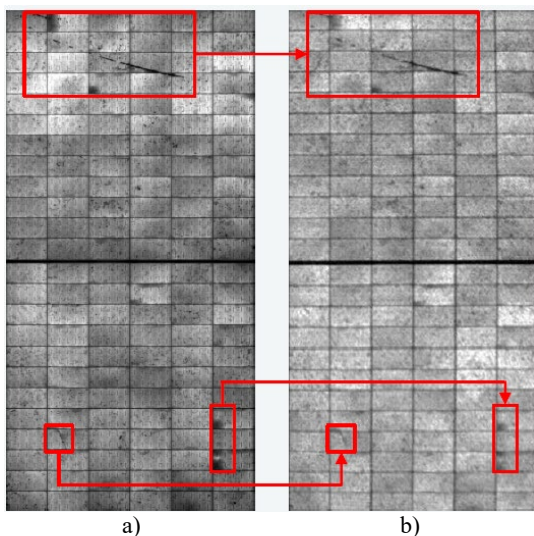
Figure 2: Defects in a polycrystalline silicon panel. a) High Resolution night Electroluminescence (disassembling) obtained with a Si camera; b) dEL image (without disassembling) obtained on-site with an InGaAs camera.

They were obtained by the two procedures mentioned above: using a high-resolution reflex camera after disassembling the panels (HR-nEL) (a), and using an InGaAs camera (on-site), before disassembly (dEL) (b). The results showed that despite the lower resolution of the InGaAs camera, the most significant defects [2], which can lead to a reduction in panel performance or an increase in degradation, are still detected.

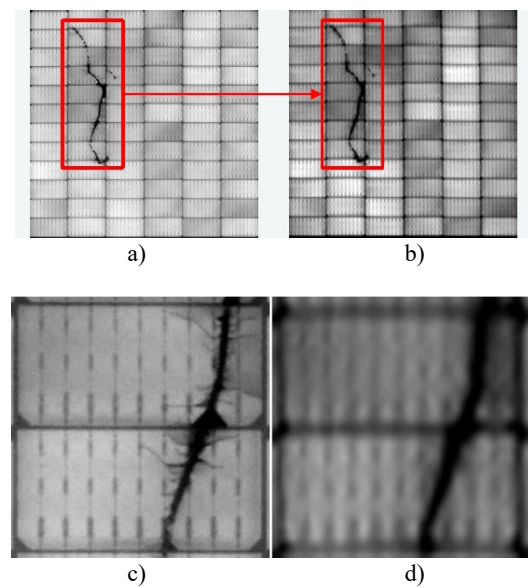
Fig. 3 shows the EL images of a monocrystalline silicon panel obtained by the two methods. The small fractures surrounding the large defect are not properly detect by dEL, although their contribution to the efficiency loss is considered lower.

Figure 3: a) HR-nEL image of an extensive defect in a monocrystalline panel; b) dEL image of the same monocrystalline panel; c) magnification of part of the defect in the same area observed by HR-nEL; d) same magnification in the dEL image

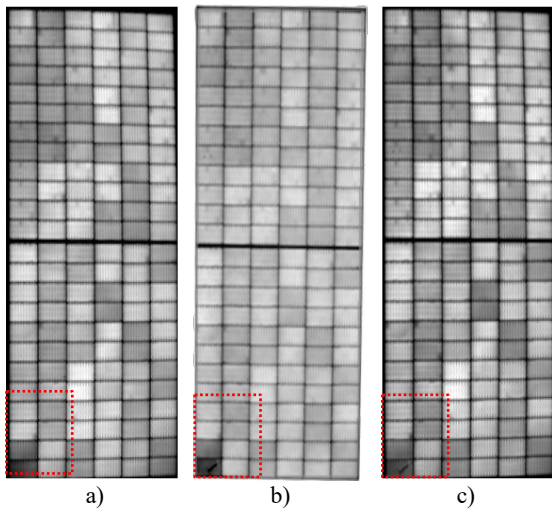
In addition to the comparative analysis of EL imaging methods, the study also investigates the potential damage caused by panel disassembly, handling and reassembly. The results show that certain defects appeared in some panels at some point during these processes. Fig. 4 presents such a case. Three EL images are shown in the figure: Fig. 4a), taken with the InGaAs camera before disassembly; Fig. 4b), taken with a Si camera after disassembly; and Fig. 4c), a new image taken again with the InGaAs camera after reassembly. Fig. 4b) shows a defect not visible in Fig. 4a). Fig. 4c) confirms the presence of the defect, which was not initially found. Fig. 5 shows the area of this defect magnified for each image. The defect should be thus ascribed to the disassembled/handling process for the HR-nEL inspection. This finding highlights the importance of using non-destructive inspection methods, such as dEL imaging on-site, to prevent damage to PV panels during EL inspection procedures.

Figure 4: a) dEL image taken with the InGaAs camera before disassembly; b) HR-nEL taken with the Si camera after disassembled the panel for a darkroom inspection; c) dEL image after reassembly. A defect has appeared in the lower left corner

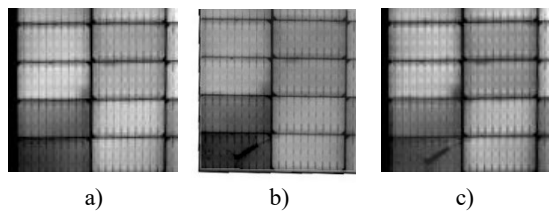
Figure 5: Magnification of the interest zone in Fig. 4 (red dotted); a) dEL image taken with the InGaAs camera before disassembly; b) HR-nEL taken with the Si camera after disassembled the panel for a darkroom inspection; c) dEL image after reassembly
