Comparison of outdoor and indoor PL and EL images in Si solar cells and panels for defect detection and classification

C. Terrados, D. González-Francés, V. Alonso, M.A. González, J. Jiménez, O.

GdS-Optronlab group, Dpto. Física de la Materia Condensada, University of

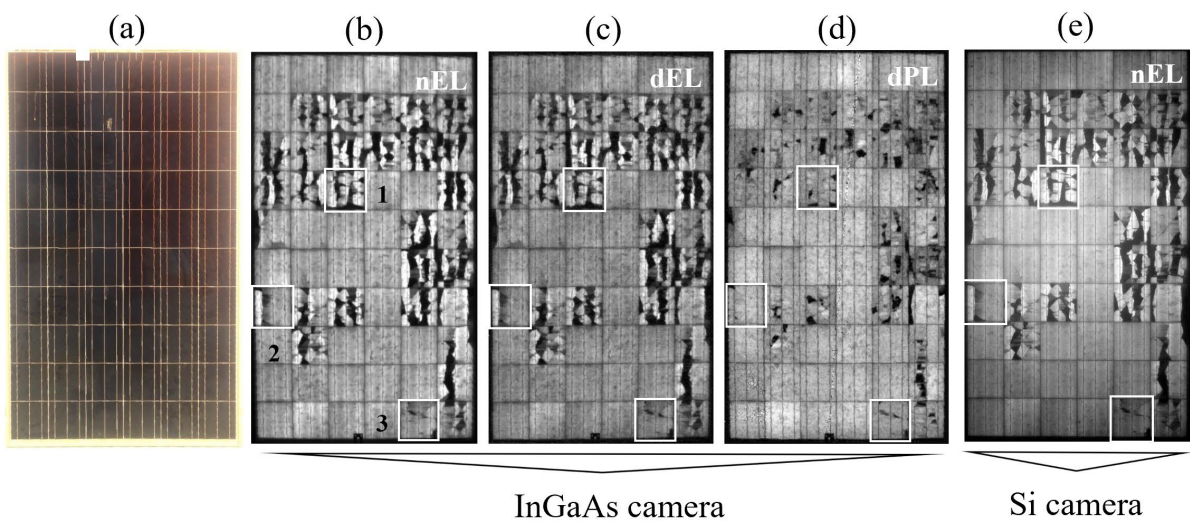
A heavily damaged (27% power reduction from the nominal value – 255 W –, obtained from the I-V curve) mc-Si PV panel was first inspected using the four imaging techniques. Figure 2(a) shows the image obtained by a direct visual inspection, in which no defects were detectable. Figure 2(b-d) shows the corresponding nEL (b), dEL (c) and dPL (d) images of the whole PV panel obtained with the InGaAs camera, while Figure 2(e) shows the nEL image obtained with the Si camera. Obviously, the nEL image obtained with the Si camera gives an image better-defined than the one provided by the InGaAs camera. However, as mentioned, Si cameras do not allow for obtaining daylight luminescence images. Since dEL (and dPL) can be very valuable for a fast and massive panel inspection on-site, it would be useful to know their limitations, and capabilities, compared to nEL performed with Si cameras.

No significant differences between the nEL and dEL images obtained with the InGaAs camera are observed, despite the high irradiation conditions under which the dEL image was obtained (900 W/m²). This demonstrates the capability of our subtracting method to obtain a high quality dEL image. On the other hand, the dPL image obtained under the same irradiation conditions (900 W/m²) shows a different image pattern, as can be observed in more detail in Figure 3, where the zoomed nEL, dEL and dPL images of three selected

Fig. 2. (a) Visual image; (b) nEL image, (c) dEL image (obtained at 900 W/m^2), and (d) dPL image (obtained at 900 W/m^2), of a whole mc-Si PV panel obtained with the InGaAs camera; (e) nEL image of the whole mc-Si panel obtained with the Si camera. Three solar cells (marked on (b), and labelled as #1, #2 and #3) were selected for a detailed inspection

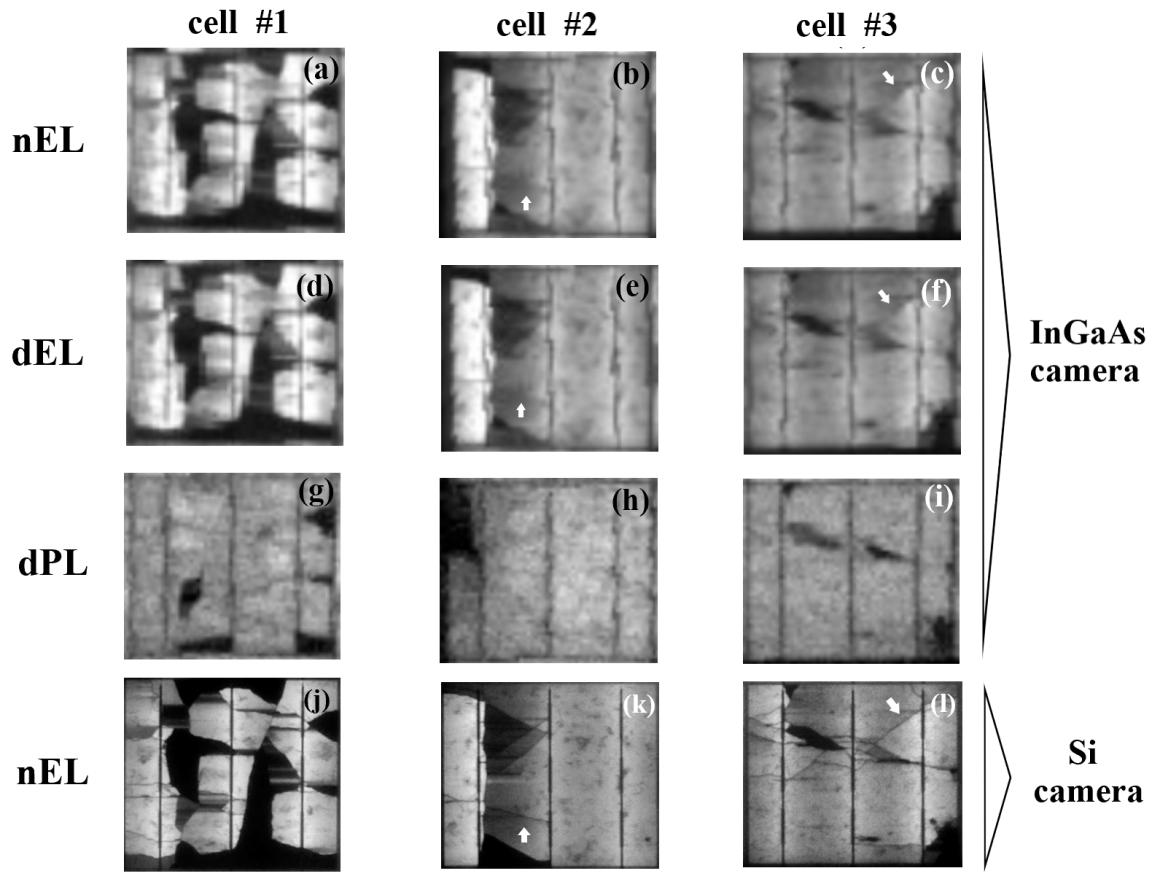
individual solar cells are shown. The selection of the cells has been performed according to their grey levels from the histogram, which can be supposed to be related to their level of damage, namely large, medium or small (labelled as #1, #2 and #3, respectively). These zoomed images evidence the lower resolution of the InGaAs camera. In fact, according to the detector dimensions and pixel sizes, the image of one solar cell (15.6 cm x 15.6 cm in this case) corresponds to approximately 425 x 425 pixels when the whole module is inspected with the Si camera, while only to approximately 64 x 64 pixels when the whole module is inspected with the InGaAs camera. For instance, thin isolated cracks are well visualized with the Si camera but are blurred when observed with the InGaAs camera [see the arrows in Figure 3 (b, e, k) and (c, f, l)].

As can be observed in Figure 3, the information provided by nEL and dEL images are essentially the same for the three solar cells, observing only a higher noise for the dEL images. The quantification of the noise has been performed by means of the SNR, as detailed below. On the other hand, the dPL image shows different features with respect to the EL images, except for the case of solar cell #3, for which the image pattern is nearly the same as for the EL images.

Fig. 3. Zoomed images of the three selected solar cells (mc-Si panel) marked on Fig. 2(b): (a-c) nEL images obtained with the InGaAs camera; (d-f) dEL images; (g-i) dPL images; (j-l) nEL images obtained with the Si camera. Isolated cracks observed with the Si camera (as those marked with arrows on (k) and (l)) are blurred when observed with the InGaAs camera due to its lower resolution [see arrows on (b,e) and (c,f)]

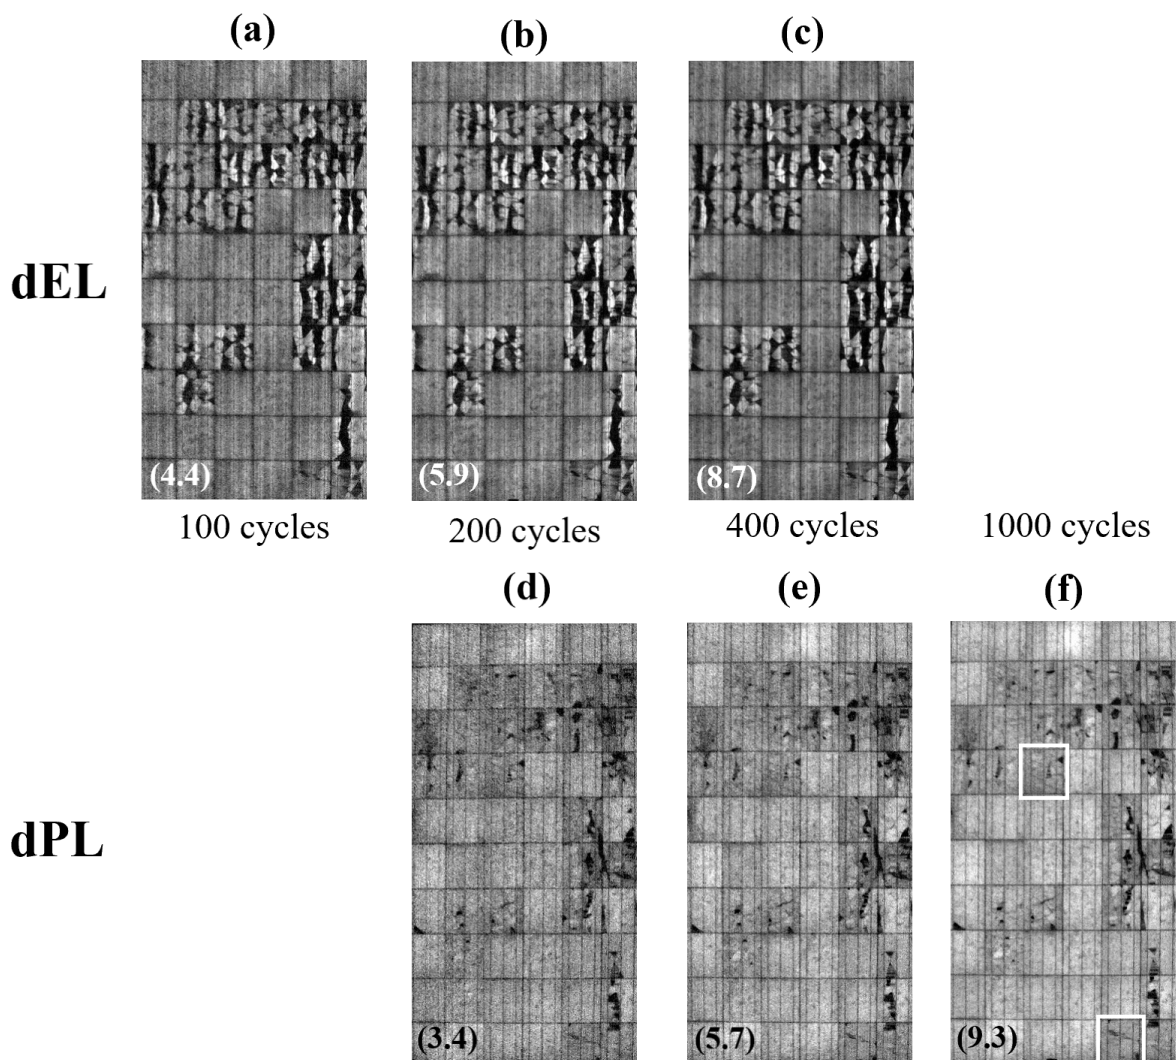
The noise level in the dEL and dPL images are due to the changes in the background light during the acquisition of the images [10, 19]. The noise can be reduced by acquiring a higher number of images (on/off cycles) (higher acquisition times). The SNR was evaluated according to the SNR_{avg} value described in ref. [19]. Figure 4 shows the dEL and dPL images of the whole mc-Si module under study, with the use of 100, 200 and 400 cycles in the case of dEL, while 200, 400 and 1000 cycles have been used in the case of dPL. The SNR_{avg} is found to increase with the number of on/off cycles, both for dEL and dPL images. On the other hand, SNR_{avg} is lower for dPL images with respect to the dEL images (comparing the

images obtained with the same number of cycles in each case), which is associated with the lower intensity of the luminescence signal in the dPL method compared to the dEL case, as will be discussed later on. According to ref. [19], a SNR_{avg} value of 5.0 is enough to have a good quality image. As observed, for dEL images this value can be reached with 200 cycles, while for dPL images the number of cycles must be significantly increased. Therefore, noise reduction can be achieved at the expense of increased acquisition time, a compromise between both is necessary.

Fig. 4. dEL images (a, b, c) and dPL images (d, e, f) (at 900 W/m^2) of the whole mc-Si module obtained with (a) 100, (b, d) 200, (c, e) 400 and (f) 1000 on/off cycles. The values of the SNR_{avg} are given for each image (left corner, in brackets). Selected individual solar cells #1 and #3 are remarked on (f).

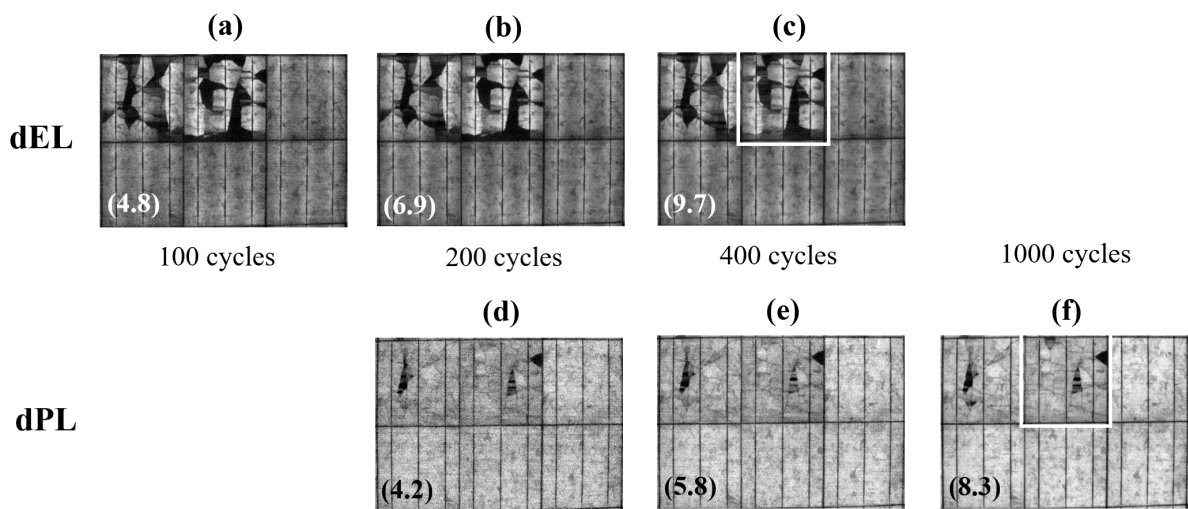
Large spatial resolution can be obtained by bringing the camera close to the module. Figure 5 shows the dEL and dPL images obtained under the same irradiation conditions and using the same experimental parameters as those in Figure 4. The image quality is increased in this case (see for instance cell #1 in Fig. 5c, compared to Fig. 3d) due to the increased spatial resolution. The SNR_{avg} is increased by increasing the number of cycles. Moreover, the SNR_{avg} is a little higher now (Figure 5) respect to the previous situation (Figure 4) for the same number of on/off cycles, due to the closer position of the camera respect to the module, which implies a higher collection of photons.

Fig. 5. dEL images (a, b, c) and dPL images (d, e, f) (at 900 W/m^2) of a smaller area of the mc-Si module shown in Fig. 4, obtained with (a) 100, (b, d) 200, (c, e) 400 and (f) 1000 on/off cycles. The values of the SNR_{avg} are given for each image (left corner, in brackets).

Selected individual solar cell #1 is remarked on (c) and (f).

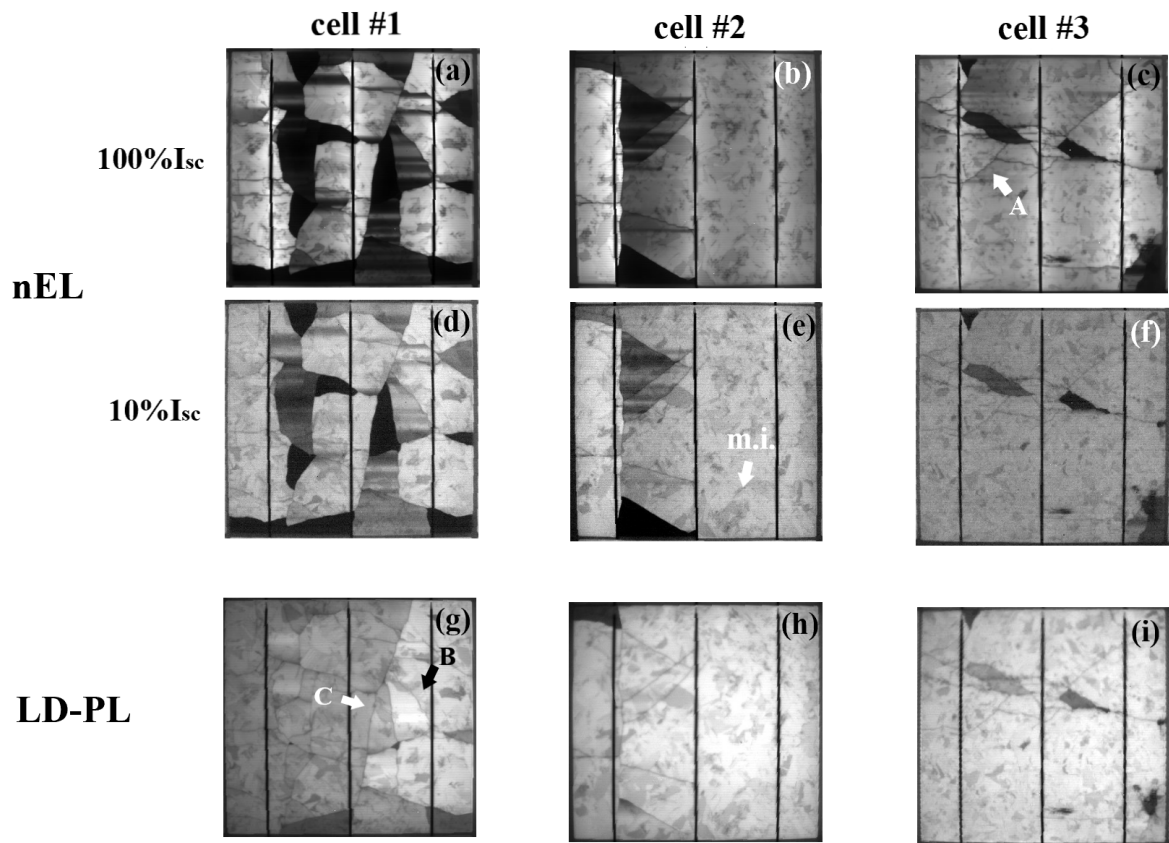
Figure 6 (a-f) shows HR-nEL images obtained at 100% I_{sc} (a-c) and at 10% I_{sc} (d-f), and Figure 6 (g-i) shows the LD-PL images of the three solar cells. The main defects observed are: i) material inhomogeneities (typical in mc-Si), which are better revealed in the LD-PL (since for the EL image this information is lost in the areas where the failure of the electrical contacts is dominant), and ii) cracks and micro-cracks, which are critical to the module failure. Not all the cracks have the same impact, in fact the contrast in the images depends on the electrical connection to the other parts of the cell. One can classify cracks in three categories [20]: A) cracks, whose the surrounding areas are still electrically connected, and appear as thin, dark lines in the luminescence images; B) cracks, with areas partially connected to their surrounding regions through a finite resistance, the luminescence of the enclosed areas depends on the value of such resistance; and C) cracks, which are fully isolated from the rest of the cell, in this case the crack enclosed areas appear fully dark in EL images.

In LD-PL all the electrically connected cell parts would have roughly the same background PL intensity, which would be the case for areas separated by A and B cracks, while areas separated by C cracks are completely disconnected and their PL intensity can differ due to different recombination rates in the different cell parts [18].

If one compares the detailed information provided by the HR-EL and LD-PL images (Figure 6) with the low resolved dPL image (Figure 3), the information provided by the last one is not clear, it seems to be connected to the presence of C cracks. Moreover, as observed from different batches of dPL results (for instance those shown in Figures 4 and 5, compared to Fig. 2d), while the contrast in the dEL image depends only on the I_{sc} value, the dPL images

appear blind to some of the defects revealed in the EL images and the results depend more largely on the experimental conditions. In fact, dPL images are highly sensitive to the background light intensity, as the detection of some of the defects depends on the experimental conditions in terms of sun irradiation conditions. Cell #1 and #2 present dPL images with noteworthy differences with respect to the EL images, and largely depending on the experiment, while for cell #3 dPL reveals the same defects as that of EL. The essentially identical information provided by nEL, dEL and dPL in solar cell #3 can be related to cracks of type C, which represent regions of the cell fully electrically isolated.

Fig. 6. Detailed inspection of the three selected solar cells (mc-Si panel) marked on Fig.1(b): (a-f) HR-nEL images at high injection (100% I_{sc} , a-c) and at low injection (10% I_{sc} , d-f); (g-i) LD-PL images ($\lambda_{exc} = 808 \text{ nm}$, $P_{exc} = 7 \text{ W}$) (m.i. \equiv material inhomogeneities; A, B, C \equiv cracks of type A, B or C)

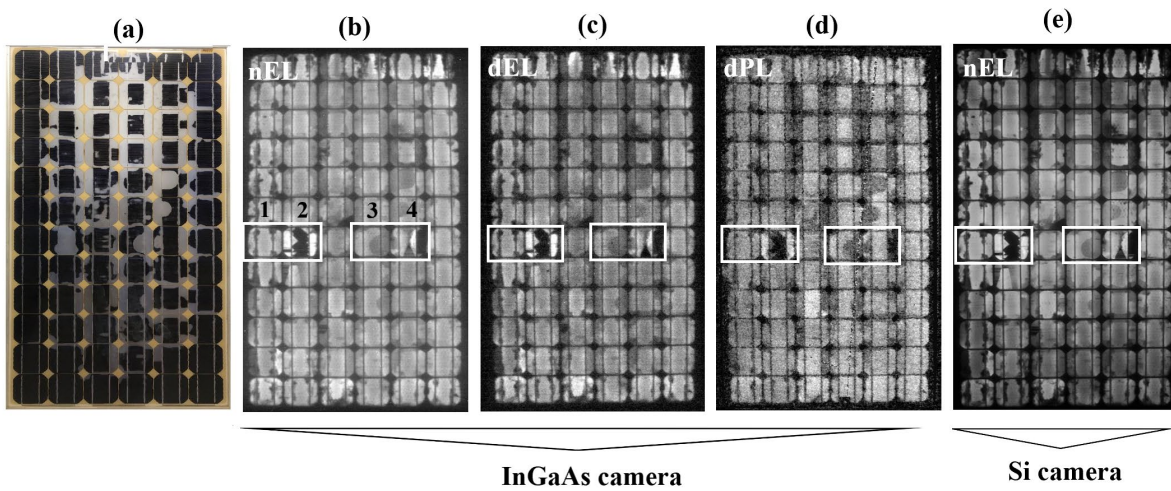
Figure 7(a) shows the visual image of a large damaged m-Si PV panel (43% power reduction from the nominal value – 175 W –, obtained from the I-V curve), where a high number of solar cells show delamination [6, 8]. Figure 7(b-d) shows the nEL, dEL and dPL of the entire PV panel obtained with the InGaAs camera, while Figure 7(e) shows the nEL image obtained with the Si camera. Four solar cells (their zoomed images are shown in Figure 8) have been selected in this case for a detailed analysis by means of HR-nEL and LD-PL characterization with the use of the InGaAs camera.

Figure 7. (a) Visual image; (b) nEL image, (c) dEL image (obtained at 900 W/m^2) and (d) dPL image (obtained at 900 W/m^2), of a whole m-Si PV panel obtained with the InGaAs camera; (e) nEL image obtained with the Si camera. Four solar cells (marked on (b), and labelled as #1, #2, #3 and #4) were selected for a detailed inspection

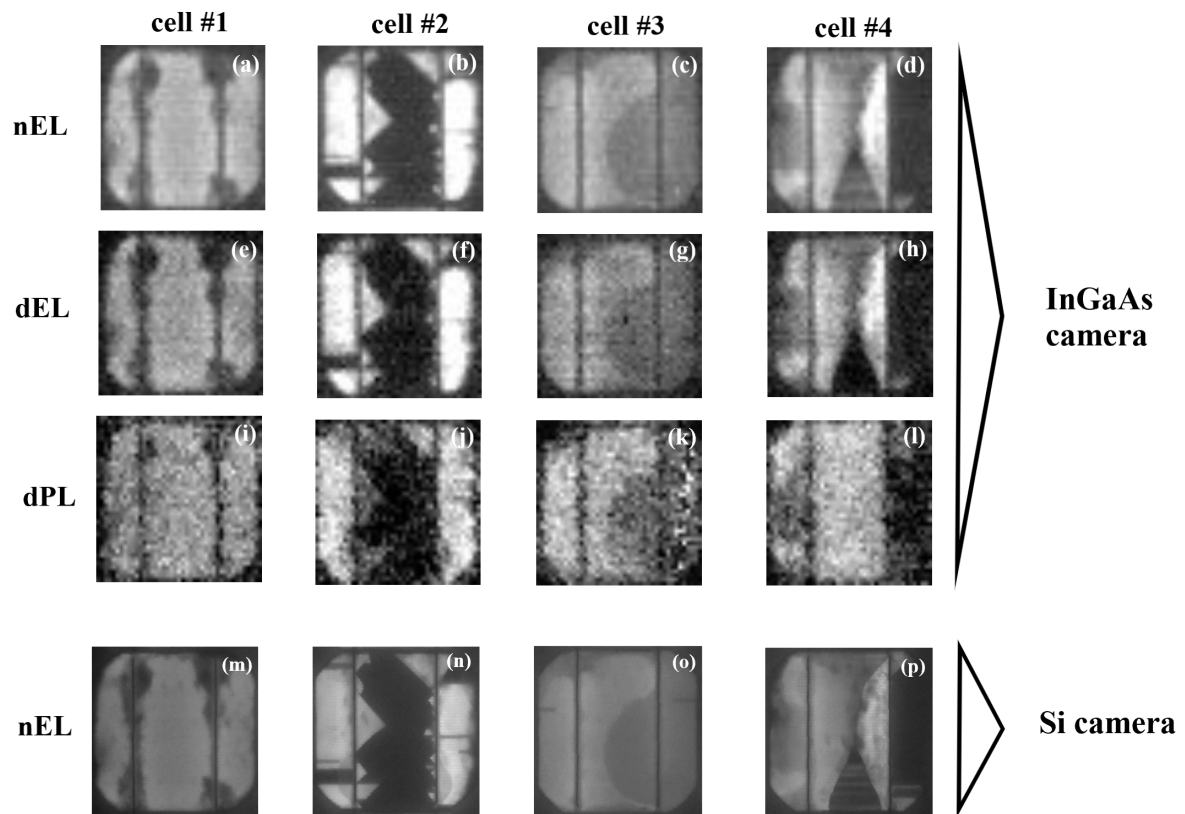
Comparing the results with those obtained from the nEL, dEL and dPL images of the entire PV solar panel, it is clear that the small resolution of the InGaAs camera is a handicap. However, essentially the same information as that obtained from the HR-nEL images can be observed both in the nEL and dEL images. On the other hand, the dPL image provides also some useful information about areas with complete isolation (C crack defects), as is the case of solar cells #2 and #4.

Fig. 8. Zoomed images of the four selected solar cells marked on Fig. 7(b): (a-d) nEL images, (e-h) dEL images, and (i-l) dPL images obtained with the InGaAs camera; (m-p) nEL images obtained with the Si camera

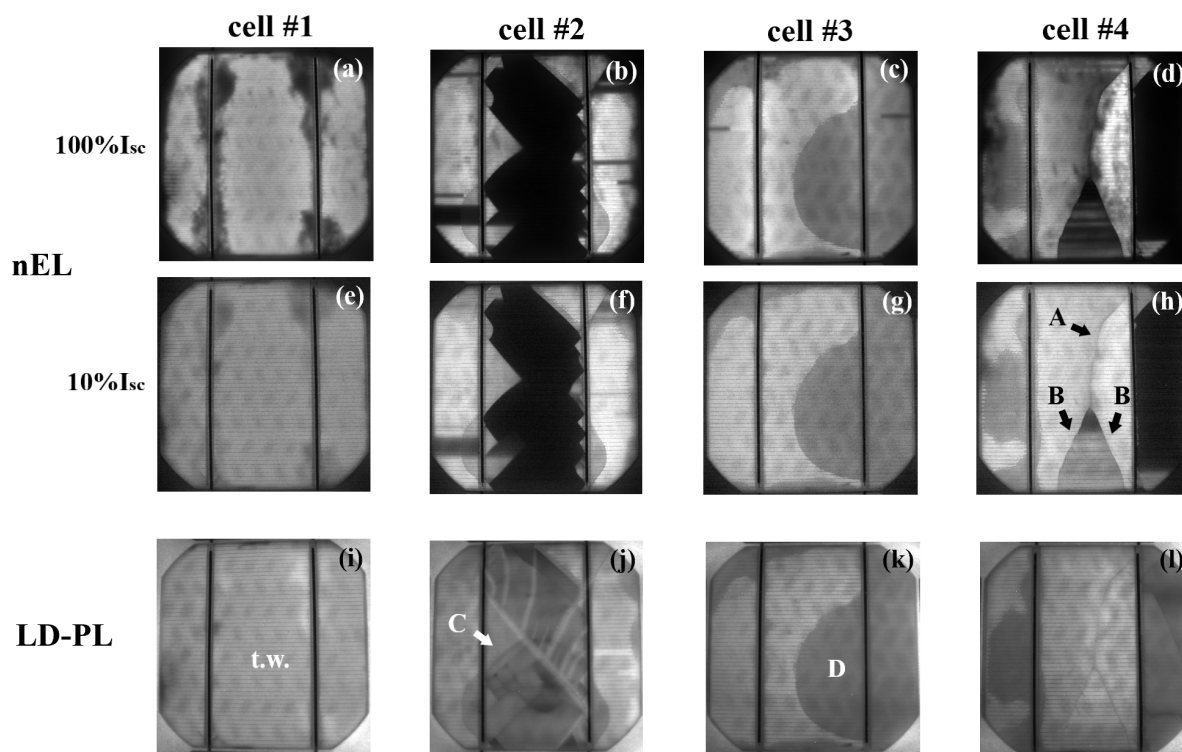
Figure 9(a-h) shows the HR-nEL images obtained at high injection (a-d) and low injection (e-h) levels, while Figure 9(i-l) shows the LD-PL images for the four solar cells. The LD-PL as well as the HR-nEL images show clearly “tire wheel” defects for all the solar cells (which are ascribed to temperature inhomogeneities of the transport belt during the firing process to obtain the cells [9]), this information is lost in the low-resolution images of the whole panel obtained with the InGaAs camera. LD-PL images show also the presence of big cracks in solar cell #2, the delamination observed in solar cell #3, and the presence of thin lines corresponding also to A or B cracks in solar cell #4. This information is also observed in the

HR-nEL images, which emphasizes more clearly the electrical contact effects. However, the HR-nEL images of solar cell #1 at high injection reveals also problems in the fingers, thus ascribed to series resistance defects, which can be hardly detected by LD-PL.

Fig. 9. Detailed inspection of the four selected solar cells marked on Fig.7(b): (a-h) HR-nEL images at high injection (100% I_{sc} , a-d), and at low injection (10% I_{sc} , e-h); (i-l) LD-PL images (t.w. \equiv “tire wheel” defects; A, B, C \equiv cracks of type A, B or C; D \equiv delamination)
