Diagnosis and assessment of a historic timber structure in La Casa del Corregidor, using non-destructive techniques

This paper presents the assessment of the timber structure of “La Casa del Corregidor” building, a singular historic building in Cuenca (World Heritage City). The building is scheduled for restoration in the near future. The study made use of both non-destructive (NDT) and semi-destructive (SDT) techniques.

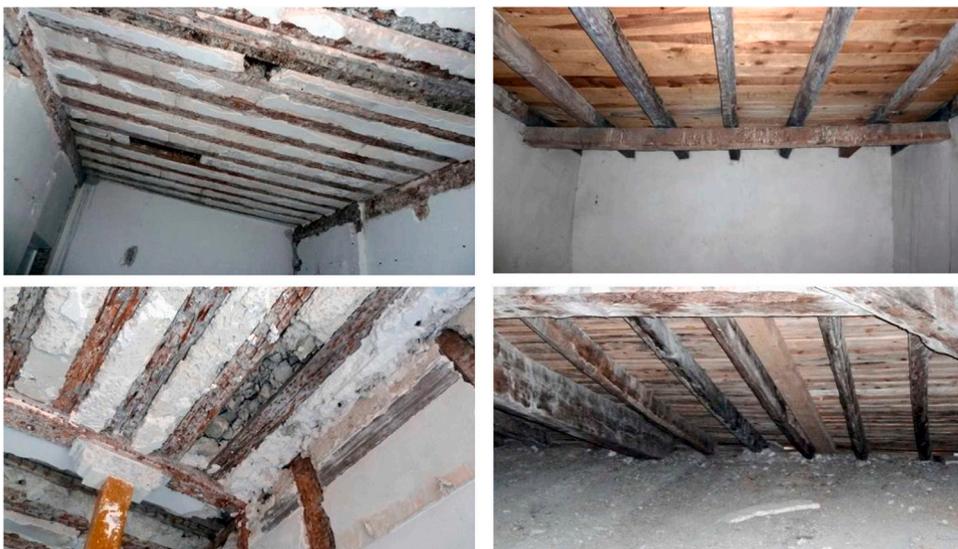
Fig. 3. Floor type 1 (left) and floor type 2 (right).

In the first typology, the space between joists is around twice their width, and it is filled of masonry materials coated with plaster on the bottom. In the second typology, the space between joists is variable and the wooden board is nailed directly to the joist upper side width [Fig. 3].

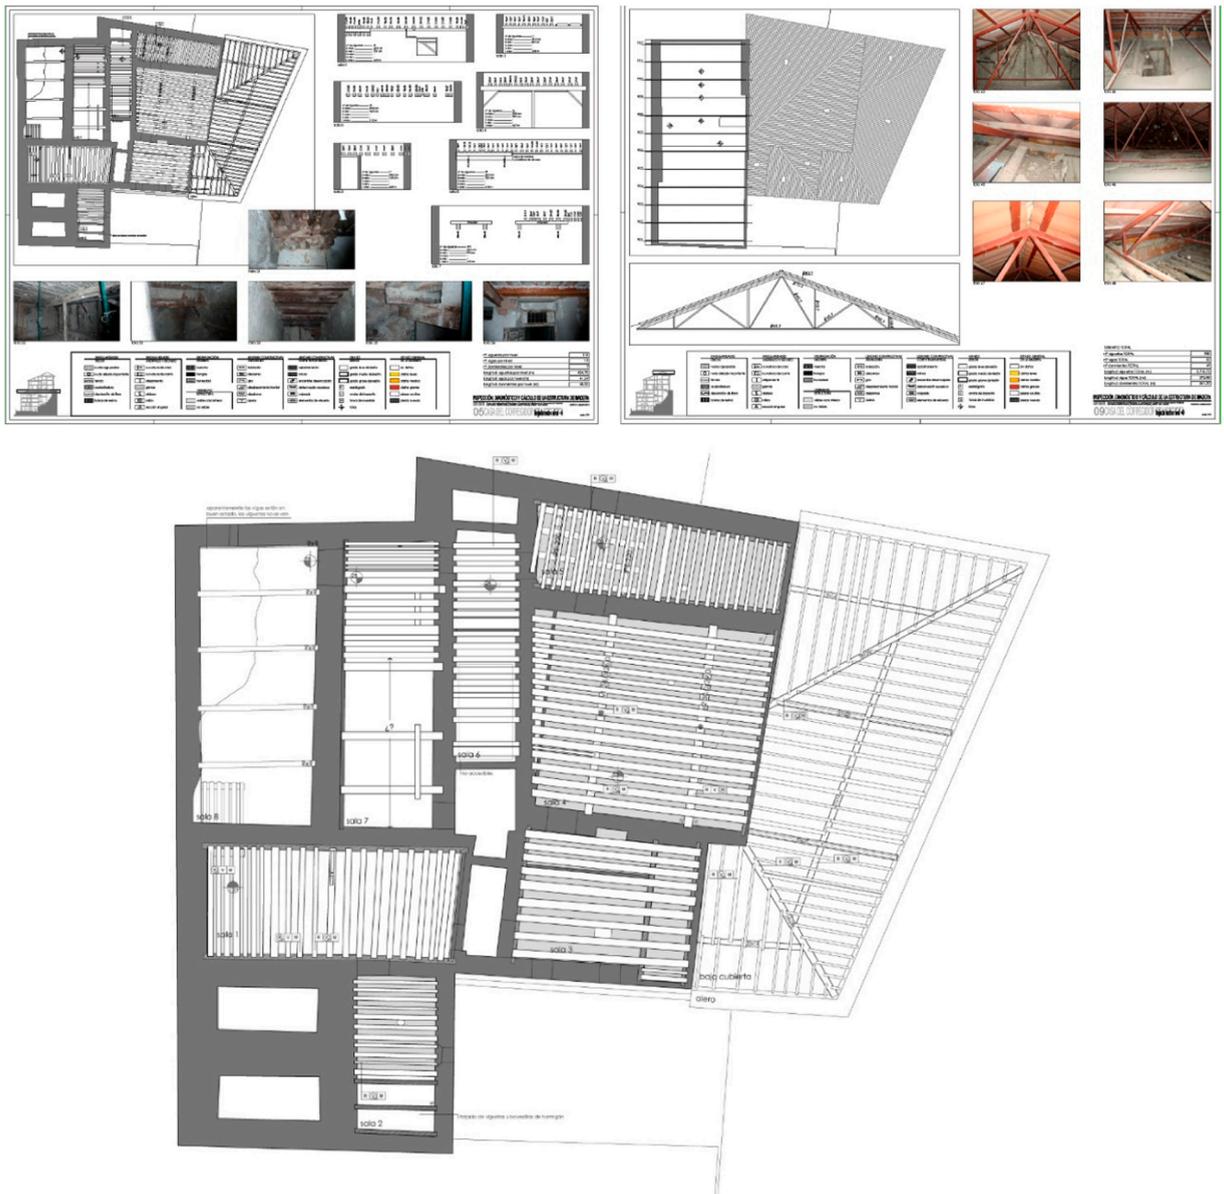
Fig. 6. Some examples of structure descriptive plans. All plans are available for consultation in [hq](#) in [17].

General photographs of each room were taken, while detailed pictures were captured of beams or joists when necessary. The point of view of each photo is indicated on the plans. An accurate geometric evaluation of both structure and cross sections of all elements were defined and represented on plans. The representation work was made according to a system implemented by our research team and standardized by UNE 41808 [16], resulting as follows [Fig. 6]:

Overall, the condition of the timber structure was good, particularly for the upper floors located above the access road. However, the lower level shows worse condition, especially in the rooms adjacent to and below to the main access, as they are in contact with the ground rock on which the city was built.

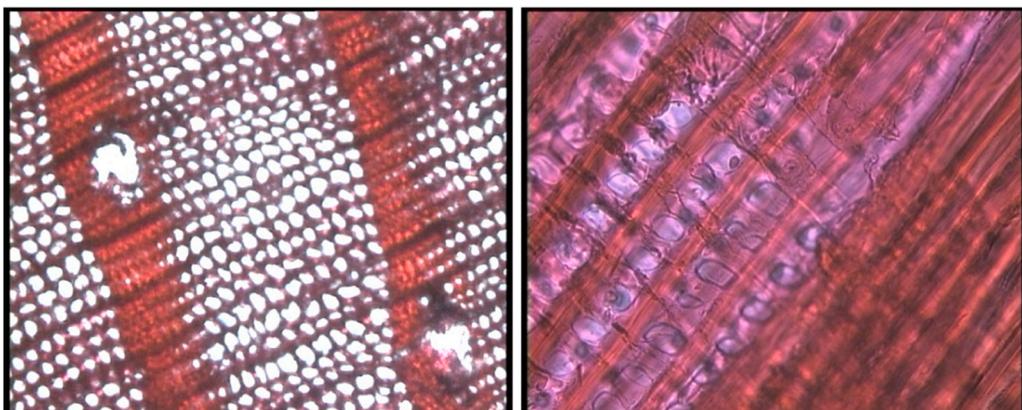
Fig. 8. Transversal and radial cut.

- a) Homogeneous structure and non-existence of vessels.
- b) Longitudinal resiniferous canals located at the end of the growth ring.
- c) Inner walls of the radial tracheids with pronounced and abundant teeth.
- d) Crossing-field pits of either pinoide I or window type; dentate radial tracheids.
- e) Uniserial woody radii; some of which are fusiform-like with radial resin canals.

The observed characters lead to the possibility, with high probability, that the analysed samples belong to the species *Pinus sylvestris* L., commercially known as Scots pine.

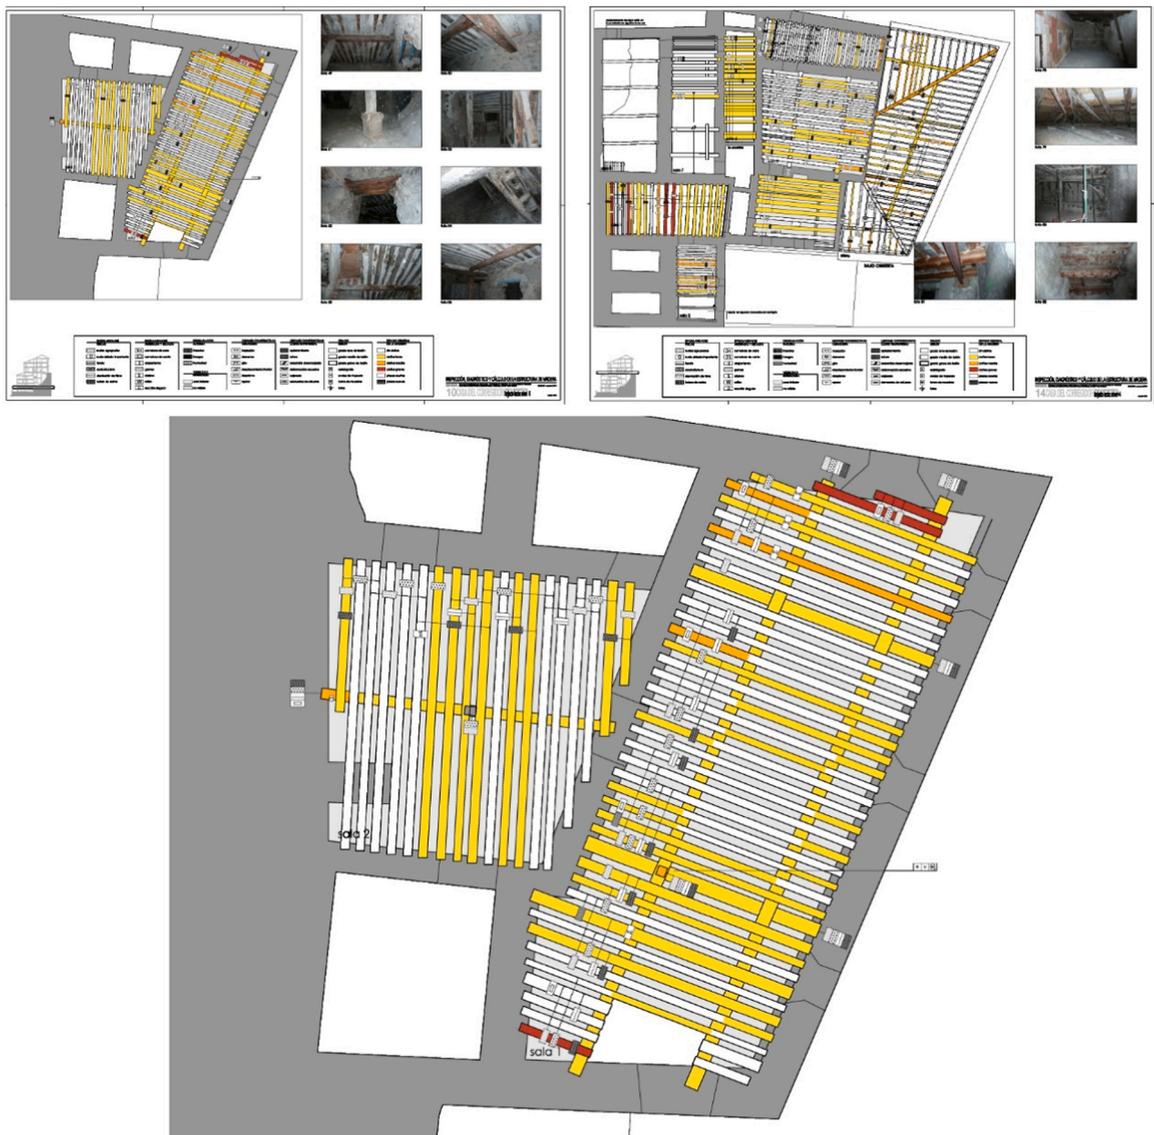
Fig. 9. Examples of diagnostic plans. All plans are available for consultation in hq in [17].

All visual and instrumental data collected were mapped on specific diagnostic plans, one per level [Fig. 9]. These scaled drawings comprised section dimensions, singularities, natural defects, timber failures and decays, construction and mechanical damages, concealed areas, as well as instrumental test and photos location. On these plans damage intensity was marked with a colour code and thickened boxes in accordance with the standard UNE 41808 [16].

These detailed maps provide local and global information about state of preservation. Deteriorated areas can be graphically shown, helping to find the causes of damage or pathologies if they exist. In addition, the use of colour facilitates taking a decision for the design of the intervention if need it.

After all the diagnostic assessment work, only 5 % of the timber elements might need a large intervention such as substitution or the addition of a prosthesis (Table 3). The remaining 95 % of the original timber structure could be maintained. Most of the timber elements only require minor restoration works like wood planning and fungicide treatment.
