High resolution LBIC characterization of defects in mc-Si solar cells

L. A. Sánchez*, A. Moretón, M. Guada, S. Rodríguez, O. Martínez, M. A. González, J. Jiménez

GdS-Optronlab, Dpto. Física de la Materia Condensada, Universidad de Valladolid, Edificio LUCIA, Paseo de Belén 19, 47011 Valladolid - Spain
*lasandom92@gmail.com

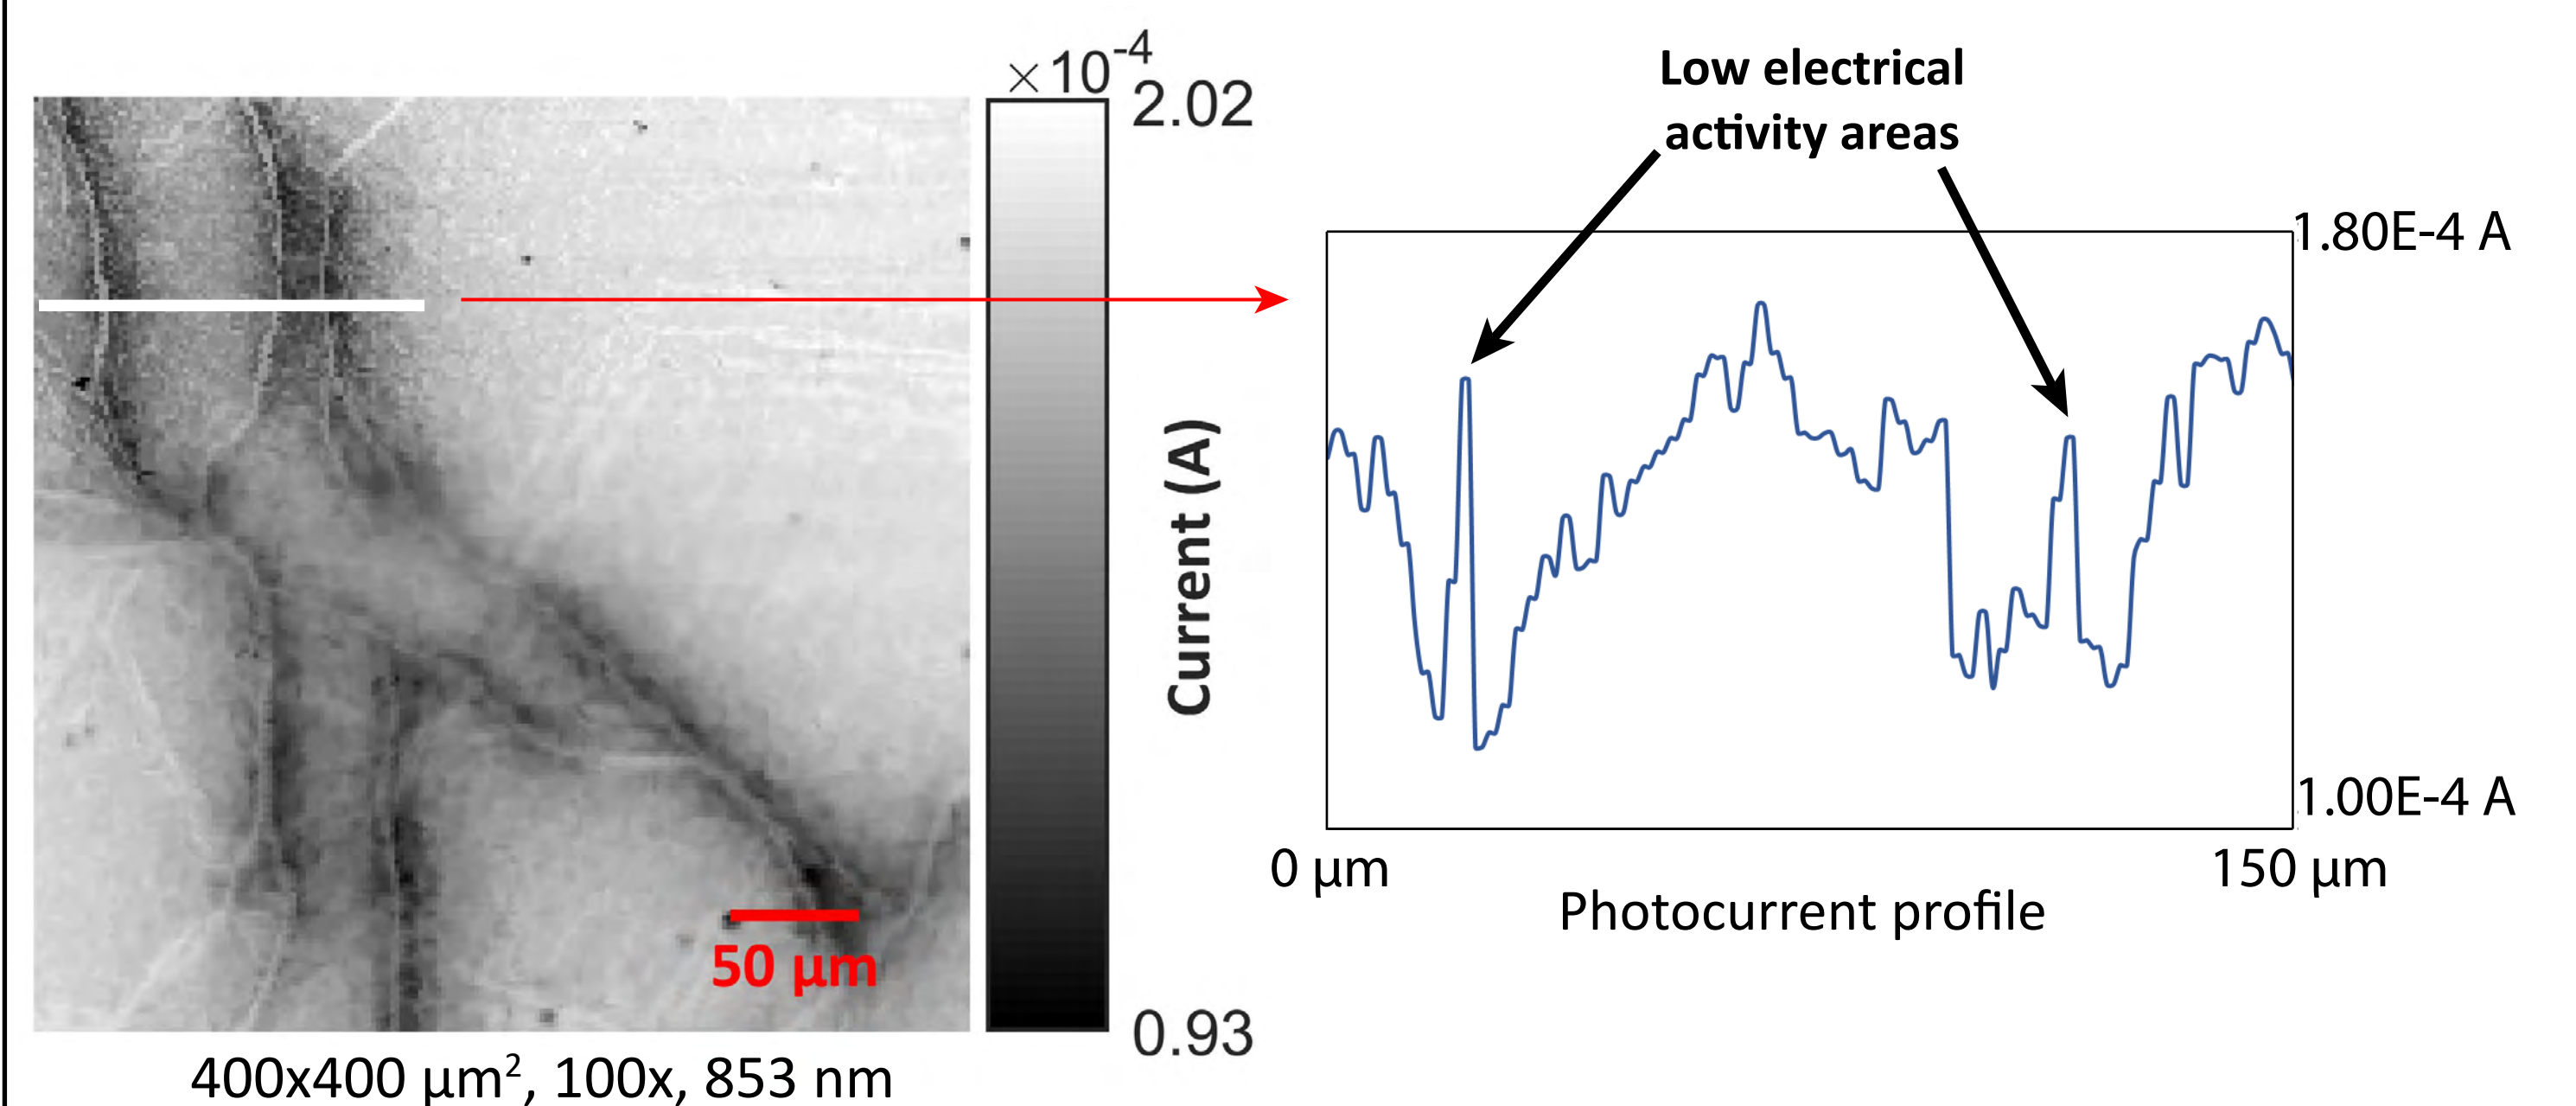
Low electrical activity along the core of the defects

- High resolution LBIC maps reveal intragrain defects presenting low electrical activity along the core of the defects and high capture rates around them
- The high current at the core can arise from impurity depletion or a higher effective excitation due to lower reflectivity
