# 4D Monitoring of Active Sinkholes with a Terrestrial Laser Scanner (TLS): A Case Study in the Evaporite Karst of the Ebro Valley, NE Spain

**Abstract:** This work explores, for the first time, the application of a Terrestrial Laser Scanner (TLS) and a comparison of point clouds in the 4D monitoring of active sinkholes. The approach is tested in three highly-active sinkholes related to the dissolution of salt-bearing evaporites overlain by unconsolidated alluvium. The sinkholes are located in urbanized areas and have caused severe damage to critical infrastructure (flood-control dike, a major highway). The 3D displacement models derived from the comparison of point clouds with exceptionally high spatial resolution allow complex spatial and temporal subsidence patterns within one of the sinkholes to be resolved. Detected changes in the subsidence activity (e.g., sinkhole expansion, translation of the maximum subsidence zone, development of incipient secondary collapses) are related to potential controlling factors such as floods, water table changes or remedial measures. In contrast, with detailed mapping and high-precision leveling, the displacement models, covering a relatively

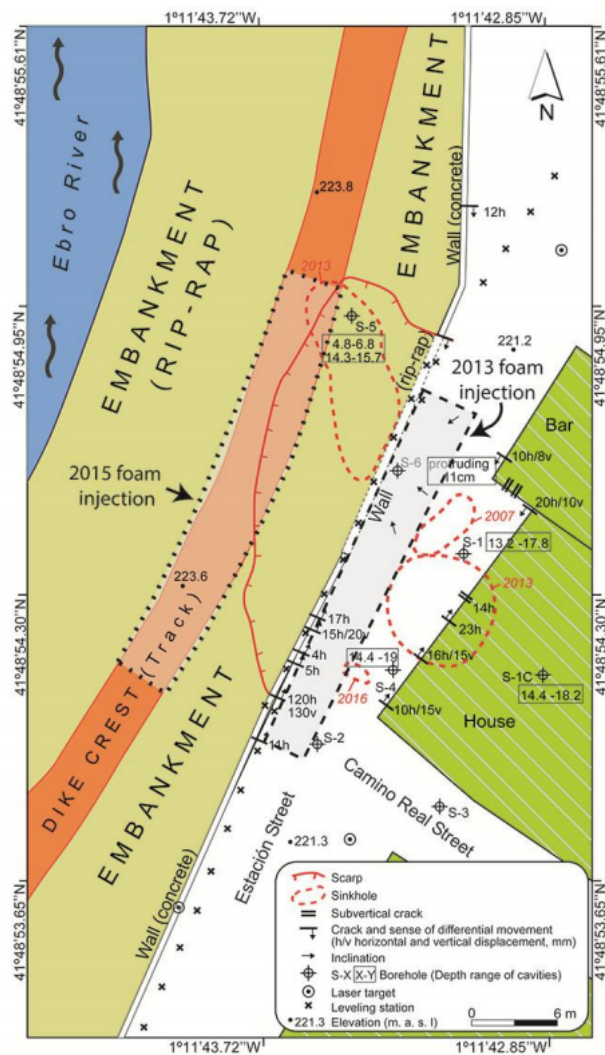
**Figure 2.** Detailed map of the Alcalá sinkhole produced in March 2016 showing the approximate locations of collapse events and remediation measures (compaction grouting with polyurethane foam), surface deformation features, positions of targets, leveling points and boreholes (numbers in parenthesis indicate the depth range of cavities).

The investigated sinkhole is located on the Western edge of Alcalá village, affecting the flood-control dike, the adjacent street (Estación Street) and two buildings: a bar and a house (Figures 2 and 3). In June 2007, a collapse sinkhole, 8 m across and 15 m deep, occurred in the street in front of the house. Since that event, the site has suffered from continuous subsidence as well as multiple collapse events (see their distribution in Figure 2) leading to a number of geotechnical investigations. A total of seven boreholes, 25–44 m deep, have been drilled in the site (Figure 2), indicating the following

stratigraphy in descending order: (1) An unconsolidated cover around 6–7 m thick, comprising an anthropogenic deposit up to 4.6 m thick, underlain by fluvial deposits; (2) a karstic residue consisting of 20 m of dark grey clays and marls with residual gypsum particles that grade downwards into the unaltered evaporitic bedrock; and (3) the Tertiary evaporitic bedrock, including gypsum, halite and glauberite beds [39]. The vertical distribution of water- and alluvium-filled cavities encountered in the boreholes is indicated in Figure 2. Borehole data reveal the presence of significant cavities beneath the investigated sinkhole and the surrounding zone, mostly concentrated at depths between 13 and 19 m, probably controlled by a salt unit (i.e., halite and/or glauberite). The water table at this site, located next to the river channel and underlain by pervious alluvium and cavernous bedrock, is controlled by the water level of the river. Elevation changes in the water table between low-discharge periods and floods may reach more than 5 m, and the sinkhole may eventually be affected by groundwater flooding. The spatial–temporal variations in the distribution and rate of subsidence in the sinkhole area may have been affected by the occurrence of collapse sinkholes—partial remediation measures carried out before and during the monitoring period—as well as by floods in the adjacent Ebro River. The main actions and events are listed chronologically below, together with the scans. The distribution of collapse events and remediation measures is shown in Figure 2:

The deformation features that developed on the ground surface and in human-built structures were mapped on March 2016, mainly to gain insight into the extent of the subsidence area (Figure 2). This map of surface deformation and structural damage indicates an elongated subsidence depression around 40 m long with an apparent N–S orientation. The area is affected by continuous sagging and embraces the multiple nested collapse sinkholes that have occurred since 2007. On the Western side, there was a conspicuous arcuate fissure-scarp, 10–20 cm high, affecting the crest and Eastern shoulder of the dike (Figure 3A). This surface rupture connected with the largest cracks that developed on the wall of the dike, showing horizontal and vertical separations higher than 10 cm. The wall also showed cracks related to its tilt towards the sinkhole center, 9.2 m and 3.2 m north and south of the main fissures, respectively. This suggests that the subsidence area along the dike comprises an inner sector, 28 m long, affected by more rapid subsidence, and an outer aureole with slow inward tilting. Surface evidence of deformation does not allow for identification of the edge of the subsidence area along its Eastern side due to the lack of adequate markers and the impossibility of accessing the house. The topographically lowest portion of the subsidence zone is located at the foot of the rip-rap wall around borehole S-6. The casing of the borehole protrudes 11 cm above the ground surface, providing a rough

measure of the amount of subsidence between 7 July 2015 (borehole installation) and 11 March 2016 (measurement) (Figures 2 and 3C).

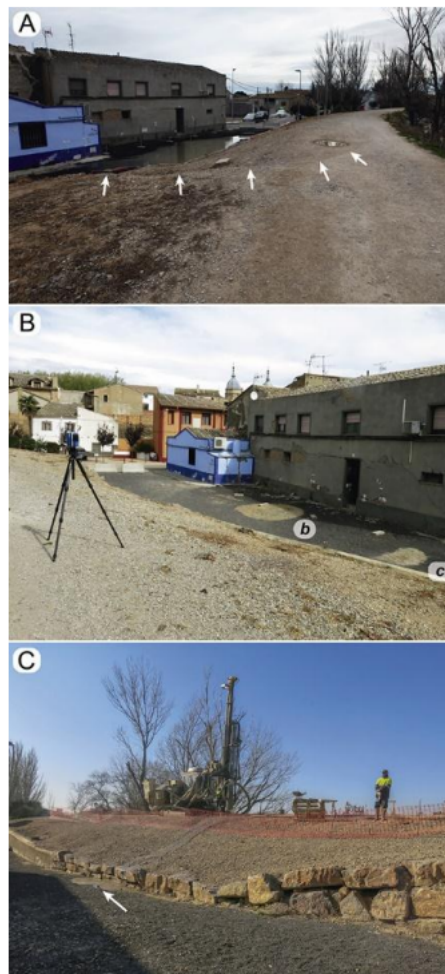
**Figure 3.** Images of the Alcalá sinkhole site taken at different dates. **(A)** Photograph taken on 2 March 2015, during the February–April Ebro River flood. The water stage in the river (right) is well above ground surface in the village, and water from the river flowed under pressure through and beneath the dike, flooding the sinkhole (left). The arrows point to an arcuate scarp-fissure developed in the dike. Note the cracking in the buildings. **(B)** Photograph taken on 5 October 2015, showing small collapse sinkholes (b and c) filled with lighter deposits. Note the cracking in the buildings. A laser scanner is to the left of the image. **(C)** Photograph taken on 1 December 2015 during the injection of polyurethane resin. The dike is affected by conspicuous sagging subsidence. The arrow points to borehole S-6, whose case protrudes above the ground surface.

4. December 2013: A new collapse sinkhole formed at the front of the house (labelled as b in Figure 3B).
5. February–April 2015: The Ebro River flooded with a return period of less than 10 years. The water stage of the river was well above the street level. The river water flowed under pressure beneath and through the dike causing internal erosion and flooding of the sinkhole (Figure 3A). Scans were carried out in October 2014 and in April and October 2015.

6. November–December 2015: A new grouting program with polyurethane foam took place along a 30 m long section of the dike through drillholes 5–15 m deep (Figure 3C).

During the period from April 2015–October 2015, following the February–April flood and the associated water-table drop, the main subsidence area (sinkhole a) kept a similar shape (Figure 6B1). However, there was a clear acceleration of subsidence between sinkhole b and the outer wall of the dike (area labelled d in Figure 6B1). In this period, the frequency of the subsidence values recorded in the main subsidence area shows a bimodal histogram (Figure 6B3), defined by a main peak at  $-8.4$  cm ( $-17$  cm/year), higher than the previous one, and a secondary peak at  $-16$  cm ( $-32.4$  cm/year) corresponding to the area labelled as d. Maximum subsidence values reached as much as  $-20$  cm ( $-40.5$  cm/year) near collapse sinkhole b. Before October 2015, collapse sinkholes b and c were filled with aggregates, so that they displayed positive values in the model (Figure 3B).

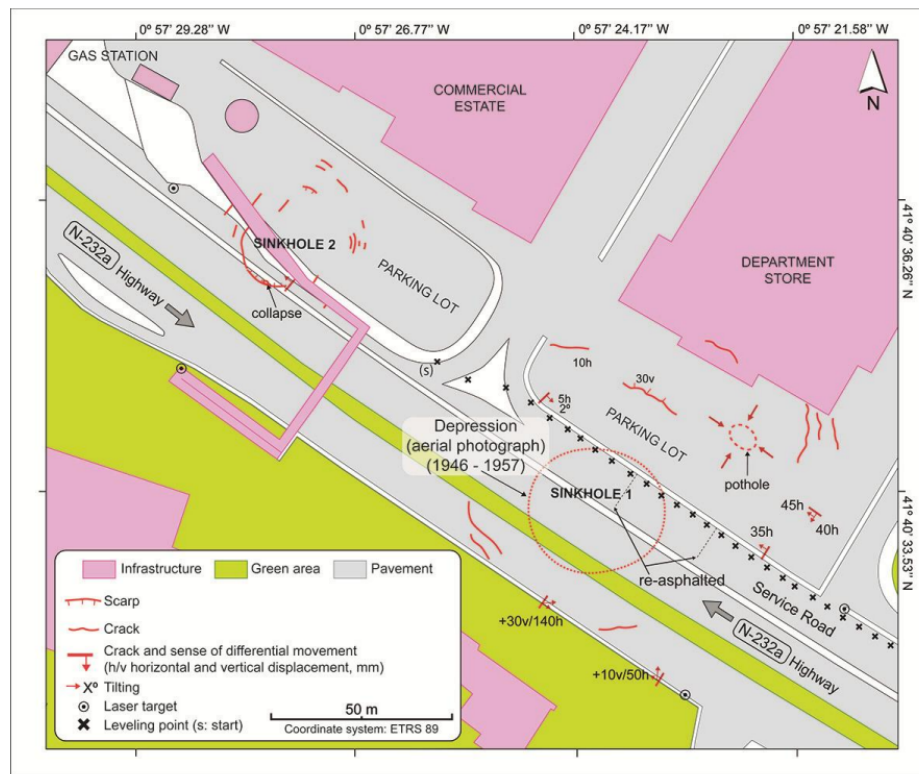
**Figure 4.** Map of the Logroño highway sinkholes. Surface evidence of deformation in sinkhole 1 (sinkhole in highway) and in sinkhole 2 (sinkhole in parking lot) were mapped in April 2016 and November 2011, respectively.

This site, located in the lowermost terrace of the Ebro River, includes two damaging sinkholes, here referred to as sinkholes 1 and 2 (Figure 4). Sinkhole 1 is a sub-circular buried sinkhole, around 110 m in diameter, that affects (1) both carriageways of the Logroño highway (N-232a); (2) the service road and a department store to the NE; and (3) a concrete wall on the SW flank of the highway [37,38]. The central and deeper part of the sinkhole can be recognised in grey-scale aerial photographs from 1945–1946 and 1957 as a sub-circular depression approximately 40 m across. Historical imagery reveal that this depression was filled sometime between 1957 and 1969. In the 1970s, a factory was built on the NE sector of the sinkhole, which was demolished in the late 1990s. At that time, the service road used to show a conspicuous sag related to rapid subsidence and poor maintenance (Figure 5A). The currently existing department store was built in 2001 (Figure 4). Nowadays, the Logroño highway and its service road are subject to re-asphalting works every one or two years. A map of this sinkhole

depicting the distribution of surface deformation features was produced in April 2016 (Figure 4). This map is rather limited due to frequent repair works but provides information on the minimum extent of the active subsidence area. Subsidence on the SW sector of the sinkhole was expressed as fresh arcuate cracks in the recent pavement of the highway, plus sagging and inward toppling in the concrete wall located along the edge of the highway. On the NE sector, a number of cracks with an overall arcuate geometry affect concrete walls, paved surfaces and the floor of the department store.

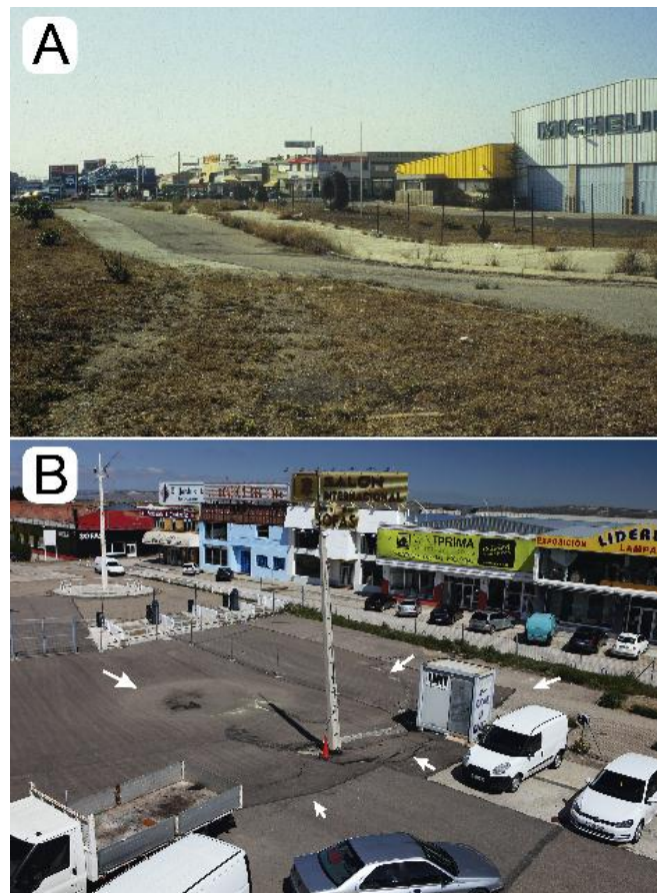
**Figure 5.** Images of the Logroño highway sinkholes. (A) Photograph taken on June 1996 at the NE sector of sinkhole 1 before the enlargement of the highway and the construction of the currently existing department store. Note the conspicuous sagging of the service road and the sidewalk. (B) Image of sinkhole 2 taken on April 2016 affecting a recently asphalted surface within a fenced area. The left arrow points to the deeper part of sinkhole and the arrows on the right mark the outermost cracks.

Sinkhole 2 is located on the NE side of the Logroño highway, beneath and next to the ramp of a pedestrian bridge built across the highway (Figures 4 and 5B). Historical imagery from Google Earth indicate that this sinkhole has been active since 2001 and has been repaired at least three times between that date and 2011. In September 2011, the sinkhole experienced a significant reactivation, damaging the service road up to the NE edge of the highway, a large diameter water-supply pipe and a portion of the parking of a car shop. The overall distribution of the fissures, scarps and small collapses mapped on November 2011 are depicted in Figure 4. These show a sub-circular depression with an approximate diameter of 40 m, with an inner sector around 27 m across, defined by more conspicuous ruptures which is affected by more rapid subsidence. After that event, the service pipe was rebuilt above the ground in order to detect any potential damage or leakage. The portion of the car shop affected by active subsidence was re-asphalted and fenced, showing rapidly evolving sagging subsidence and concentric fissures and scarps (Figure 5B). Several geotechnical boreholes drilled within or next to this sinkhole indicate the following stratigraphic succession, in descending order: (1) anthropogenic fill 3.5–4 m thick; (2) fluvial gravels 12–15.1 m thick; (3) karstic residue 19.7–35.4 m thick, consisting of grey marls with residual gypsum; and (4) fresh evaporitic bedrock at  $\geq 25$  m depth. The water table depth at this site typically varies between 5 and 9 m, with the highest levels recorded by the end of the summer season, since the recharge of the alluvial aquifer is mainly related to irrigation.

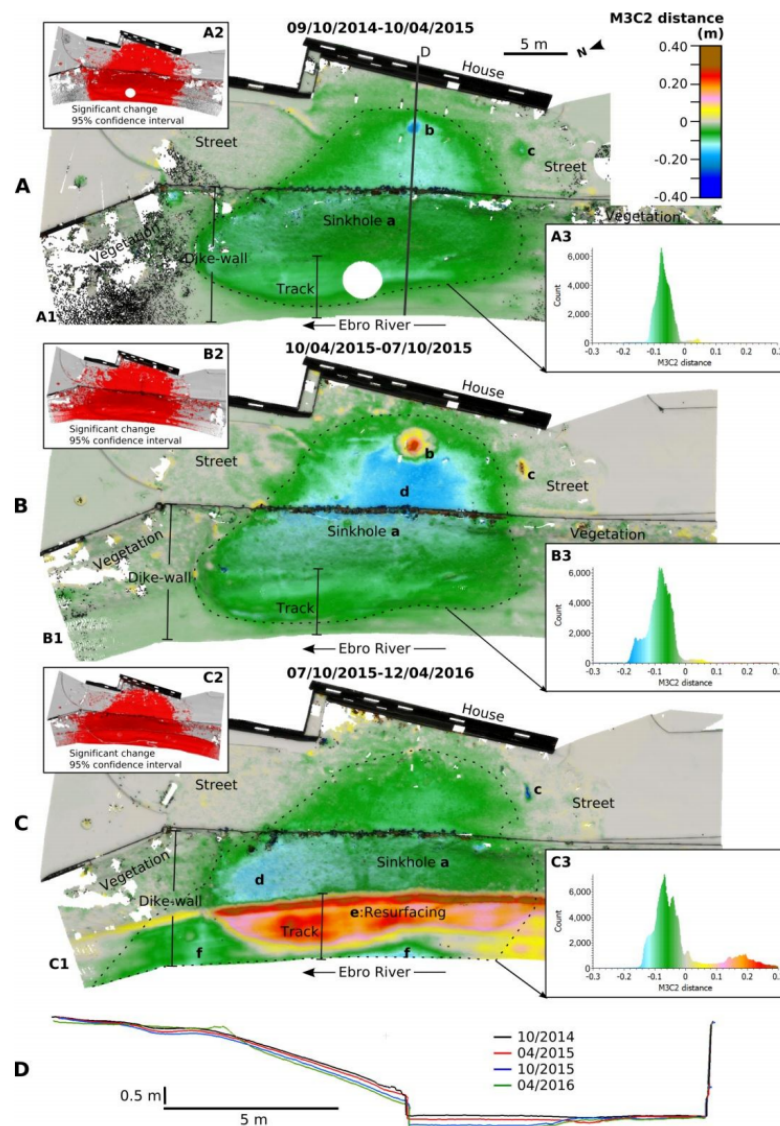
**Figure 6.** 4D monitoring of surface changes in the Alcalá sinkhole carried out between October 2014 and April 2016. (A) Changes from 09/10/2014 to 10/04/2015 (183 days). (B) Changes from 10/04/2015 to 07/10/2015 (180 days). (C) Changes from 07/10/2015 to 12/04/2016 (188 days). Surface-change frequency histograms are shown on the right of the displacement models. (D) Relative displacements along line D, depicted in image A.

In the Alcalá sinkhole, four 3D surveys were conducted on October 2014, April 2015, October 2015 and April 2016, covering a time span of 551 days (Table 1). In each survey, we carried out 15–21 scans of medium resolution (7–12 mm at a 10 m scanning distance) to cover an area of 1304 m<sup>2</sup>. The resulting 3D point clouds displayed errors of 2–3 mm from the registration process and 1–2 mm from the referencing process using the B/W targets. The comparison of 3D point clouds allowed the accurate measurement of the deformation with a high spatial resolution (ca. 1 cm) in the portion of the sinkhole affected by greater subsidence.

The time lapse covered by the first comparison (October 2014 and April 2015) included the February–April 2015 Ebro River flood, during which water flowed through the dike, and the sinkhole was flooded by the water-table rise. The displacement model reveals an elongated subsidence area with a major axis of 26 m located on the Western sector along the dike, and a minor axis of 18 m on the Southern zone (sinkhole a in Figure 6A1). This subsidence area, which affects the dike and the street, and is embraced within the distribution of surface changes with a 95% confidence interval (Figure 6A2), can be considered the minimum extent of the zone affected by ground settlement. Surface displacement within this subsidence area shows a unimodal distribution with a main peak at  $-7.5$  cm ( $-14.9$  cm/year), and a maximum value of  $-25$  cm ( $-49.8$  cm/year) (Figure 6A3). The maximum subsidence was measured in a nested collapse sinkhole located in the street in front of the house (b in Figure 6A1). Changes were also detected outside the main subsidence area. To the south, there is a meter-sized collapse sinkhole with a maximum displacement of  $-18$  cm (c in Figure 6A1). Around the main subsidence area, the model captured displacements of up to  $-1$  cm at points, with a scattered pattern. The changes could be attributed to subsidence, but also to other changes unrelated to sinkhole activity, such as the movement of loose gravel in the street or the vegetation located on the dike.

In the last period analysed (October 2015–April 2016), which included the shallow polyurethane grouting program carried out along the dike, the subsidence area (sinkhole a) expanded significantly to the west and north, mainly in the dike (areas labelled as f in Figure 6C1). Additionally, the area affected by the greatest subsidence translated completely from the street to the dike (area labelled d in Figure 6C1). The frequency of the displacement values of the 3D model in the main subsidence area showed a polymodal distribution with peaks at  $-4.3$  cm ( $-8.3$  cm/year),  $-6.8$  cm ( $-13.2$  cm/year) and  $-12.2$  cm ( $23.7$  cm/year) (Figure 6C3). The maximum subsidence occurred in the dike (area d in Figure 6C1), affecting the outer shoulder, and probably also the track on the dike crest. However, this latter zone showed apparent upward displacement due to the accumulation of a man-made fill in the subsidence zone, developed at the foot of an arcuate scarp (area e in Figures 6C1 and 3A). The nested collapse sinkhole b seems to have been inactive during this period. In contrast, collapse sinkhole c was reactivated after the previous fillings. The elongated geometry of this sinkhole, with an orientation parallel to the edge of the main subsidence zone, suggests that it may be related to ravelling of surficial deposits through an extensional fissure developed in the marginal zone of the main sinkhole.

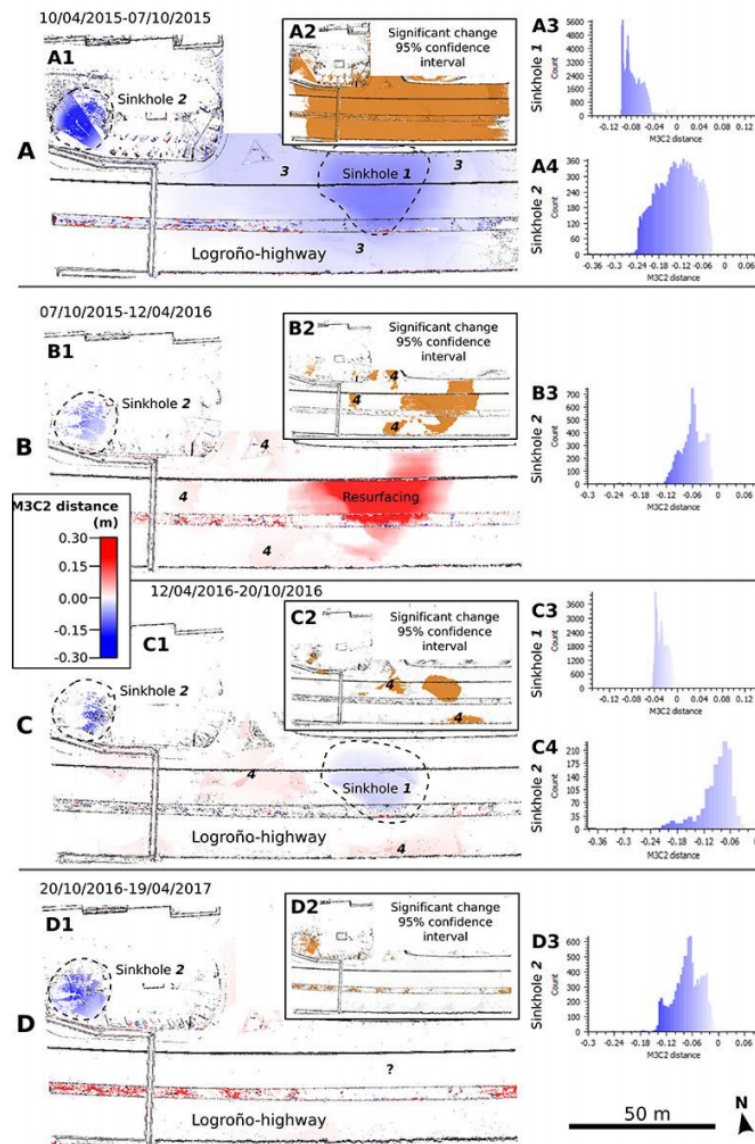
**Figure 7.** 4D monitoring of surface changes in the Logroño highway sinkhole, carried out between April 2015 and April 2017. (A) Changes from 10/04/2015 to 07/10/2015 (180 days). (B) Changes from 07/10/2015 to 12/04/2016 (188 days). (C) Changes from 12/04/2016 to 20/10/2016 (191 days). (D) Changes from 20/10/2016 to 19/04/2017 (181 days). Surface-change frequency histograms are shown on the right of the displacement models.

The comparison between the 3D point clouds from April 2015 and October 2015 revealed two active sinkholes (Figure 7A1). Sinkhole 1, mainly affecting the Logroño highway, showed a high inner subsidence area, characterised by a complex polymodal displacement distribution between  $-4$  and  $-10$  cm ( $-8.1$  and  $-20.2$  cm/year) (Figure 7A3), with the highest mode at  $-9$  cm ( $-18.1$  cm/year). This inner high-subsidence sector of sinkhole 1 is surrounded by an ill-defined aureole (labelled as 3 in Figure 7A1) with a mean subsidence of  $-4$  cm ( $-8.1$  cm/year). Sinkhole 2, located in a non-accessible fenced plot, north of the highway, could not be scanned completely. Nonetheless, it showed the greatest

subsidence (Figure 7A4), mainly ranging between  $-2$  and  $-25$  cm ( $-4$  and  $-50.4$  cm/year), with the main mode at  $-12$  cm ( $-24.2$  cm/year). Subsidence in both sinkholes was measured with a 95% level of confidence, although the data do not allow precise mapping of the sinkhole edges (Figure 7A2).

Between October 2015 and April 2016, the central sector of sinkhole 1 was filled and re-paved, displaying positive distance values in the comparison model (Figure 7B1). Sinkhole 2 showed subsidence activity, but with a lower rate and different pattern than in the previous period. Subsidence values showed a trimodal distribution, ranging between  $-2$  and  $-13$  cm ( $-3.9$  and  $-25.2$  cm/year), with the main mode at  $-6$  cm ( $-11.6$  cm/year) (Figure 7B3). This comparison also showed other significant positive distance changes with scattered distribution (labelled 4 in Figure 7B1,B2), which can be ascribed to scanning errors, discussed in the next section.

The subsequent comparison (April 2016–October 2016) also showed positive distance changes attributable to scanning errors (labelled 4 in Figure 7C1,C2). Nonetheless, the model captured negative changes related to subsidence in both sinkholes. Subsidence in sinkhole 2 ranged between  $-2$  and  $-24$  cm ( $-3.8$  and  $-45.9$  cm/year) (Figure 7C1), with a main mode of  $-7$  cm ( $-13.4$  cm/year) (Figure 7C3). Subsidence values in sinkhole 1, with the highest mode at  $-4$  cm ( $-7.6$  cm/year) (Figure 7C4) were lower than those measured during the first period.

Perhaps surprisingly, the M3C2 displacement model of the period from October 2016–April 2017 did not capture subsidence activity in sinkhole 1 (Figure 7D1). Although the model showed values of  $-1$  to  $-1.6$  cm ( $-1.9$  to  $3$  cm/year) for this sinkhole, the high referencing error involved in this comparison model (Table 1) did not allow the detection of significant changes with a 95% confidence interval (Figure 7D2). Conversely, the rapid subsidence in sinkhole 2 allowed the measurement of negative, vertical displacement, displaying a similar trimodal distribution to that observed during the period October 2015–April 2016 (Figure 7D3), concentrated between  $-1$  and  $-13$  cm ( $-1.9$  to  $-24.7$  cm/year), with the main mode at  $-7$  cm ( $-13.3$  cm/year).
