DIAGNOSIS OF HERITAGE BUILDINGS BY NON-DESTRUCTIVE TECHNIQUES

Diagnosis of Heritage Buildings by Non- Destructive Techniques

3.2.1.1 History and context of the building

3.2.1.2 Building characterization

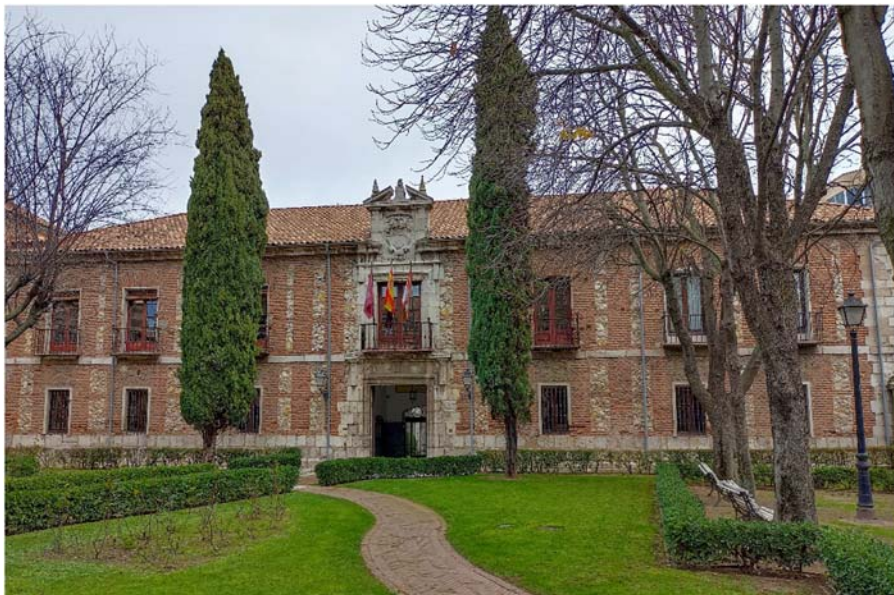
Figure 3.3 Guesthouse (current Santa Cruz Residence Hall). Main facade.

combination of masonry and brick, according to 17th-century preferences [Fig. 3.3](#). The masonry is quite correct, with stones of great size, while the brickwork is done with a relatively thick tendril in which cracks are marked achieving a play of light and shade.

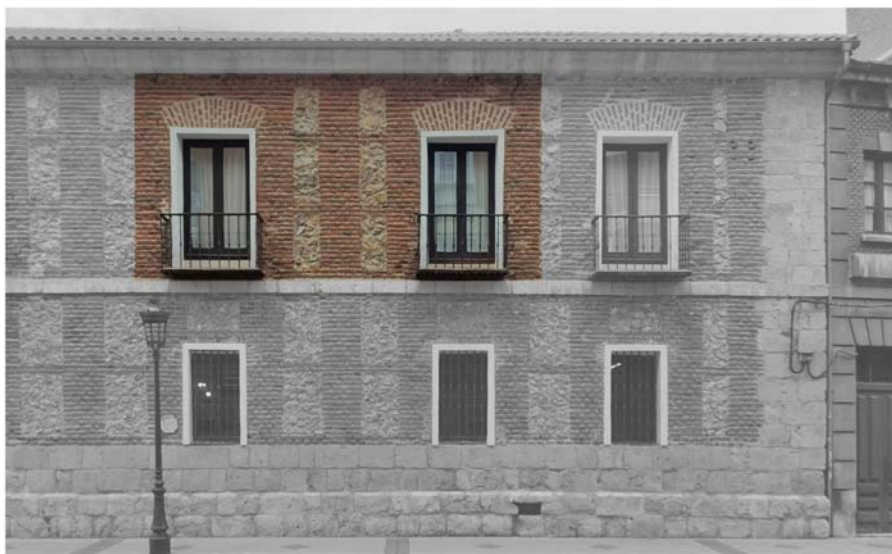
Figure 3.6 Room of the guesthouse under study. Elevation.

A suite room on the southeast facade, facing Cardenal Mendoza Street, was chosen as the area to be studied, according to the floor plan in [Figs. 3.5–3.7](#). The name of the room honors a former resident, Juan de Marquina. Tests were carried out considering the whole suite but also excluding the volume of the bathroom.

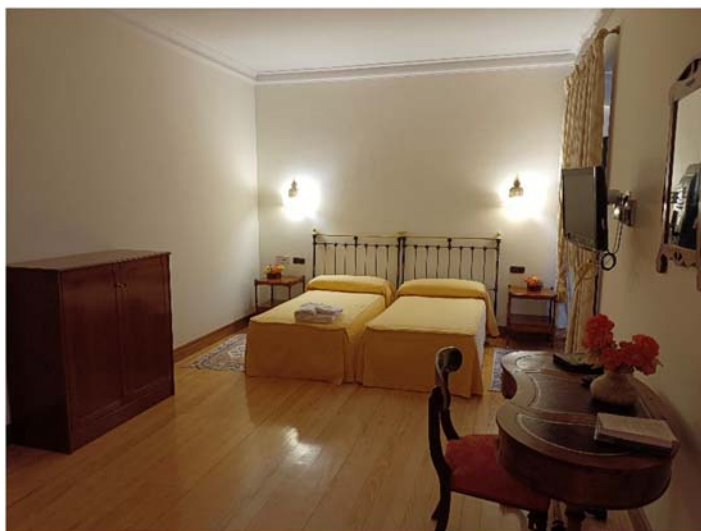
Figure 3.7 Room of the guesthouse under study. Interior layout.

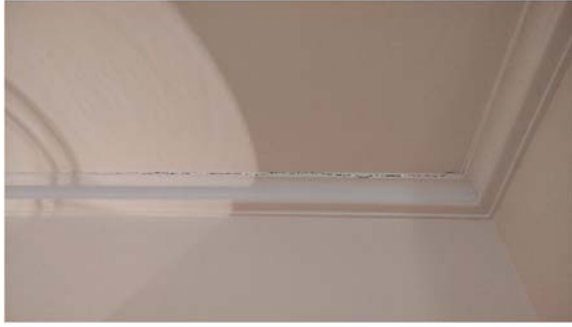
Figure 3.8 Room of the guesthouse under study. False ceiling pathology.

The room presents hardly any pathology. Only some cracks in the false ceiling were found, probably due to some movement of the building, after an intervention (Fig. 3.8).

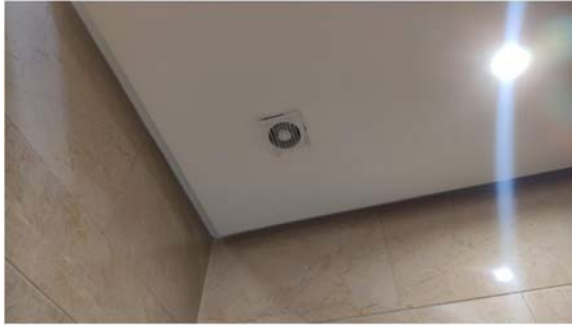
Figure 3.9 Room of the guesthouse under study. Bathroom extraction.

The building's conditioning system, installed in the second half of the 20th century, consists of a diesel boiler, currently replaced by a gas boiler, and water radiators in the rooms. Regarding ventilation, there is only mechanical exhaust ventilation in the bathroom commanded by the bathroom light (Fig. 3.9). Fresh air enters the room through leakages in the envelope as a consequence of the depressurization caused by the exhaust.

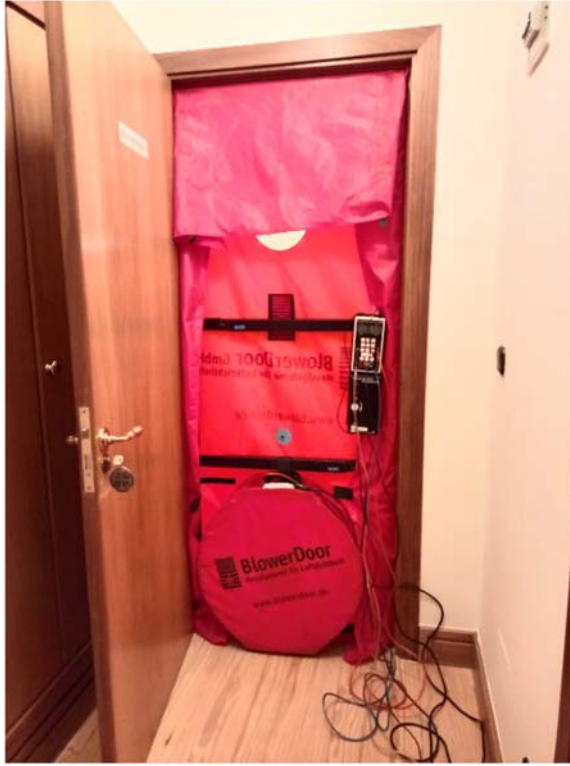
Figure 3.10 Airtightness test layout. Blower door system.

For the test, a fan temporarily replaces the main door of the space to be measured and generates a pressure difference between the inside and the outside of the room (Fig. 3.10). Depending on the position of the fan, the depressurization or pressurization of the room forces the entrance/exhaust of the outdoor/indoor air, respectively. In this way, the airtightness of the envelope is measured.

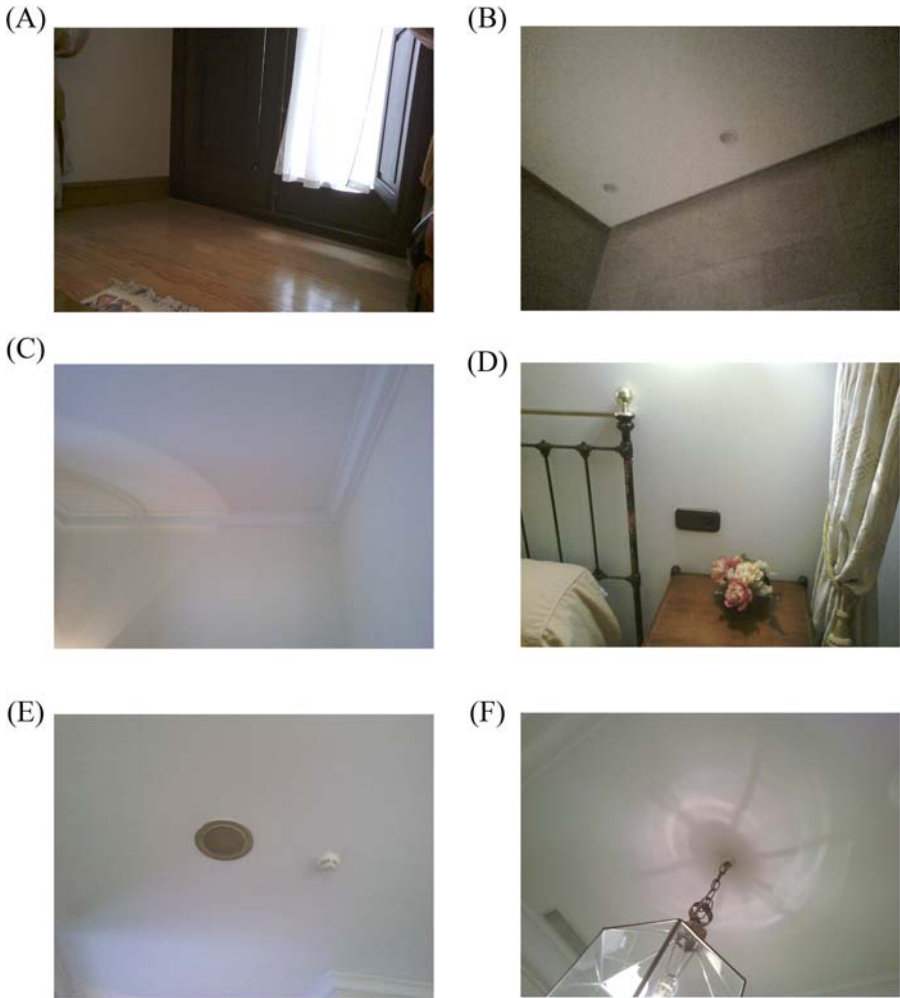
Figure 3.11 Typical leakage paths. (A) Window frames, (B) material joints, (C) wall cracks, (D) electrical grids, (E) ceiling holes for facilities, and (F) plafonds.

After that, several IRT images are taken inside, focusing especially on the usual leakage paths (Fig. 3.11). A Flir e75 IR thermal camera is used to picture leakages. These are typically found in joints such as window frames, materials joints, wall cracks, electrical and sanitary grids, wall-mounted and ceiling lighting and other security facilities such as smoke detectors or emergency lighting in ceilings, and so on. The IR thermal camera has a 320×240 (76,800 pixels) resolution with an object temperature range of -20°C to 120°C in an 18 mm lens.

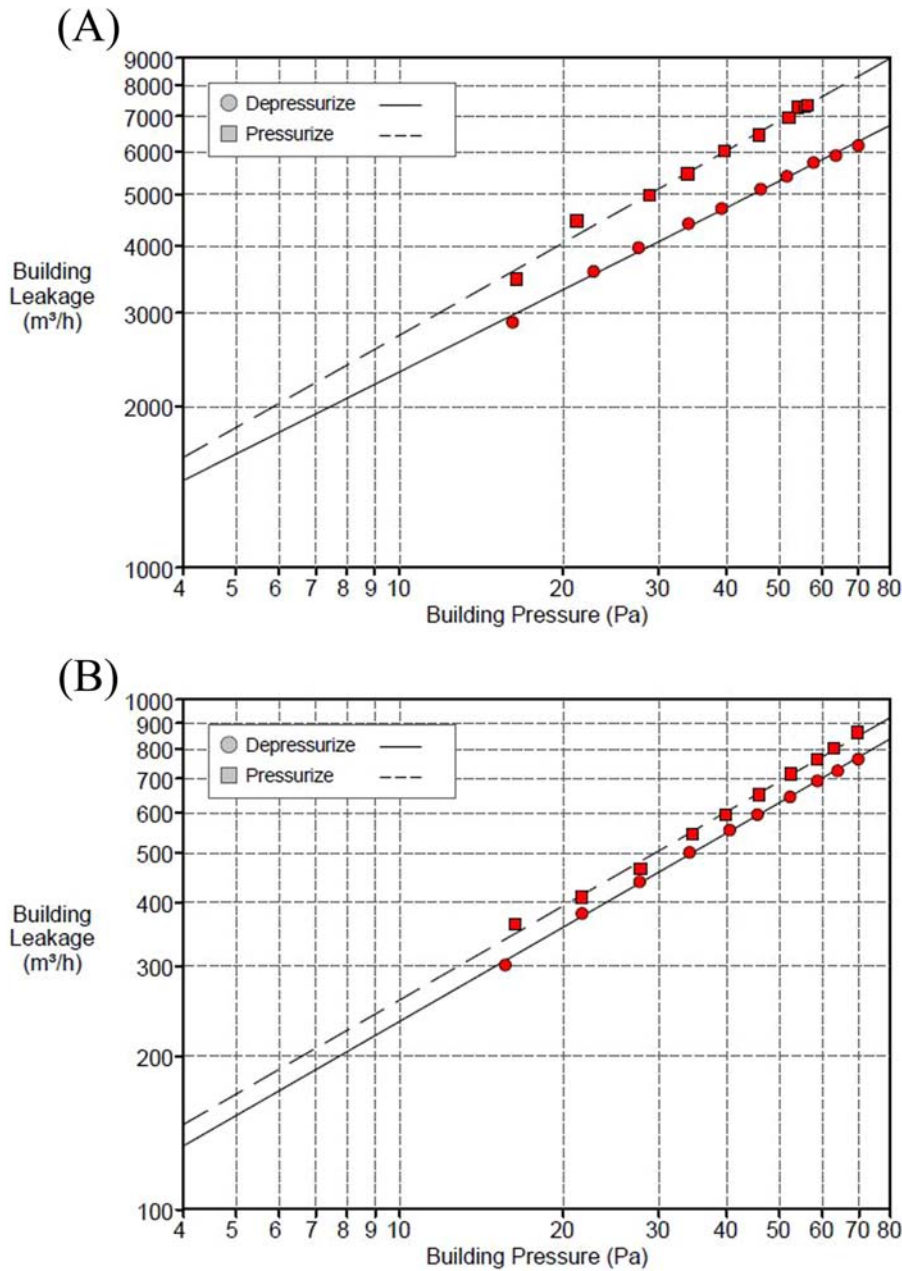
Figure 3.13 Pressurization tests graphs. (A) Test 1 graph (whole volume of the room) and (B) Test 2 graph (volume of the room excluding the bathroom).

Finally, it can be observed in the graphs that the airflow rates during the pressurization stage are larger in both cases than the ones during depressurization. This can be explained by the fact that the building is subject to unnatural conditions, which can alter the leakage characteristics, especially false ceilings, traps, or some kinds of windows (Charlesworth, 1988). Leakage curves do not overlap as a result of a possible valving effect or asymmetric geometry of some leakages in relation to the flow direction (Allen, 1985; Baker et al., 1986).

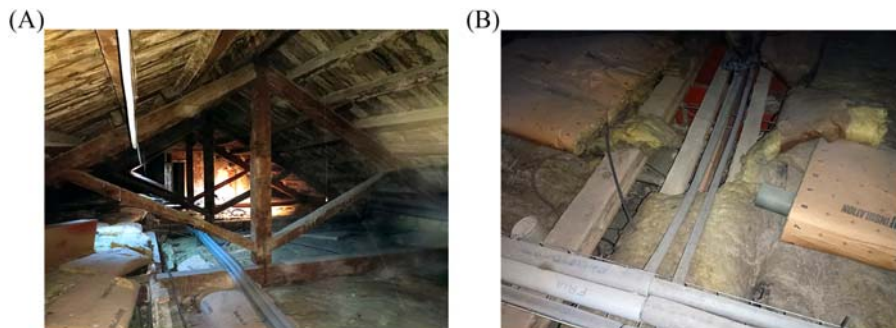
Figure 3.16 Upper crawl space. (A) General view and (B) detail of the construction elements.

The hypothesis of a nonfinished false ceiling and insulation was then proved. As can be observed in Fig. 3.16, the wooden platform of the ceiling and the insulation show important discontinuities and even holes of great dimensions. Furthermore, the ventilation exhaust of the bathroom is open and not connected to the exhaust duct. This clearly explains the airtightness test results, which constituted a key element in the diagnosis of the energy performance of the room.
