## Assessment of the risk of surface condensation on cultural heritage mechanical brick facades: the importance of surface temperature measurement. The case of a historic building in Valladolid.

**Citar como:** Rodríguez-Esteban, M. A., et. al. (2025). “Assessment of the risk of surface condensation on cultural heritage mechanical brick facades: the importance of surface temperature measurement. The case of a historic building in Valladolid.”. Editado por: Ángel Castillo Talavera, José Luis García Calvo, Enio J. Pazini Figueiredo y Pedro Castro Borges (Eds.), Memorias del XVIII Congreso Iberoamericano de Patología de la Construcción y XX Congreso de Control de Calidad en la Construcción, CONPAT 2025. Madrid, España, (pp. 616-627). DOI: <https://doi.org/10.21041/CONPAT2025/V2PC23>

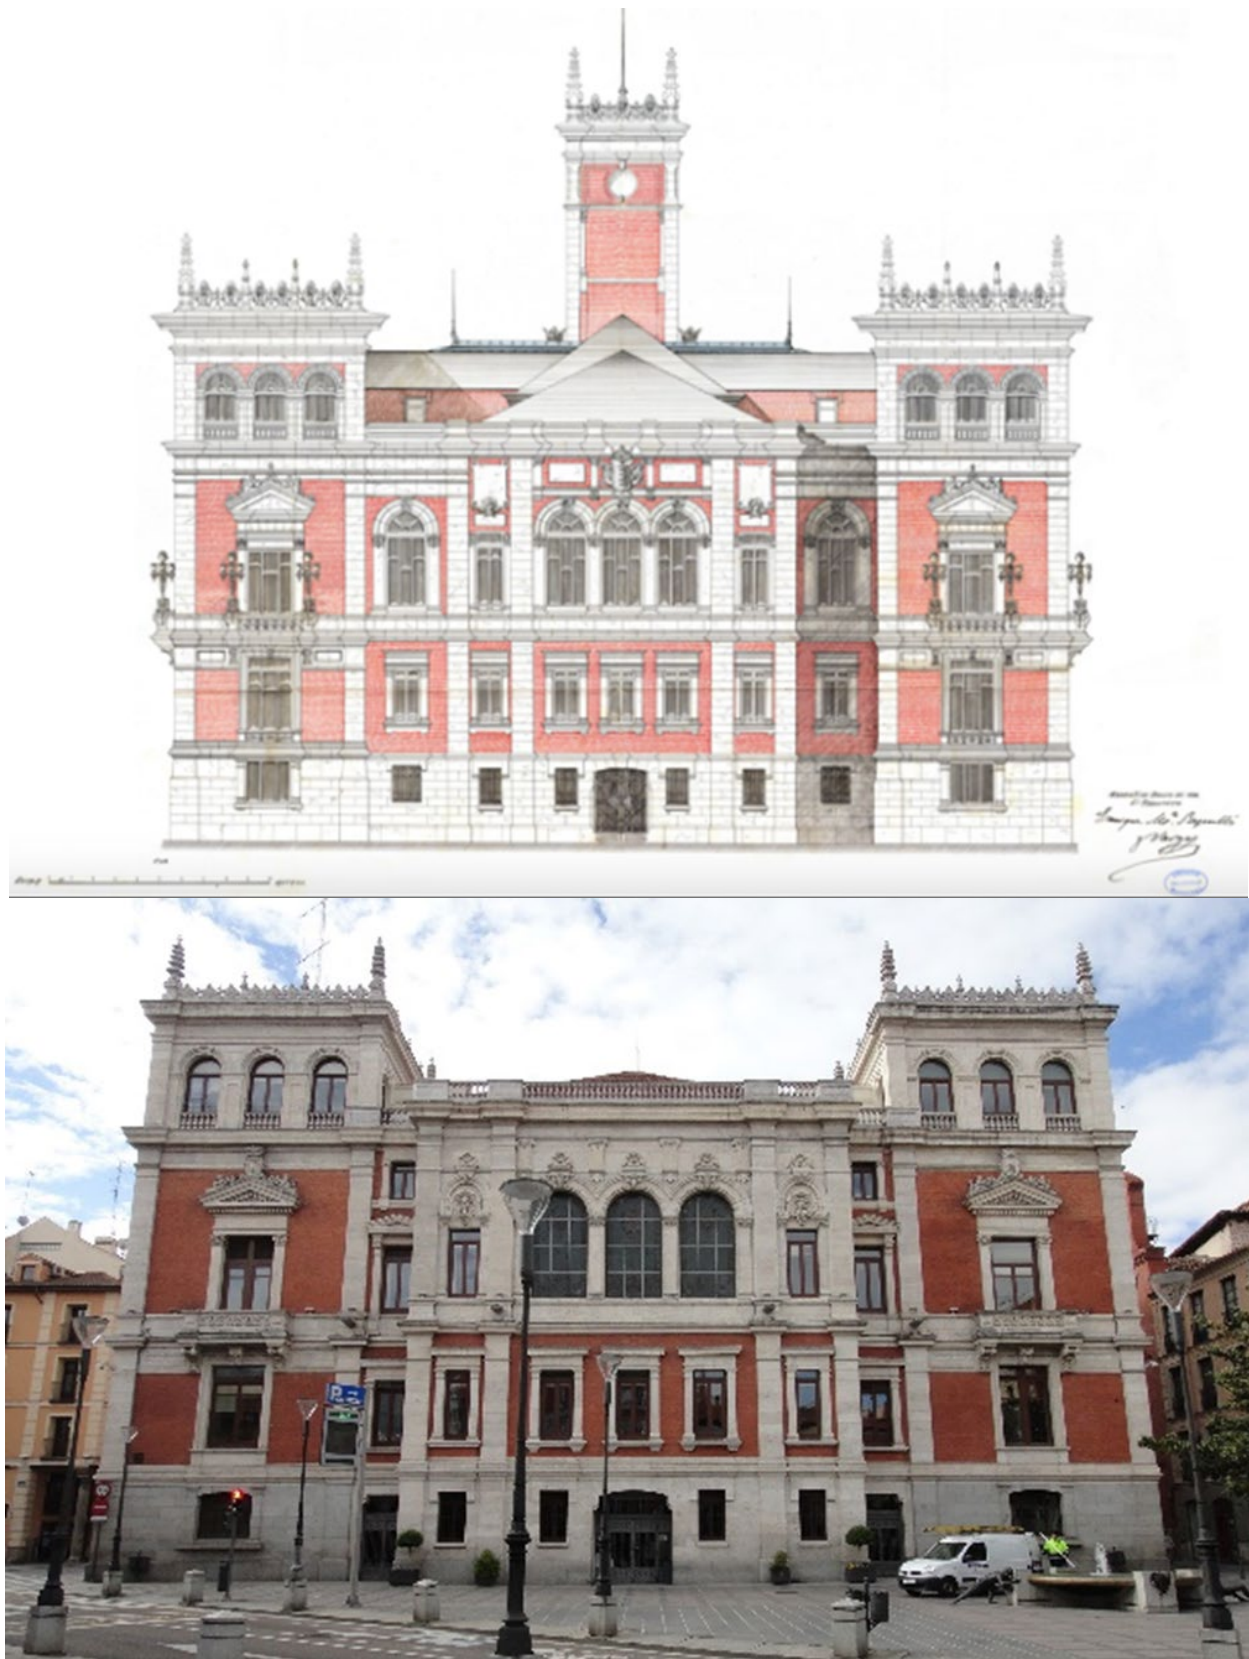
The first test of the study was carried out in situ, in the Valladolid City Hall building. This is a historic building, designed by the architect Enrique María Repullés y Vargas in 1898, whose elevations are shown in Figure 1. The test was carried out on the north-facing facade to avoid the incidence of the sun, coinciding, moreover, with the rehabilitation works that were being carried out on other floors of the building. This allowed us to measure and visualize the interior of the facade wall, confirming the initial hypothesis that it is made of pressed brick laid “Spanish style”. In total it has a thickness of 1.12 meters, formed by an outer sheet of “fine” brick and a lower quality pressed brick on the inside. The thin brick comes from “La gran tejería mecánica de D. Eloy Silió”, as is visible in the engraving of some pieces and, possibly, the other bricks of the wall, of poorer quality, also come from this tile factory.

Figure 1. Rear facade of Valladolid City Hall. a) Left: plan of the original project (AMVA); b) Right: current state (authors' photograph).

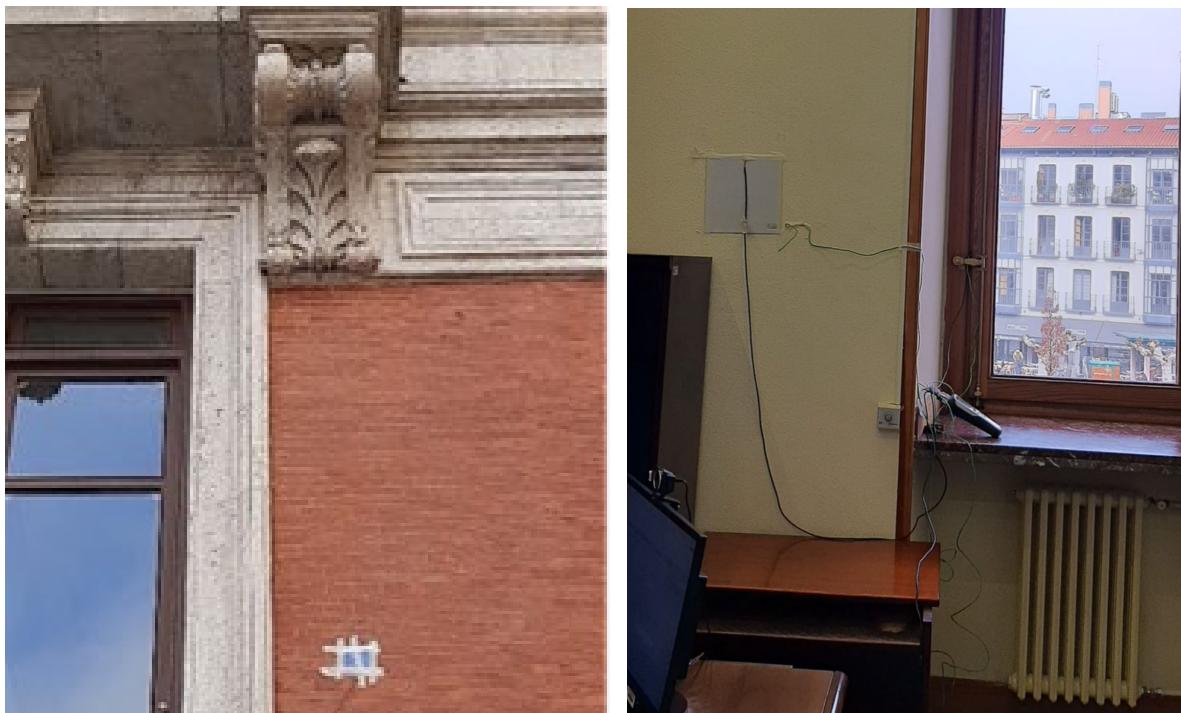
The test consisted of placing thermocouples on the inside and outside of the wall, in order to have the ambient and surface temperatures on both sides, as shown in Figure 2. The reading period was prolonged during the months of December and January, because these are the months with the lowest outside temperatures in Valladolid. Of all this time, the last week of December was selected for the study, since the greatest variation of temperatures was observed both in the heated interior and in the exterior, which made it possible to analyze the most extreme cases.

The four thermocouples used to measure temperatures have an accuracy of  $\pm 0.05^{\circ}\text{C} \pm 0.05\%$  of the measured value. The data were stored in a data logger model Almemo 2590, of the Ahlborn brand with an accuracy of 0.03% (the accuracies are provided by the manufacturer).

Figure 2. In situ test on the north wall of the Valladolid City Hall, a) Left: exterior plate, b) Right: interior plate (authors' photograph).

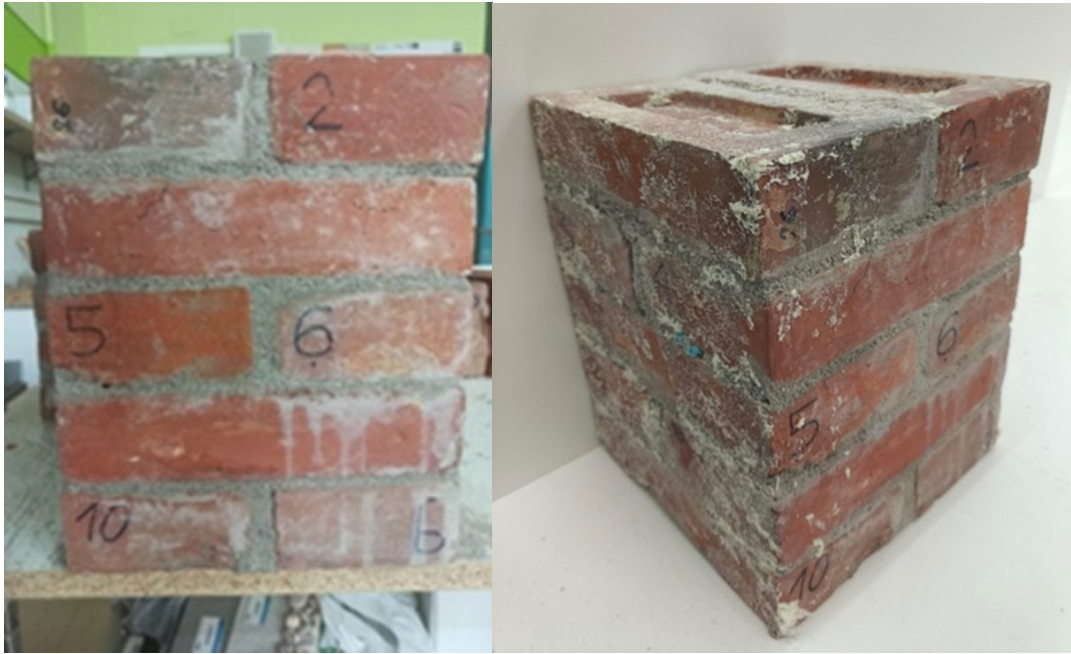
To estimate the thermal conductivity of this type of walls, the values of the standards can be used, or a thermal flow test can be carried out. In this case, the latter possibility was chosen since it was considered that the conductivity values resulting from the test would be closer to the real values of the facade than those that could be taken from tables and standards. For this purpose, a test specimen was built with bricks from the same tile factory, using pieces taken from other buildings that have been rehabilitated. This specimen emulated the wall of a façade 22.5 centimeters long, 28 centimeters high and 22.5 centimeters thick, as shown in Figure 3.

Figure 3. Test specimen tested in laboratory (authors' photograph).

The thermal flow test was carried out in a constant regime using a highly insulated cold box located in the construction laboratory of the E.T.S. of Architecture of the University of Valladolid. The following measuring instruments were used for the measurement:

- Ahlborn model FQAD18TSI AMR heat flow meter (120 mm x 120 mm x 3 mm), which was placed outdoors (plate accuracy 0.02% of the measured value).
- Four thermocouples to measure surface temperature and ambient temperatures: outside and inside (to the box built in the laboratory) (accuracy  $\pm 0.05^\circ\text{C} \pm 0.05\%$  of the measured value).
- A Data Logger model Almemo 2590, made by Ahlborn, for the storage of heat flow and temperature data (accuracy 0.03%).
