***Reduction of air production***

## Reduce compressed air production

# Heineken®

Group Heineken/AVANS

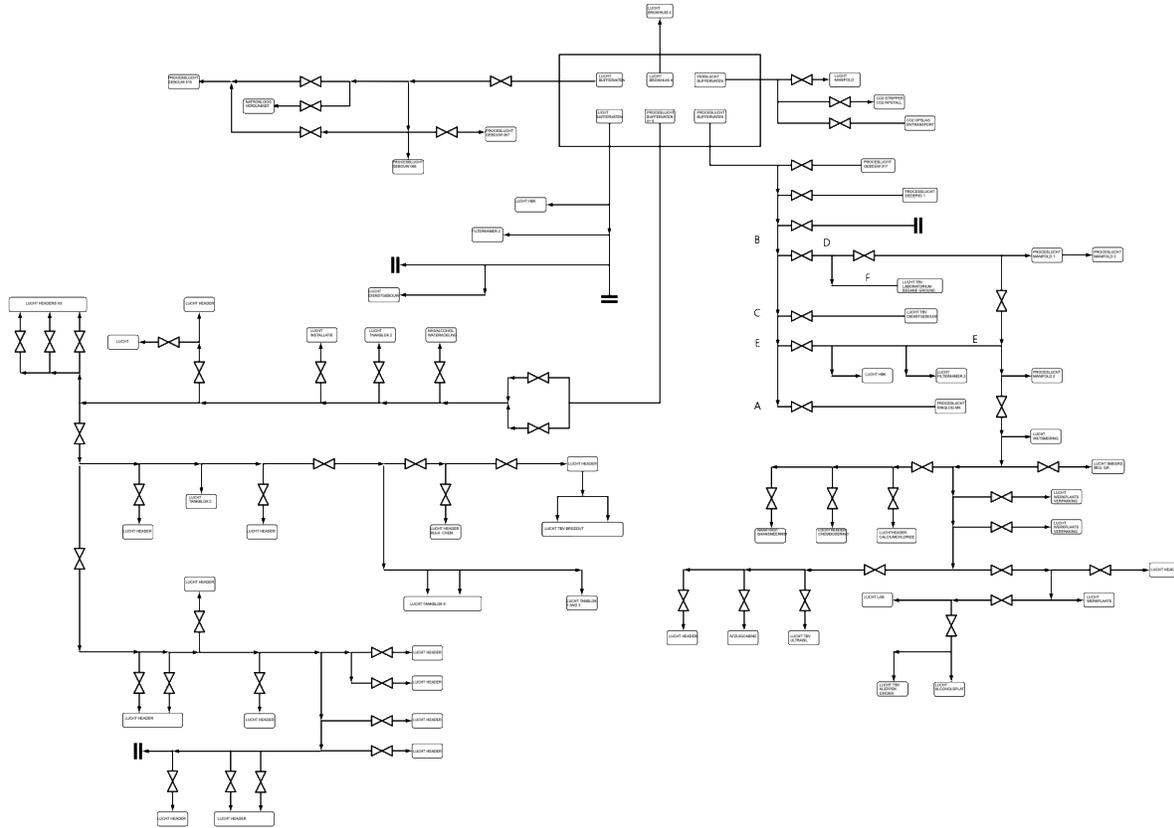
## General drawing

Technical drawings were examined to map out the compressed air distribution system to identify areas of loss, isolation logic was applied by using conceptualized valves to divide the network into its branches and then monitor how much consumption was affected, using the Enterprise Resource Planning (ERP) system. This methodology allowed the areas that had caused most of the non-production consumption to be identified. Many of the branches had a very small reduction in air demand when production ceased, indicating that they were consuming a continuous baseline amount regardless of their operational requirements.

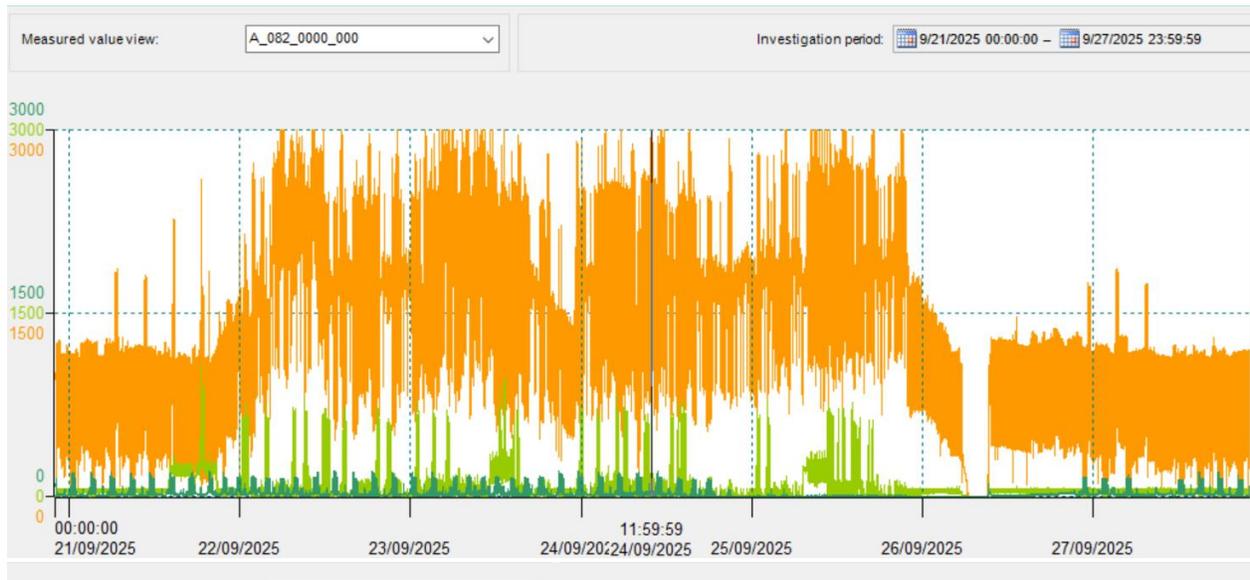
26/09/2025 10:21:53 - 26/09/2025 16:29:12

Measuring point	Designation	Unit	Decimal places	Minimum	Maximum	Average value	Standard deviation	Integral
MVA_FT_082_0000_006	Proceslucht flow	Nm <sup>3</sup> /h	1	2,8	1.480,4	769,2	470,1	16.953.812,0
MVA_FT_082_0000_008	Instrumenten lucht flow	Nm <sup>3</sup> /h	1	0,9	152,1	42,8	19,3	943.633,5
MVA_FT_082_0000_011	Brouwhuis 4 lucht flow	Nm <sup>3</sup> /h	1	-1,6	117,1	14,0	14,8	309.233,4

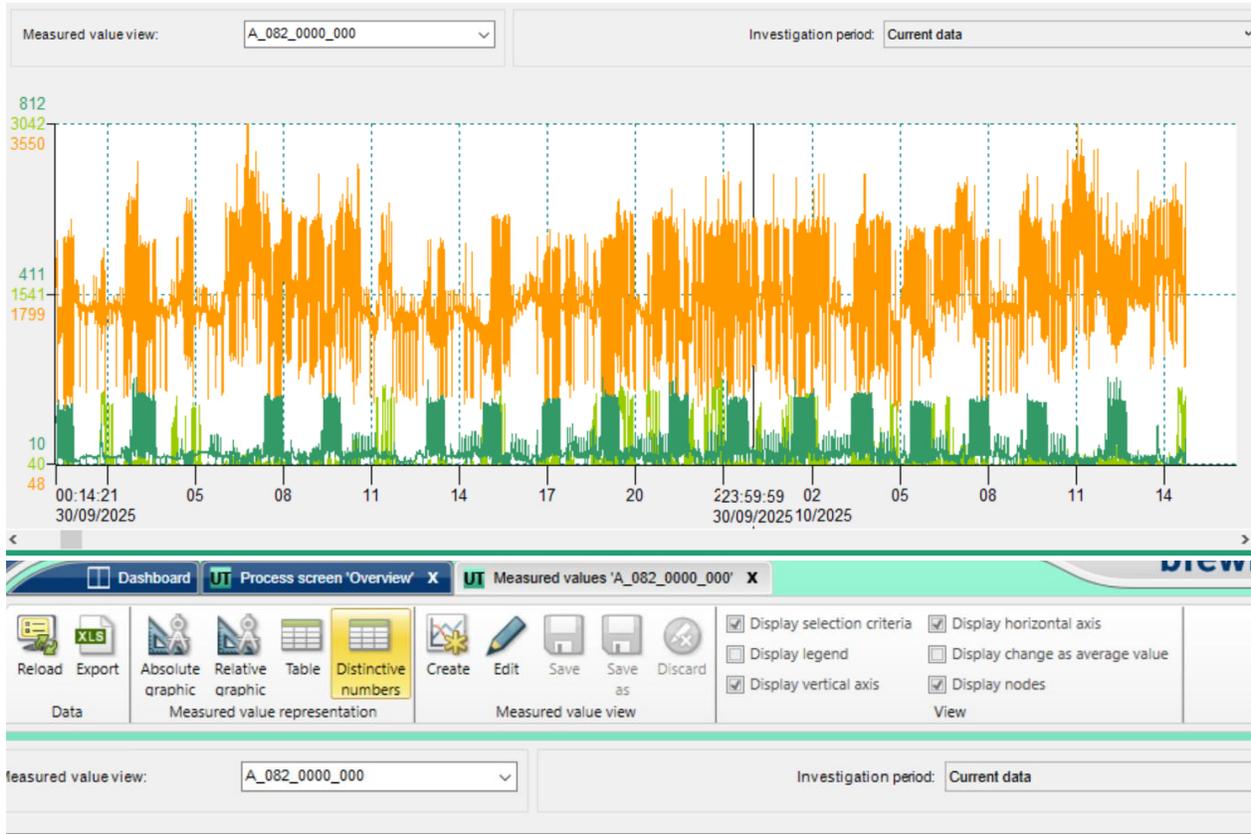
30/09/2025 00:14:21 - 01/10/2025 16:27:31

Measuring point	Designation	Unit	Decimal places	Minimum	Maximum	Average value	Standard deviation	Integral
MVA_FT_082_0000_006	Proceslucht flow	Nm <sup>3</sup> /h	1	439,8	3.775,0	1.829,7	486,3	253.556.592,0
MVA_FT_082_0000_008	Instrumenten lucht flow	Nm <sup>3</sup> /h	1	0,9	914,9	73,6	126,2	10.200.838,0
MVA_FT_082_0000_011	Brouwhuis 4 lucht flow	Nm <sup>3</sup> /h	1	-1,6	219,7	52,5	41,8	7.275.001,0
