Diagnosis and assessment of a historic timber structure in La Casa del Corregidor, using non-destructive techniques

This paper presents the assessment of the timber structure of “La Casa del Corregidor” building, a singular historic building in Cuenca (World Heritage City). The building is scheduled for restoration in the near future. The study made use of both non-destructive (NDT) and semi-destructive (SDT) techniques.

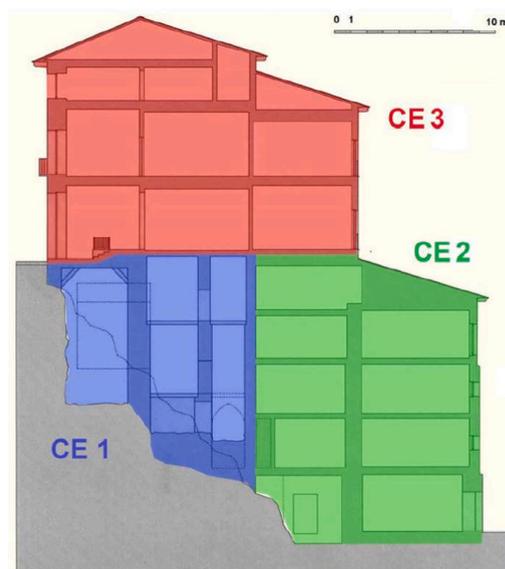
The section reflects a marked overlap in height resulting from the special topography of the San Martín district, and the use of the building [Fig. 1]. It is divided into two distinct sections: an upper residential part for the Corregidor and a lower section accessible from the slope of Santa Catalina. The lower part, which encompasses the first five floors, is not visible from the main entrance but can be observed from the canyon of the Huecar River. This section constitutes the largest portion of the building [Fig. 2].

Fig. 1. Section marking the three constructive stages.

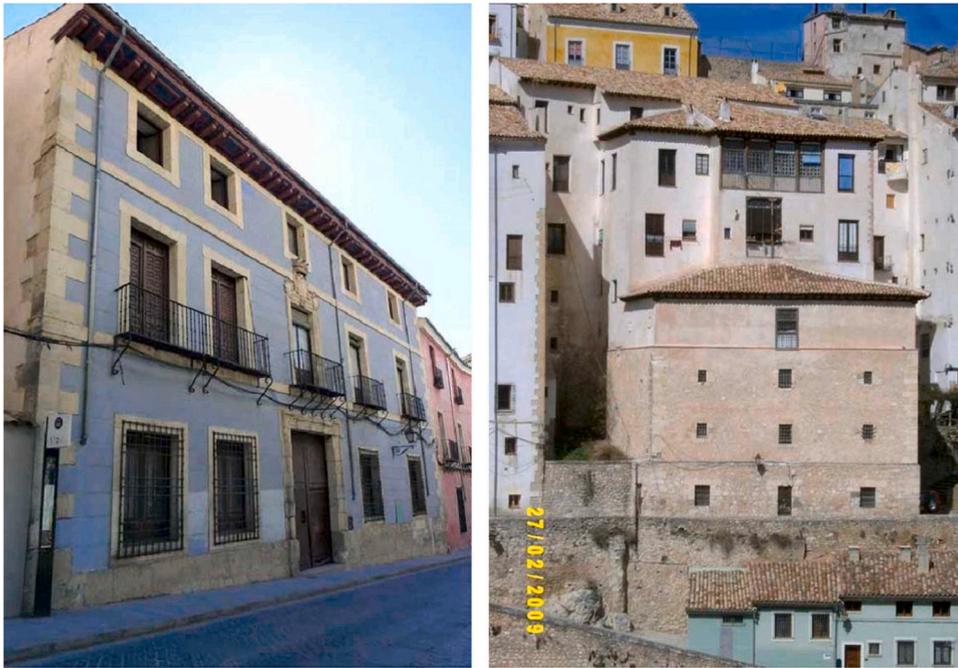
The facade overlooking Alfonso VIII Street is austere, with a series of balconies on the main floor. It is emphasized by an asymmetrical shield on the access axis. The openings of the different floors and the corners are framed in stone, and adorned with delicately textured coatings, simulating cut stone masonry. The interior is accessed through a hallway that leads to two sets of stairs, one descending to the prison’s basement and the other ascending to the residential first floor [Fig. 2]. From the rear, the building entity and its imposing volumetry can be clearly seen. It shows a stone masonry wall partially plastered. Several of the openings and corners are also framed with better quality masonry pieces [Fig. 2].

Fig. 2. Facade to Alfonso VIII Street (left) and rear facade (right).

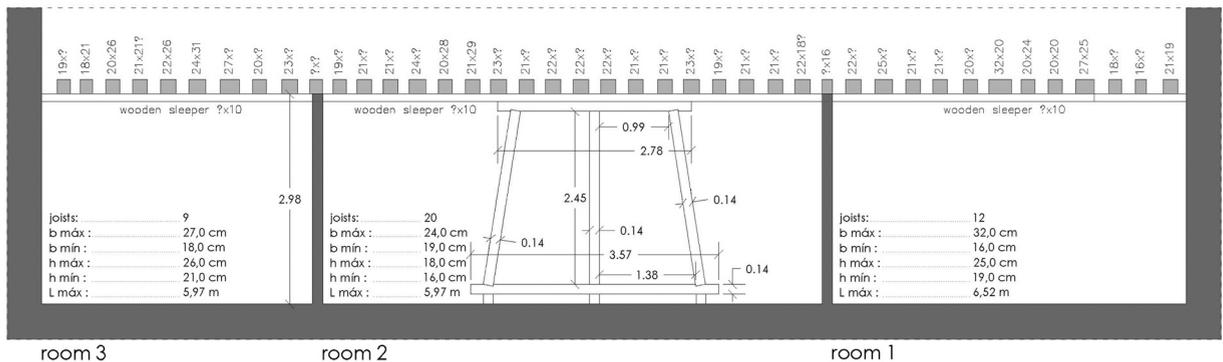
Each room was drawn in section to check the sections geometry and the regularity of the space between joists as follows [Fig. 5]:

Fig. 5. Room section.

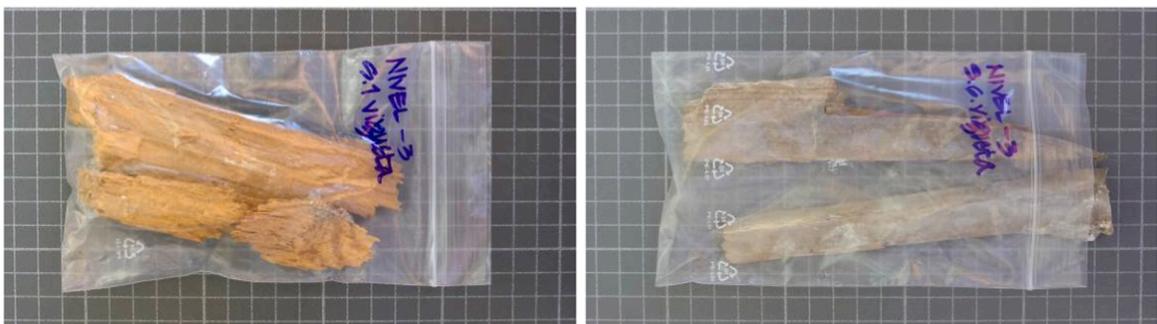
Fig. 7. Wood samples available for consultation in [17].

A visual macroscopic analysis indicates that the wood used in the structure belong to the general group of softwood, specifically to the genus *Pinus*. However, in order to get a positive identification of the species, nineteen material samples of 150 × 150 × 150 mm were obtained from different areas of the structure inspected [Fig. 7].
