DOCTORATE PROGRAM IN INDUSTRIAL
ENGINEERING

**DETECTION, CLASSIFICATION AND
CHARACTERIZATION OF DEFECTS IN
PHOTOVOLTAIC MODULES THROUGH
THE USE OF THERMOGRAPHY,
ELECTROLUMINESCENCE, I-V CURVES
AND VISUAL ANALYSIS**

Presented by Sara Gallardo Saavedra
to qualify for the degree of
Doctor from the University of Valladolid

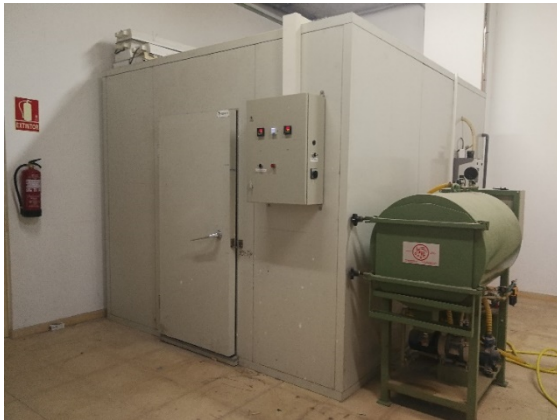
Figure 1: Temperature and humidity controlled chamber at the EIFAB in Soria, Spain

An important part of the experimental investigations for failure diagnosis on PV modules using visual inspection, IRT, EL and I-V techniques have been performed in the EIFAB facilities, at the Campus Duques de Soria of the Uva. There, indoor and outdoor tests have been conducted. Between the indoor tests, EL has been performed in controlled ambient conditions simultaneously than IRT in the fourth quadrant. For these tests, the University has a temperature and humidity controlled chamber, which is shown in Figure 1. In this chamber, each module is continuously fed with its short circuit current, using a laboratory source, during 72 hours. EL images are captured with a PCO 1300 camera each 30 minutes with an exposure of 5,000 ms. Thermal images have been captured with a Flir C2 system and a Workswell Wiris Pro camera. This capturing system

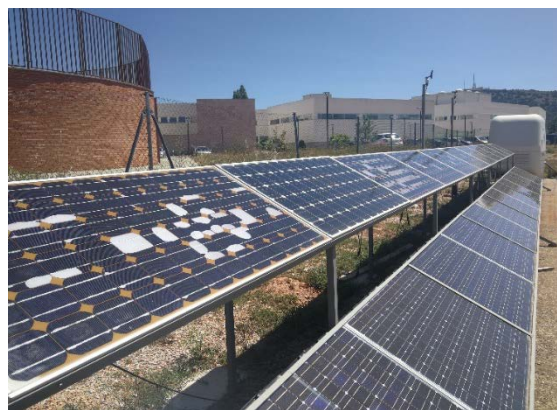
Figure 3: PV field of the Campus Duques de Soria, University of Valladolid.

Outdoor tests include I-V curves, IRT and Red, Green Blue (RGB) images in the PV field of the Campus Duques de Soria, which can be seen in Figure 3. The thermal camera used outdoor is a Workswell Wiris Pro camera, with a 640x512 pixels resolution, a thermal sensitivity of 0.05°C and an accuracy of $\pm 2\%$ o $\pm 2^\circ\text{C}$. Additionally, the camera has a frame rate of 30Hz, is calibrated to be used with two different lenses, 32° y 69°, and includes a Full HD RGB sensor with a resolution of 1920x1080 pixels and x10 zoom. The I-V curves have been traced using an IV HT 1500V Solar I-V tracer.

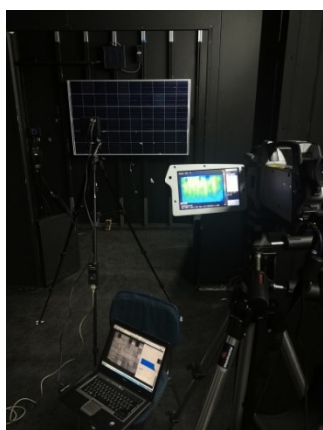
Figure 4: Set up of the EL and IRT cameras for the indoor tests at the Photovoltaic Solar Energy Unit of the CIEMAT, in Madrid.

The nondestructive characterization of solar PV cells defects by means of EL, IRT, I-V curves and visual tests has been performed in the Photovoltaic Solar Energy Unit at the Energy department of CIEMAT, in Madrid. Firstly, the indoor measurements have been performed in the Solar Simulator Pasan SunSim 3CM, class A, flash type. Starting with the I-V curves acquisition at two different irradiance levels, $1,000 \text{ W/m}^2$ and 100 W/m^2 , with temperature controlled conditions of $25 \pm 0.5^\circ\text{C}$. The second irradiation level has been chosen to characterize the defects behavior in low irradiation conditions. With the objective of better characterizing the defects behavior, EL tests to individual cells have been performed to identify the light emission caused by radiative recombination of carriers in each case. During this EL test, the temperature of the different cells has been measured with IRT. In this case, the module is fed with a power source and the EL and IR images are captured with a PCO 1300 and a FLIR SC 640 camera, respectively. EL tests to individual defective cells have been performed at the Isc injected current, 8.9 A, a focal distance of 4 cm and exposure time of 40 s. EL tests to the whole module have been performed at two injected current levels, 8.9 A and 0.89 A, with a focal distance of 4 cm and exposure time 50 s and 15 min, respectively. This image acquisition is presented in Figure 4. RGB images of the module have been taken with a Nikon D80 camera and images in detail of defects in the PV laboratory at the CIEMAT in Madrid with a Nikon SMZ 800 microscope. Finally, IRT has also been performed outdoor using the same IR camera, as presented in Figure 5.

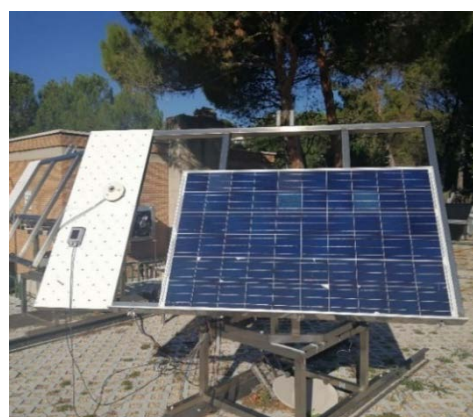
Figure 5: Outdoor IRT testing bench at the Photovoltaic Solar Energy Unit of the CIEMAT, in Madrid.

These images have been taken in the lower current step of the I-V curve at 7.3A-24 V and in the middle current step of the I-V curve at 7.8 A-15 V at 933 W/m². Further information about this study methodology can be found in the paper presented in subsection 2.2.5.

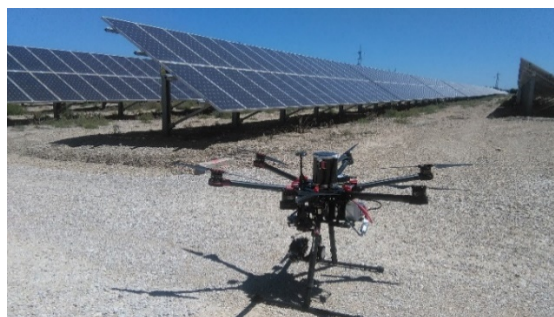
Figure 6: Equipment used in the aerial inspections to the 3 MW PV site, composed by a thermographic camera FLIR TAU 2 640 on board of a hexacopter DJI S900. At the back the STREAM monocrystalline modules with two portrait distribution.

be integrated into aerial vehicles. These aerial inspections were performed at 30 m and 80 m from the ground level respectively. These heights have been selected with the objective of obtaining results that clearly show the impact of Spatial Resolution. With this aim, and considering that the available manual images already have a high resolution, it has been selected 30 m of elevation that provides a pixel size of 3.9 cm x 3.9 cm, which is within the acceptable range for this application (considering an acceptable pixel of 3 cm to 5 cm) and 80 m, that results in a pixel of 10.4 cm x 10.4 cm, out of this acceptable range. Both inspections were performed in 3 hours, considering all the time needed on-site to prepare and mount the equipment, prepare the inspection based on the previously prepared flight plan, taking off and landing, changing the batteries and downloading the images. The UAV used to deliver the FLIR TAU 2 thermographic sensor and the black edition go pro +3 RGB camera during the inspections is presented in Figure 6. It is a hexacopter model DJI S900, prepared to fly with the RGB and the thermographic cameras at the same time, in addition to other telemetry sensors. A hexacopter was chosen since they are more powerful than quadcopters, allowing the transportation of heavier payloads and being safer.

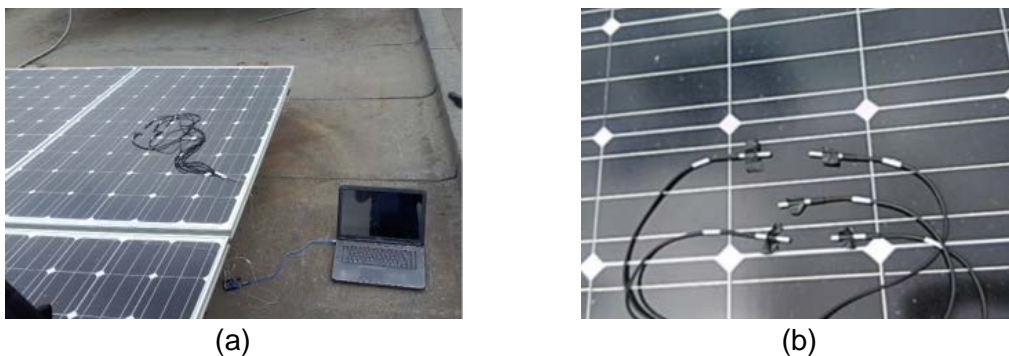
Figure 7: Temperature sensor matrix validation (a) Setup (b) Sensors deployed.

The low-cost IRT application has been studied in cooperation with the Department of Electrical Engineering of the Faculty of Engineering of the University of Cuenca, in Ecuador, in which thermographic analysis with different cameras and I-V curves have been captured. University of Cuenca's solar farm has 35 kWp installed, with a total of 160 modules, and it has been under production since 2016. After manual inspection of all these modules, only two were found with hot spots. These anomalies have been further studied with a Flir One Pro, a Cat S60 and a Flir TG167 cameras, obtaining temperature tables, image reconstruction intensity graphs, X-Y dispersion of the thermal images, three-dimensional mesh, contours of the three-dimensional mesh of the thermal image and standard grayscale static images. Results have been validated using a Solmetric PVA-600 IV tracer [74] and DS18B20 temperature sensors (Figure 7).

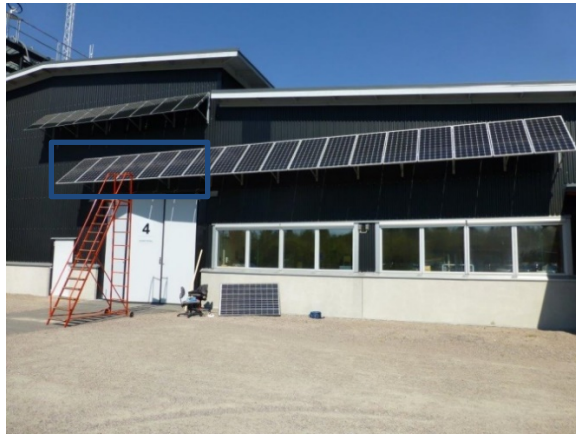
Figure 9: String of six modules with bypass diodes at HIG laboratory.

The PV installations at Höskolan i Gävle (HIG) laboratory, in Sweden, are presented below in Figure 9 and Figure 10. The string of six modules is monocrystalline EOPLLY 125MF / 72 200W and the individual module is a monocrystalline Windon 265W.

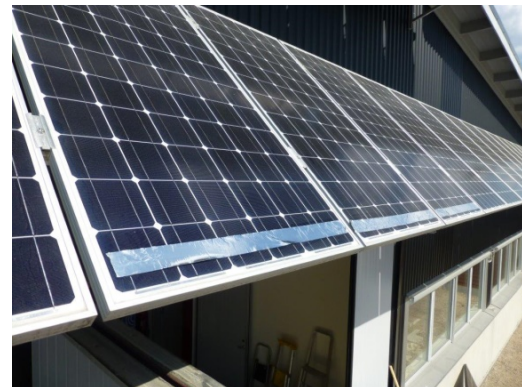
Figure 10: One of the shading cases studied (37% of a row shaded in three modules).

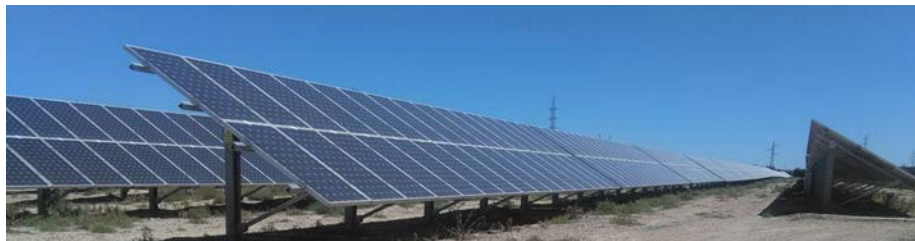
Figure 13: General view of the PV structures of the 3 MW PV plant analyzed.

sixteen modules, which are connected in parallel in the combiner box. PV structures have a fixed 30° tilt structure and a general view of them can be seen in Figure 13. Each module has 72 cells (12x6).

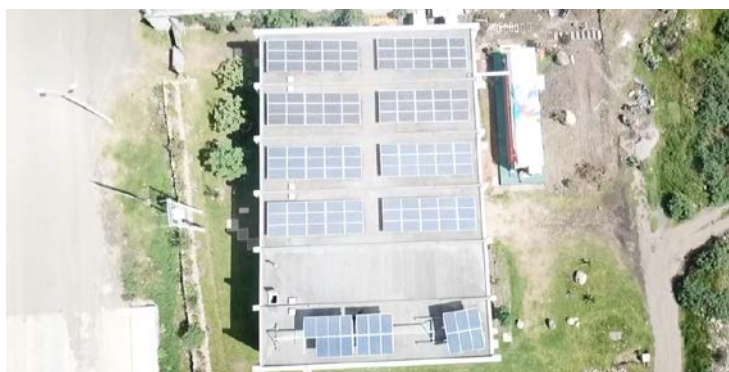
Figure 14: General view of the PV modules of the 35kWp at the University of Cuenca.

University of Cuenca's solar farm, in which the low-cost infrared cameras analysis has been carried out, has 35 kWp installed, with 80 polycrystalline and 80 monocrystalline PV panels, (a total of 160 modules), and it has been under production since 2016 (Figure 14). PV panels found with hot spots are monocrystalline ATERSA A-250P of 250 Wp.

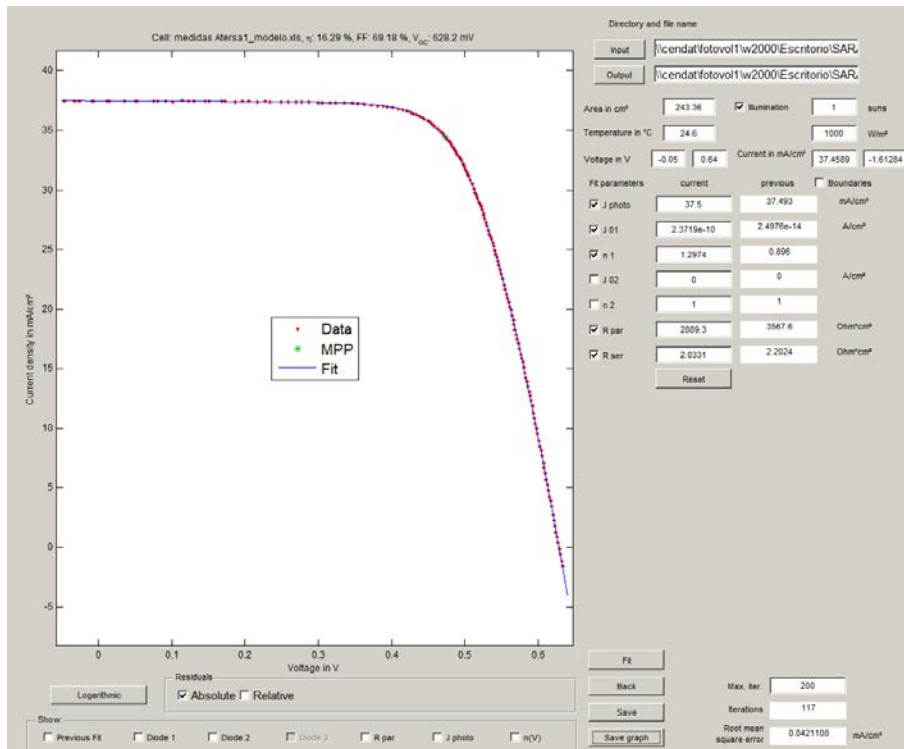
Figure 15: 2/3 Diode Fit program screenshot while obtaining the single-diode model of a solar cell equivalent circuit.

- **2/3 Diode Fit** [75]: it has been used to calculate the main parameters of the single-diode model of a solar cell equivalent circuit for the PV cells characterization (subsection 2.2.5). A screenshot of the program is shown in Figure 15.

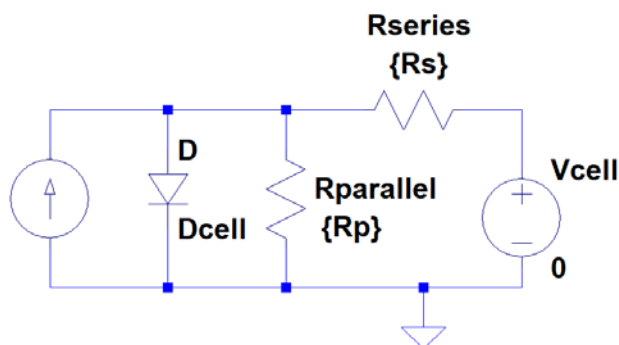
Figure 17: Real single-diode model of a solar cell simulated in Ltspice IV.

- **LTSpice** [77]: simulation, validation and analysis of the electrical model of faulty and shaded cells have been carried out using LTSpice program. To obtain an accurate model, the I-V curve obtained experimentally has to be used to adjust the ideality factor, n , and the parallel resistance, R_p . Later on, the cell model has been used to create the desired PV module, as it can be seen in Figure 16 and PV array, connecting the desired number of PV modules in series. The model selected to do the simulations is the real single-diode model of a solar cell (1M5P), which is presented in Figure 17. Further information about this study methodology can be found in the paper presented in subsection 2.2.1.

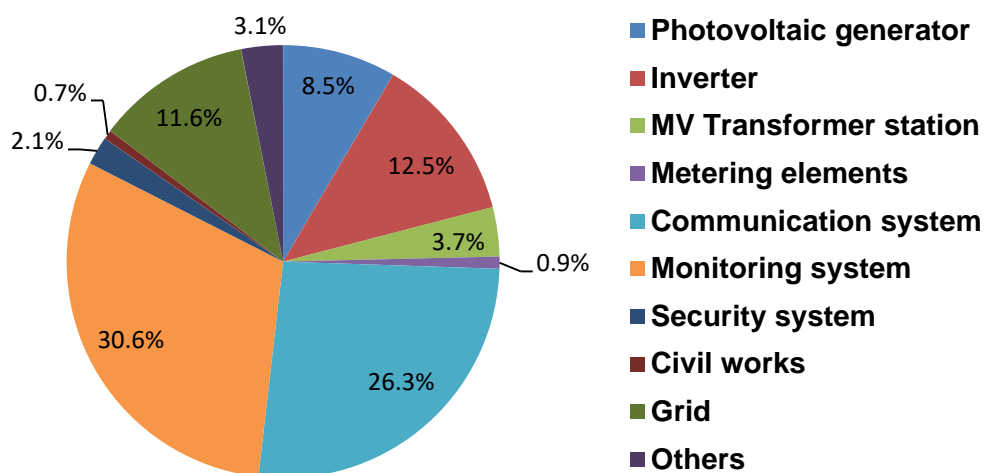
Figure 21: Distribution of the registered failures in each of the PV plants monitored elements, considering data from 2012 to 2016.

All these alarms are distributed among the different elements that compose the PV sites as presented in Figure 21. The existence of failures in different components can lead to the detection of failures in the monitoring or communication system, which explains the large amount of failures attributed to them, adding more than 50% of the alarms. For instance, a failure in the auxiliary services transformer can be responsible of an interruption of communications, as it feeds the communication system. In this case, the presence of a failure in the auxiliary services transformer would also generate a communications alarm. Further information about the results of this research can be found in the paper presented in subsection 2.1.1.

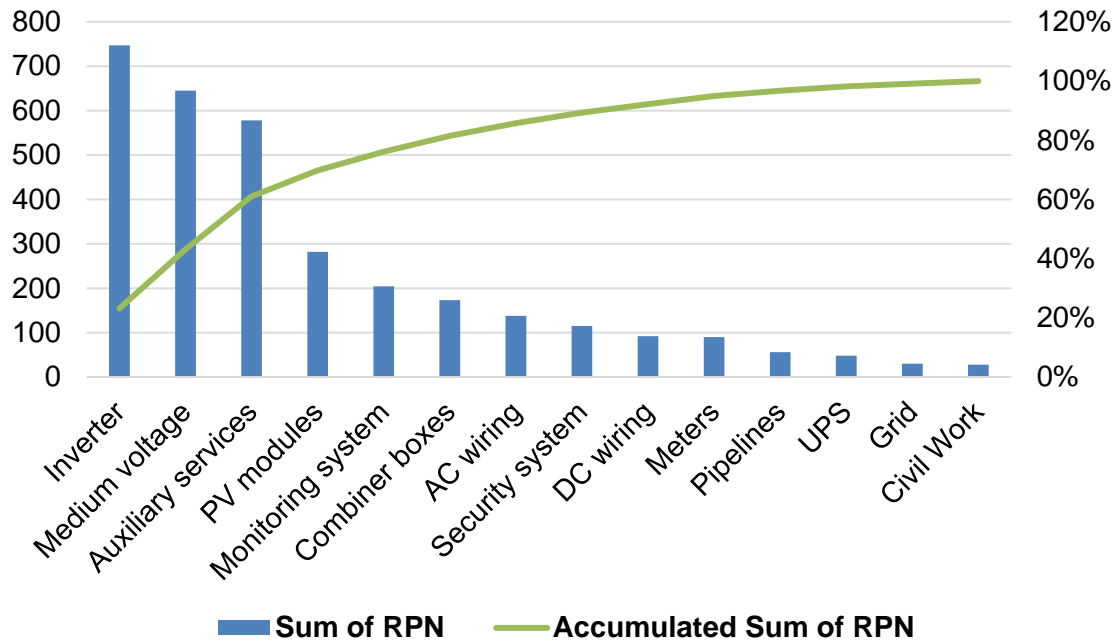
Figure 22: Sum of the RPN for each of the groups of elements under study and the accumulated RPN sum

However, having a higher failure rate does not mean they are the most relevant alarms of the plant, as shown in Figure 22. In a FMECA, the results present the failure modes and the severity of the consequences with relatively high probability, obtaining the RPN that multiplies severity, detection and occurrence based on a ranking criteria. Further information about the results of this research can be found in the paper presented in subsection 2.1.2.

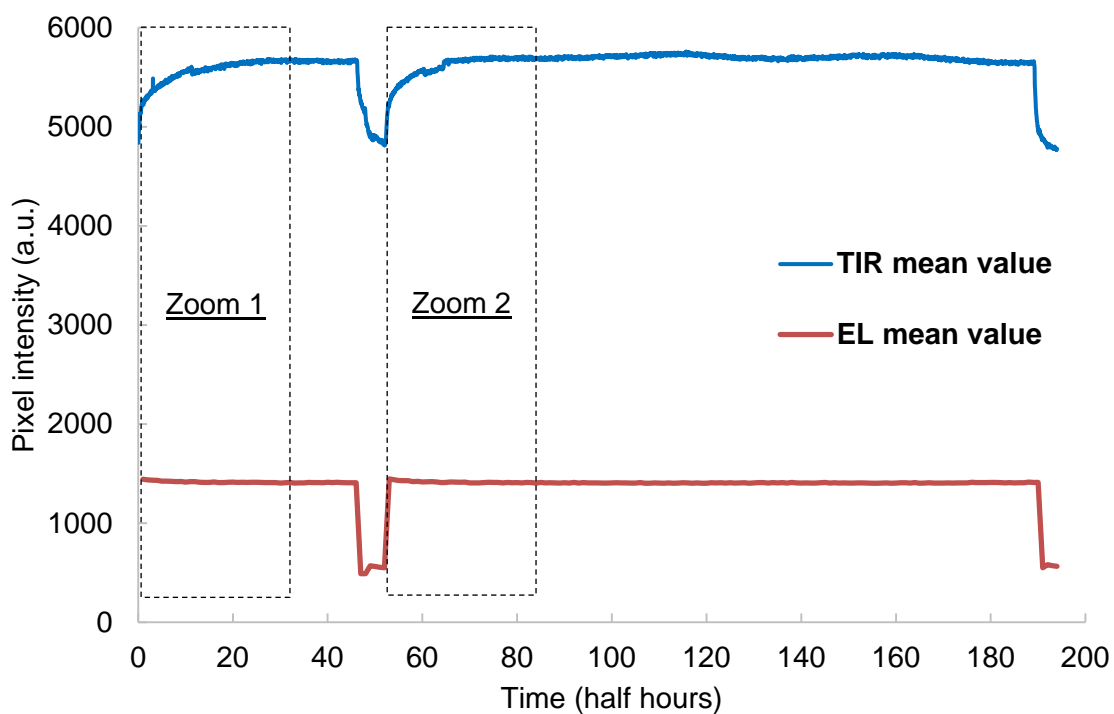
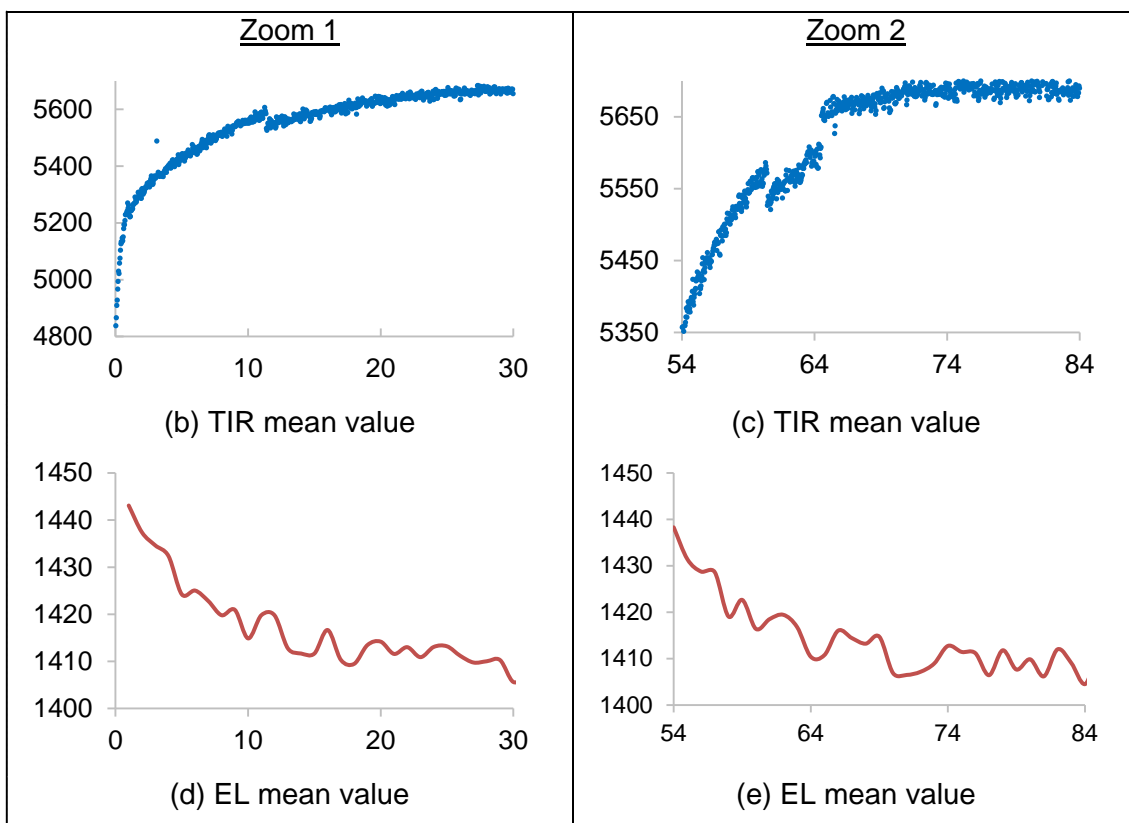
Figure 24: Evolution of the IRT and EL mean value intensities with the current injection in the module (a). Detailed evolution after the initial current injection in two periods are depicted in (b-e).

The mean values of the EL and IRT intensity over the full images were calculated, Figure 24. For a better understanding of the results and to analyze how EL could affect the modules efficiency, the current injection was switched off after 24 h to check the module behavior in a second EL test after completing a first injection cycle. In this way, the module was cooled during 24 h, after which the current injection was reestablished for a total time of 96 h.

In the tests carried out in this work, it is not appreciated that the current injection in EL measurements has any negative effect on the performance of damaged modules. However, it has been observed a small effect during the heating period in the EL intensity results at the beginning of each test, presenting a direct relationship between the heating of the module and the decrease of the EL signal. But that decrement is very small ($\leq 3.5\%$) and stops when the PV module temperature is stabilized, not affecting the module performance.

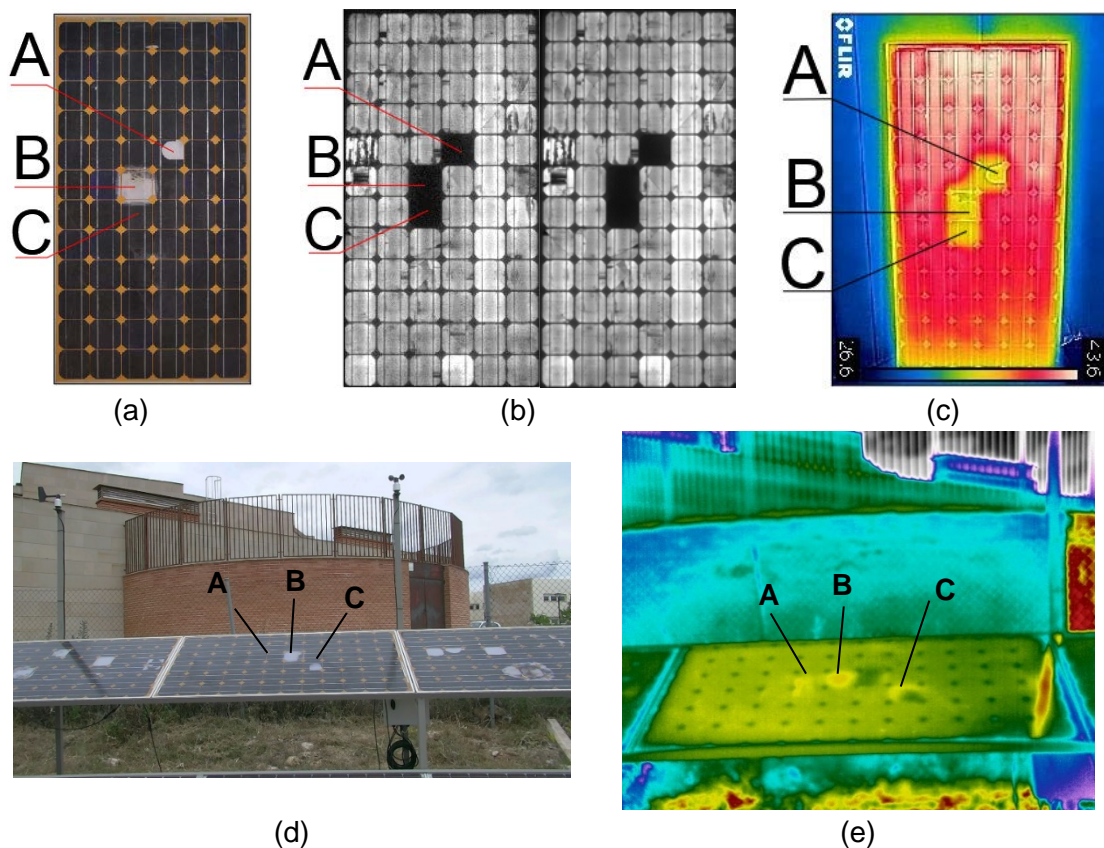
Figure 25: S-E1 PV module: RGB appearance (a), first and last EL images (b), IR image in the fourth quadrant during the EL test (c), visual (d) and IR (e) outdoor images in ordinary module operation.

For each of the defective modules presented in Figure 11, it has been performed its I-V curve before and after the EL, EL images each 30 min during 72 hours, thermal images of the fourth quadrant each minute during the EL process and thermal images of the second quadrant during the modules operation in the PV field of the Campus Duques de Soria. Additionally, RGB images have been captured before and after each test. All these tests have allowed the detection of their defects. As an example, the resultant RGB, IR and EL images of S-E1 module are presented in Figure 25, and further information of these results can be found in subsection 2.2.3.

Results confirm that EL and IRT under current injection on modules are closely correlated, while IRT under normal operation (sun exposure) reveals complementary information not detected in EL but existing in the visible spectrum.

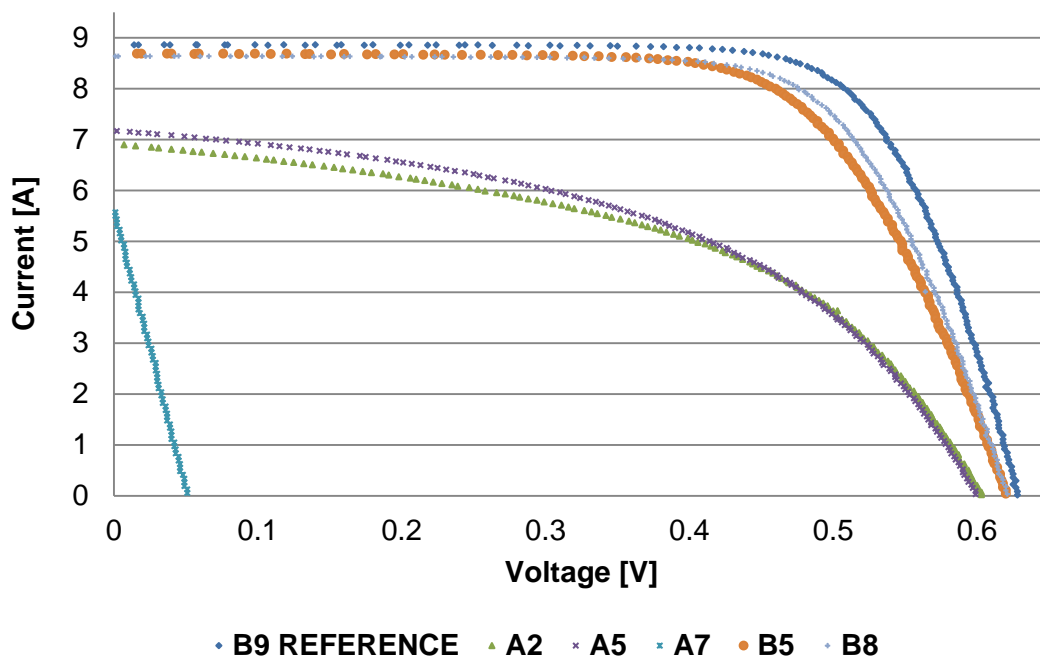
Figure 27: I-V Curves of the manufacturing defective cells of the first string (string AB) at 1,000 W/m², using B9 as the healthy reference cell of the string for comparison.

Three different kinds of manufacturing defects have been studied: low efficiency, medium efficiency and short circuited cells. I-V curves of the manufacturing defective cells studied at 1,000 W/m² and 100 W/m² are presented in Figure 27 and Figure 28, respectively. As it can be seen, manufacturing defects are much more evident at higher irradiance levels, having a greater impact. The module has been properly cleaned before each test to avoid any soiling influence.

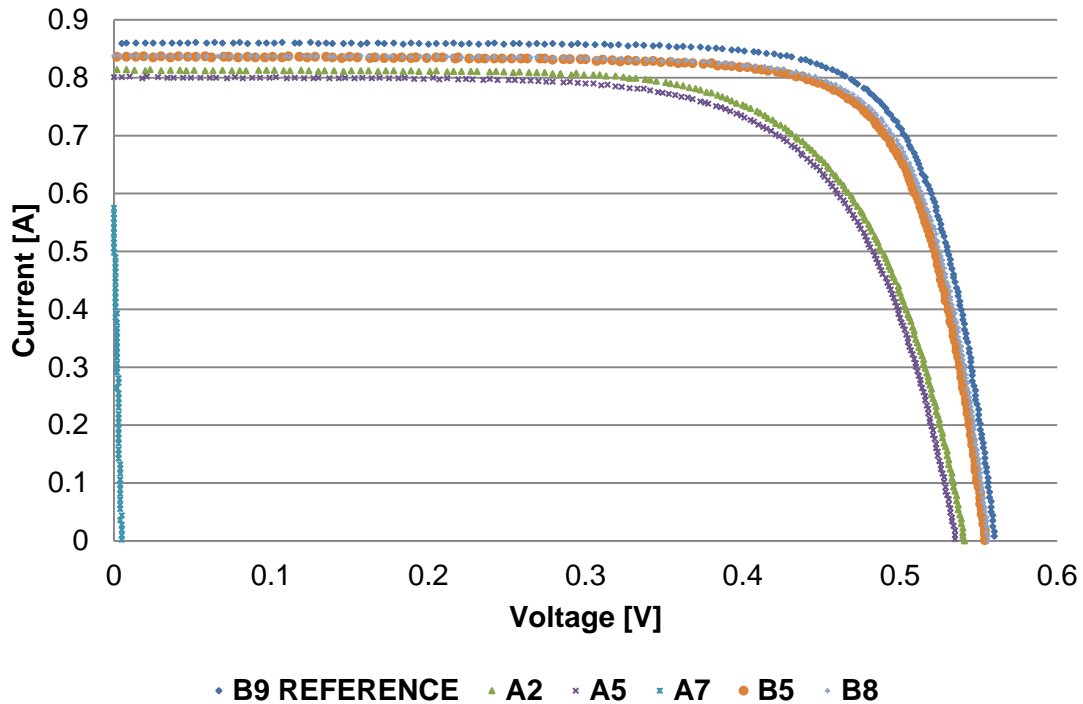
Figure 28: I-V Curves of the manufacturing defective cells of the first string (string AB) at 100 W/m^2 , using B9 as the healthy reference cell of the string for comparison.

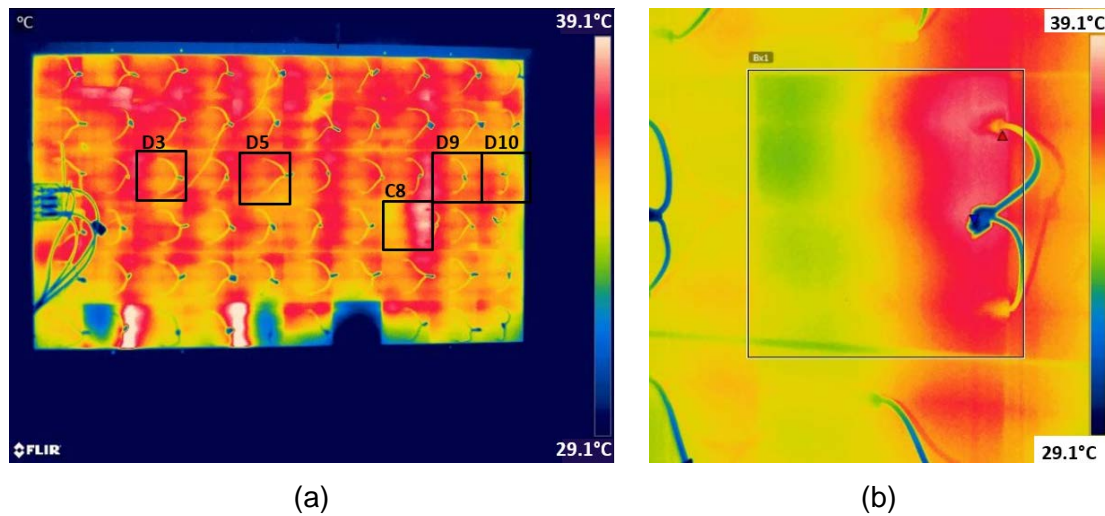
Figure 31: Indoor IRT images of the back side of the module (a) and of the C8 cell (b) during EL tests, injecting current of 8.9A. Images taken with FLIR SC 640 IR camera. The maximum and minimum temperatures in C8 cell in these conditions are: $T_{max}=38.2^{\circ}\text{C}$ and $T_{min}=29.6^{\circ}\text{C}$.

Soldering defects studied are not visible in EL. It could be because the faults are made on the back side of the module. An additional analysis has been performed to check if these defects are visible with IRT performed from the back side of the module in short circuit current injection conditions. The IRT image of the back side of the whole module can be seen in a). In these conditions, the only defect which certainly experiments an overheating is cell C8, corresponding the heating area with the centimeter of the three buses welded.

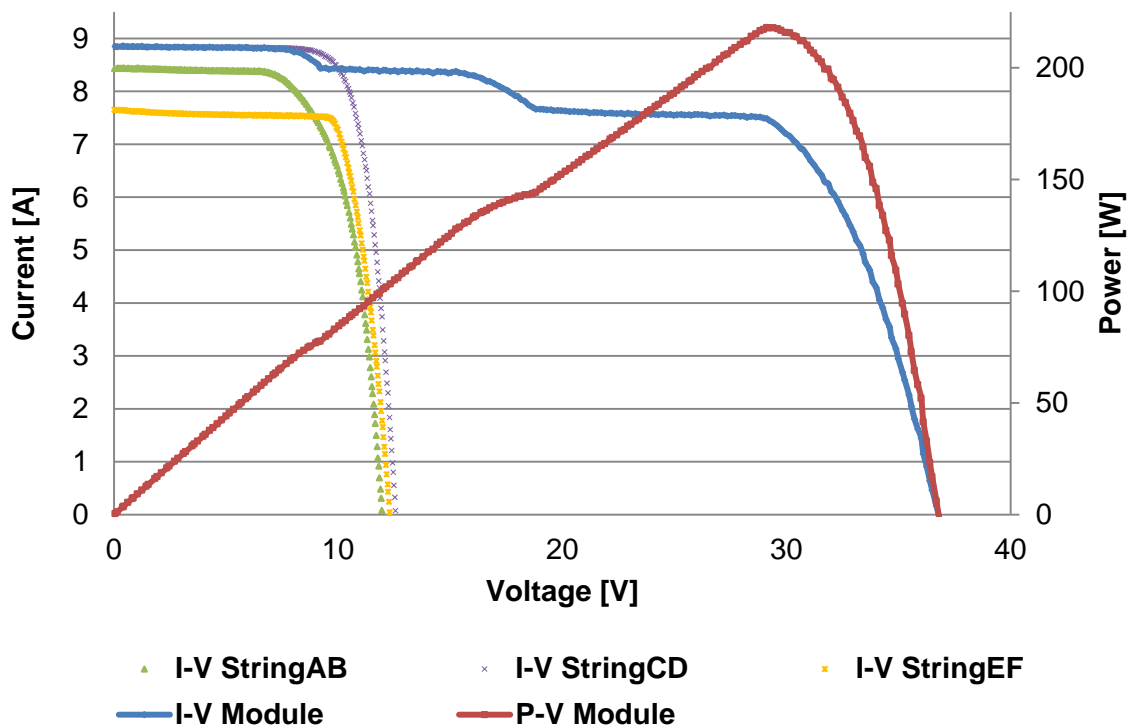
Figure 34: I-V Curves of the complete module and separate strings at 1,000 W/m². The secondary axis presents the P-V curves of the module at this irradiance.

Regarding the three kinds of defects combination or mix within a module, it has been seen how when the cells are series connected, the cell which delivers the lowest current will limit the current of the string. In this module, there is a total of three bypass diodes, one every 20 cells. As it has been seen, each bypass string contains different defects (of manufacturing, soldering and breaking cells) and each of them is able to produce a different current. Therefore, the electrical characteristic curve of the whole module, which is composed by the three bypass circuits in series, will contain three steps, each at the I_{sc} of each bypass circuit, as seen in Figure 34.

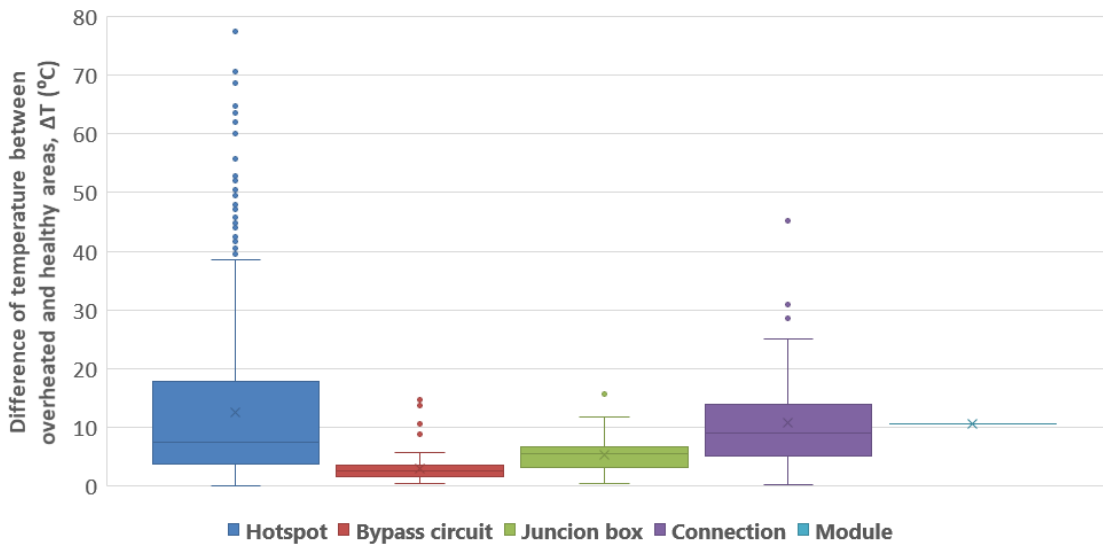
Figure 37: Box chart showing the delta temperature between overheated and healthy areas, ΔT , grouped by defect type for each of the 1,140 defective modules detected

Commonly, the severity of defects is given, based on the difference of temperature between overheated and healthy areas, ΔT , within a module. The absolute temperature of the defect is not used to determine the severity as it is strongly dependent on different weather conditions, as the ambient temperature, the irradiance or the wind speed. This ΔT varies significantly between different kinds of defects, as it can be observed in Figure 37, which presents a box chart showing the difference of temperature for each of the 1,140 defective modules detected, grouped by defect type.

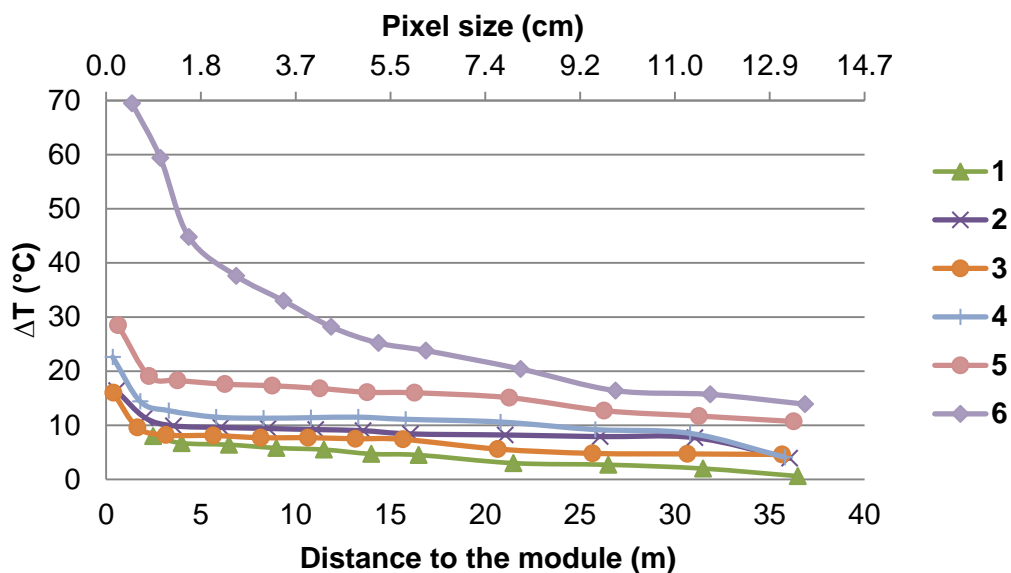
Figure 40: Difference of temperature between the hotspot and the healthy area of the six defects captured at twelve different distances. The secondary horizontal axis shows the pixel size at each distance. The images have been captured manually with the camera Testo 870-2.

It has been proved that the same failure will be registered as a different temperature depending on the distance from the thermographic camera to the faulty cell. Therefore, it is necessary to determine the severity range criteria to classify the failures detected as a function of the flight height, as it cannot be the same as the criteria used previously in the manual inspections. For the inspections performed, this criteria should change from the manual (1) to the aerial inspections at 30 m (2) and 80 m (3) as follows: severe failures, temperature difference higher than 30°C (1), 17.8°C (2) and 9.0°C (3); medium severity failures, from 10°C to 30°C (1), from 4.4°C to 17.8°C (1), from 0°C to 9°C (1) ; and minor failures, lower than 10°C (1), lower than 4.4°C (2) and not detectable (3).
