Article

Methodology for the Study of the Envelope Airtightness of Residential Buildings in Spain: A Case Study

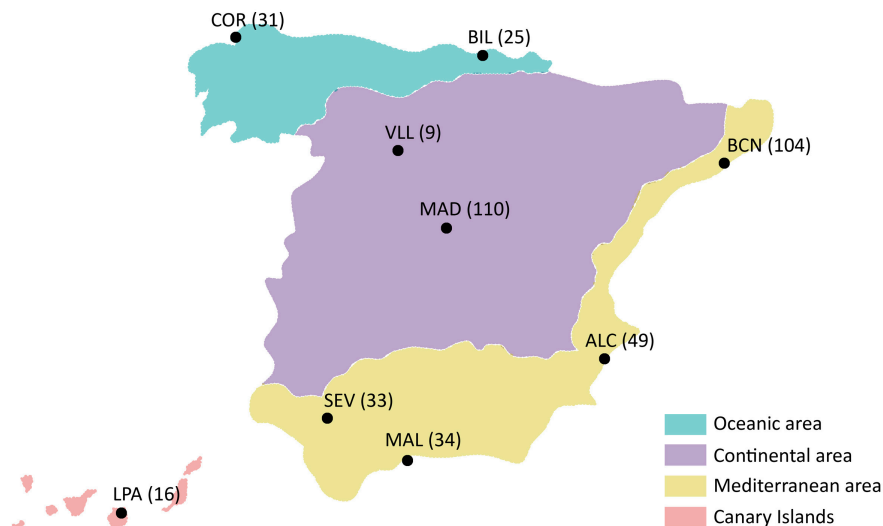
Figure 1. Considered climate zones in Spain, location of the participant Universities, and size of the sample of each of them.

The climatic zone also has a significant impact on airtightness. Buildings located in cold climates tend to be more airtight than others located in temperate climates [41]. Climatic zones do not only affect weather conditions, but they can also establish differences in regulatory requirements or different construction systems [28]. A simplification of the climatic zones in Spain has been made, obtaining a total of four zones: Continental, Oceanic, Mediterranean, and Canary Islands (Figure 1).

A total of nine universities (Figure 1) participated in the characterization and testing of the required cases. To this end, testing campaigns have been organized throughout 2016 and 2017, taking into account the number of cases assigned to each site and paying special attention to the expected climatic conditions, given that the EN 13829 standard [45] determines limitations with respect to the wind during the test. Each site consisted of a coordinator and one or two teams of technicians, with a total of 11 teams to cover the field work. These teams were trained before the campaigns to ensure proper compliance with the developed protocol. A common cloud server was created to allow constant data transfer and supervision from the coordinating University (VLL).

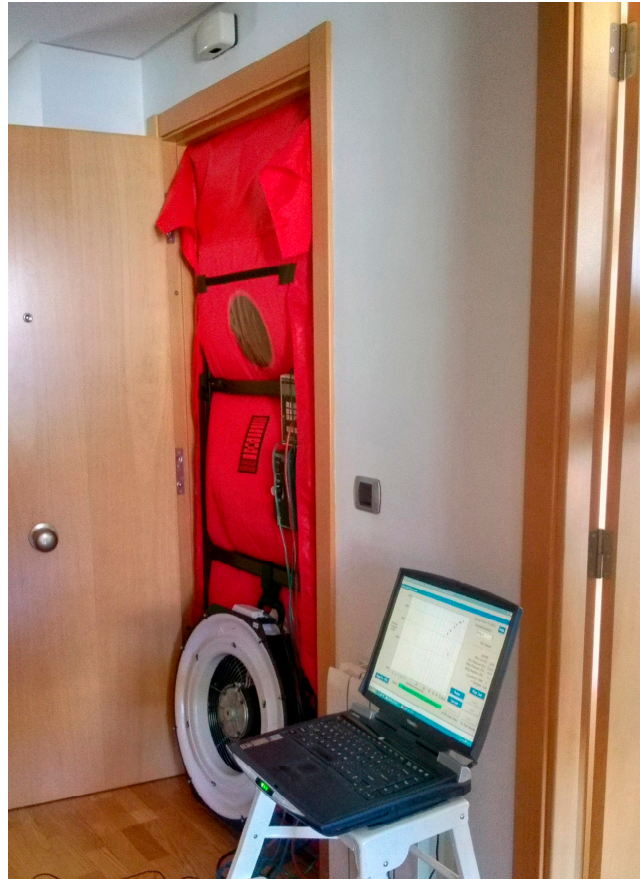
Figure 2. Blower door system.

The evaluation of the leakages is carried out in accordance with EN 13829 standard [45], used for the determination of air permeability of buildings by the fan pressurization method, commonly known as Blower door test (Figure 2).

Through an automated test using the software provided by the blower door manufacturer (TECTITE Express), a total of 10 data points were measured, with increments of 6 Pa in the range 11–65 Pa.

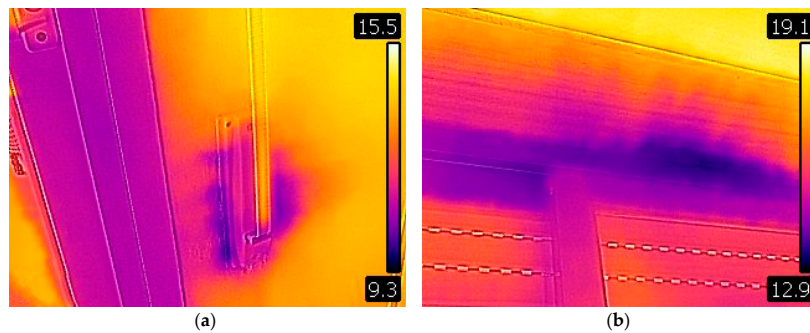
Figure 3. Usual leakage paths detected with thermography. (a) Leakage path at the strap coils of rolling shutters; (b) Leakage path at window joints.

During the depressurization stage, leakage points were identified by thermography (Figure 3). However, due to the climatological conditions of the areas where the tests were carried out, a large thermal gradient to allow thermographic observation was not always expected. In these cases, thermography will be replaced by the use of smoke generators.

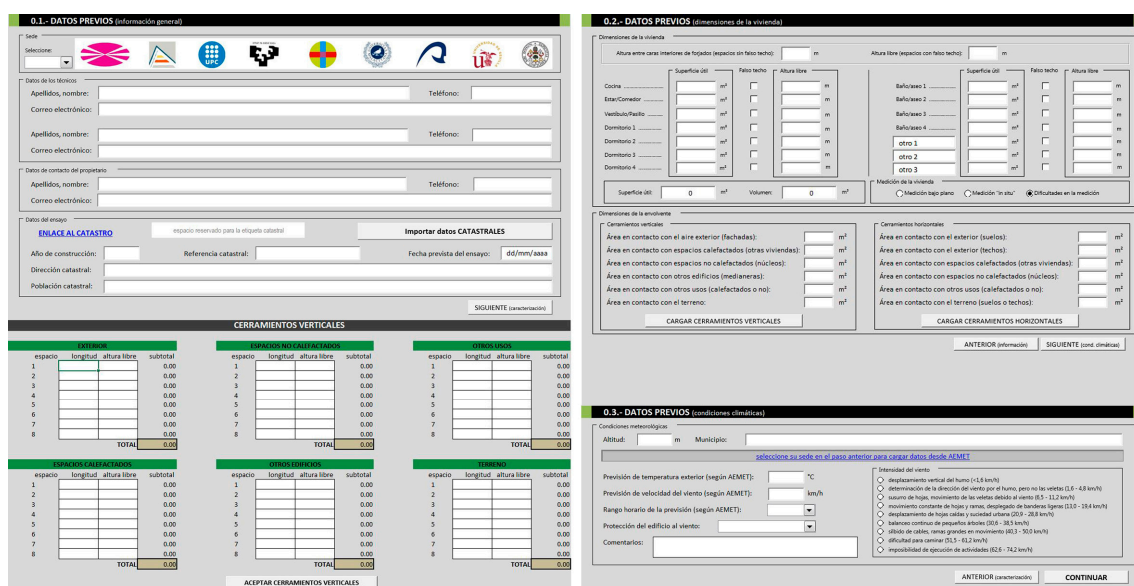
Figure 4. Screenshots of “infil-APP”. Previous Data.

The first stage is completed before the test performance and comprises data of the technicians and the owner, responsible university, location, and year of construction of the dwelling (Figure 4). A code is automatically generated for each case, which allows personal data protection and the identification of each case. Dimensions are also gathered at this stage whenever graphical documentation of the dwelling is available. Otherwise, simple floor plans are sketched on site in order to obtain the required information. Dimensions such as floor area (A_F), volume (V), envelope area (A_E), or shape factor (S_f) are automatically calculated from partial dimensions. In order to guarantee suitable meteorological conditions limited by EN 13829 standard [45], weather forecast at the expected date, and time of the test is also introduced. If the wind speed exceeds 6 m/s, “infil-APP” does not allow one to continue to further steps and the test needs to be postponed.

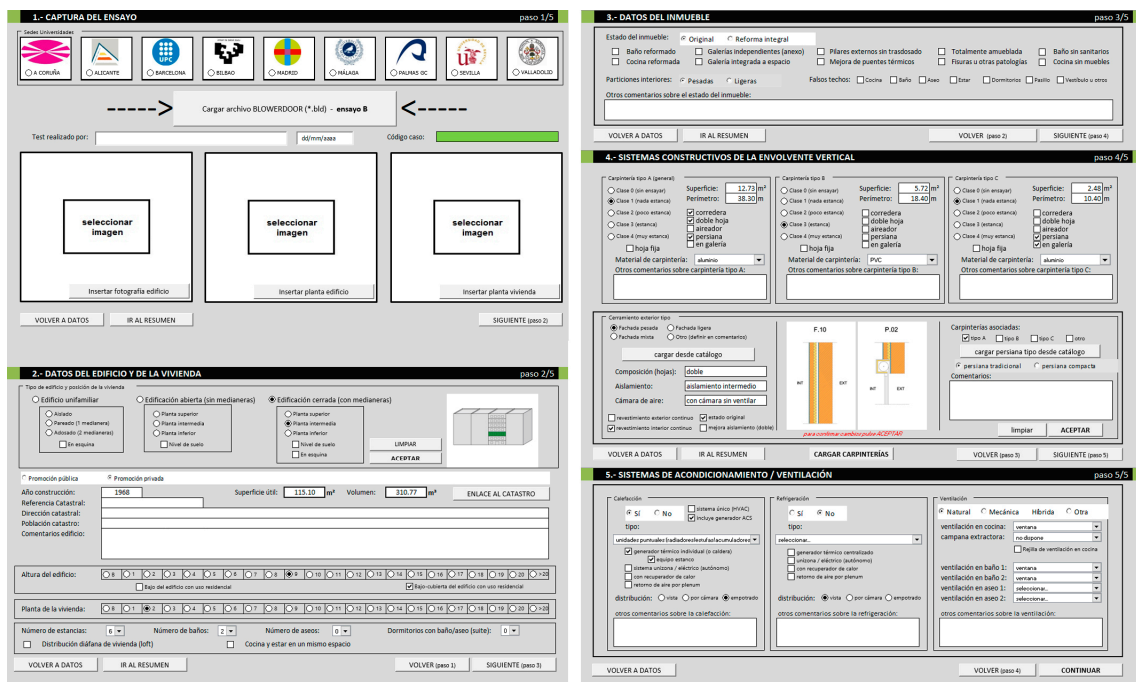
Figure 5. Screenshots of “infil-APP”. Characterization of the case.

The second stage is the characterization of the case (Figure 5). It is done during the visit to the dwelling. Pictures of the exterior, each room, windows, systems, special features, and cracks or other pathologies detected are taken. General information about the dwelling, construction systems, and conditioning and ventilation systems are saved in “infil-APP”.

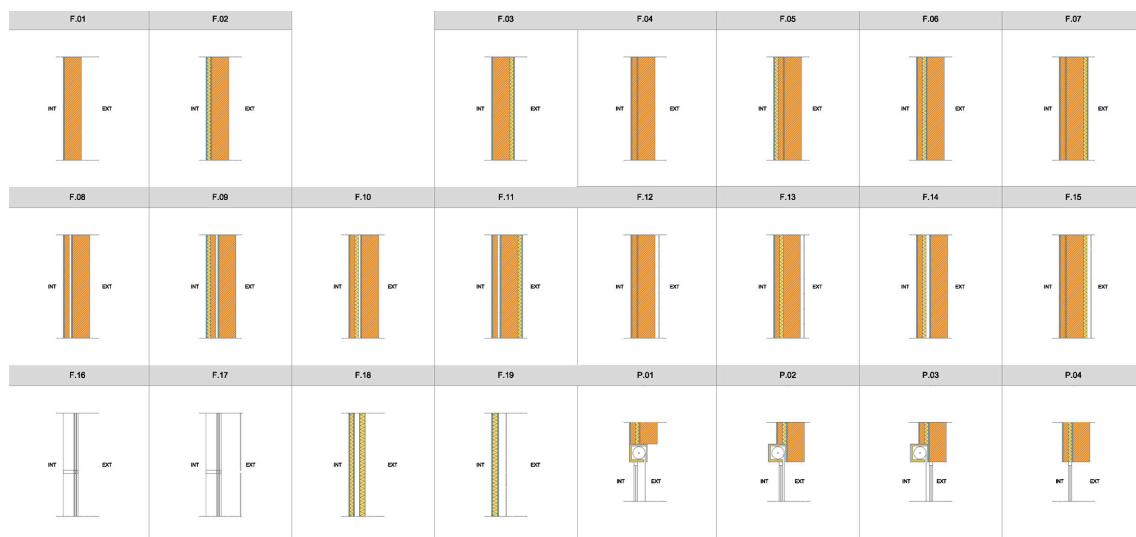
Figure 6. Catalog of preset typical façade and rolling shutters in Spain.

A catalogue of preset typical construction solutions in Spain has been developed (Figure 6), paying attention to singular elements such as shutters. Nevertheless, customized solutions are also possible to introduce. The retrofitting state of each case has been considered in detail due to its decisive relevance.

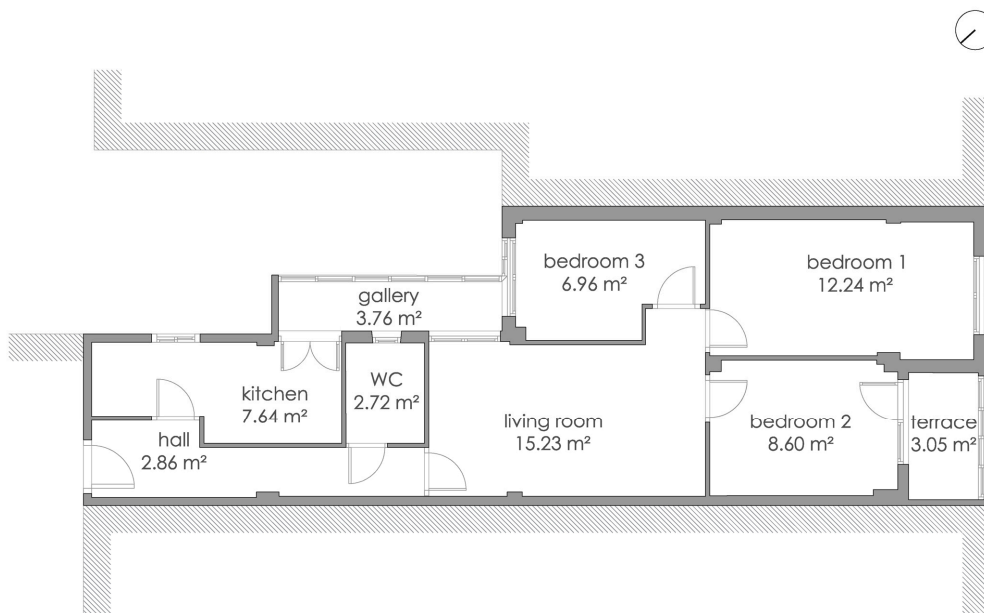
Figure 9. Floor plan of the dwelling.

The building was constructed in 1968, before regulations in Spain considering energy losses were implemented. The building consists of 9 floors and an attic. The apartment is on the ninth floor and has a south orientation in its main façade to Padilla Street and a secondary façade to a wide internal courtyard with east orientation (Figure 9). All the specifics are detailed in Table 7.

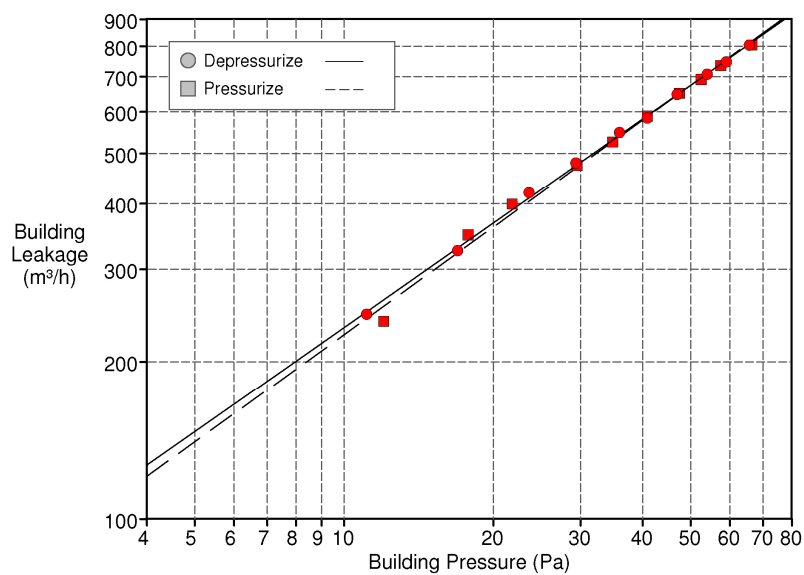
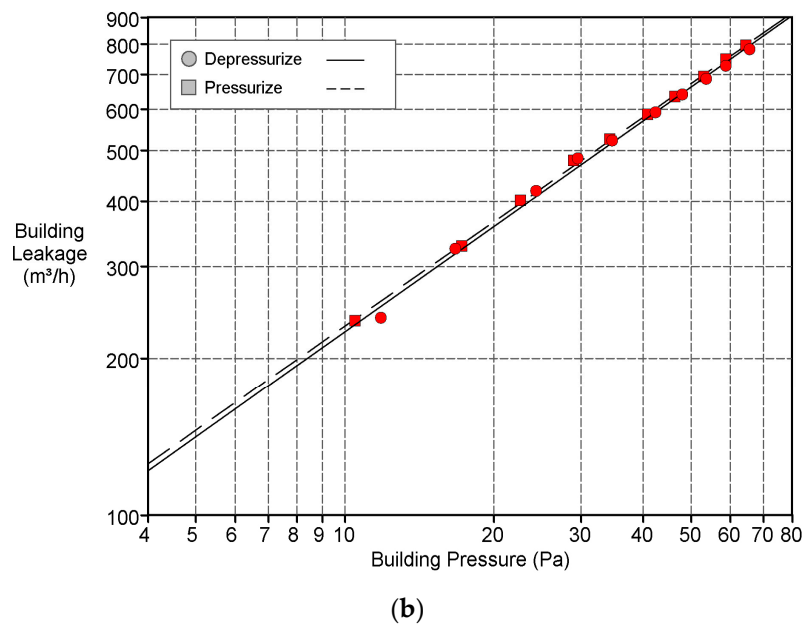
Figure 10. Automated test graph. (a) graph for Method A; (b) graph for Method B.

In order to measure the airtightness of the dwelling, blower door tests are carried out with an automated performance testing system and following the project protocols (Figure 10). Tests were carried out in February 2017 with the environmental conditions described in Table 8. Test results are detailed in Table 9.

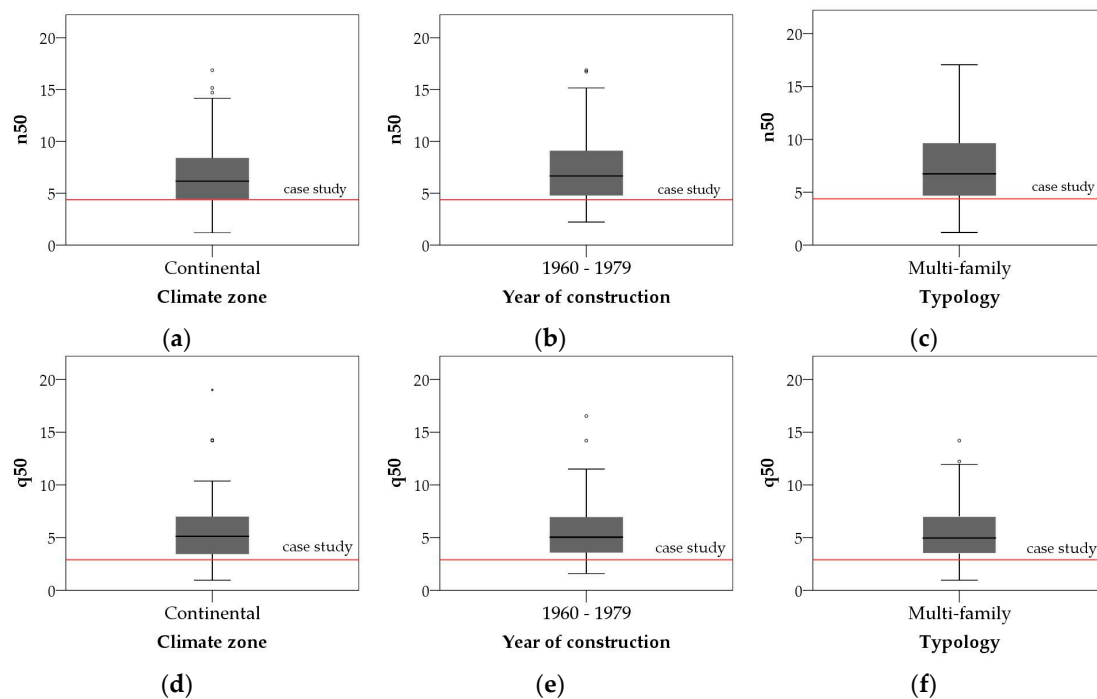
Figure 11. Boxplot of database results compared to the case study results, indicated by the red line. (a) n_{50} for Continental climate zone; (b) n_{50} for dwellings built within the period 1960–1979; (c) n_{50} for multi-family dwellings; (d) q_{50} for Continental climate zone; (e) q_{50} for dwellings built within the period 1960–1979; (f) q_{50} for multi-family dwellings.

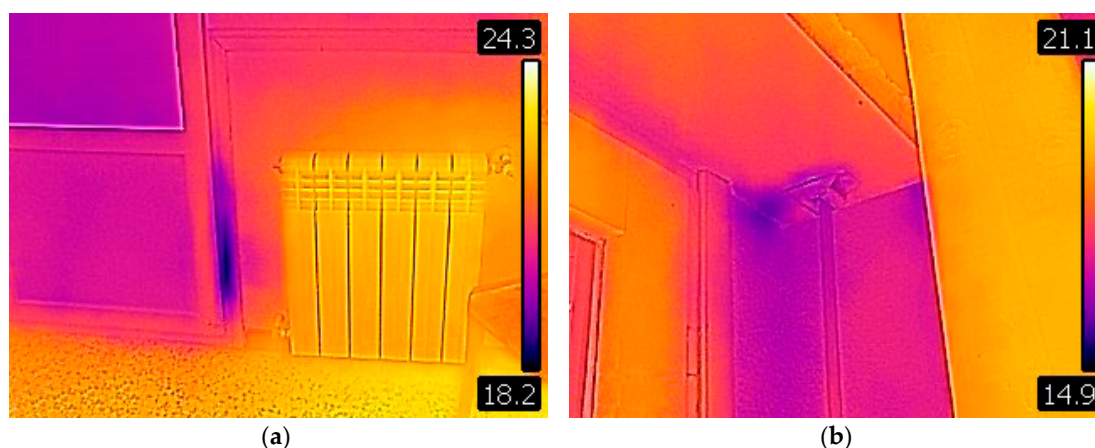
Figure 12. Leakage paths detected with thermography. (a) Leakage path located in a door frame; (b) Leakage path located in the tape guide of the rolling shutter.

To determine infiltration locations and distribution, thermal imaging was undertaken during the depressurization stage. Since there was a great temperature difference between the inside and the outside of the dwelling leakage points were easily visualized. Most leakages were located in window frames and shutter boxes (Figure 12).
