Youth in Conservation of Cultural Heritage, YOCOUCU 2012

Tiermes Cultural Lab: Excavation, conservation and musealization of the archaeological site of Tiermes (Soria, Spain)

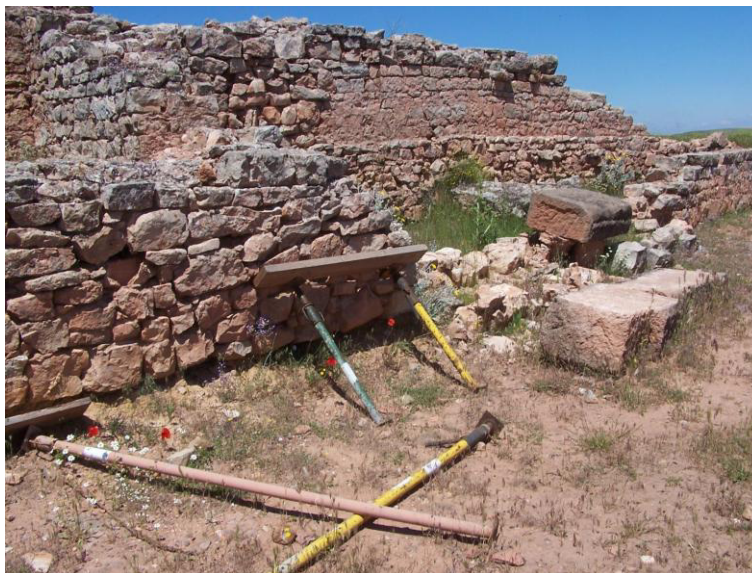
Fig. 1. Archaeological site, previous state. Collapsed walls, uncontrolled growth of vegetation and obsolete fastening elements.

To consolidate the walls three types of strategy have been used: when it comes to adding material so as to create an area of sacrifice to avoid the deterioration of the original material, we have proceeded to put a bond similar to that existing, one separated by a plastic mesh only in cases where it is clearly identifiable with the homogeneity of the construction. In the case of large gaps that do not ensure the existence of a homogeneous rig, the consolidation is effected by the use of brick, slightly delayed with respect to the plane of the original

Due to the neglect and lack of support some of the walls appeared collapsed, so we took the next step by relocating them; relocation received by mortar of lime, sand and red earth. Also, by concrete backings made with similar technique, there has been underpinning of structures that due to the effect of water runoff or over-excavation had lost some of their original medium. These measures have allowed the removal of obsolete fastening elements, including props that were no longer working and also the felling that carried by steel profiles unloaded, on shaky ground, the east wall of the Forum.

Also, we have proceeded to re-grow with a row of sacrifice all those walls that needed a guarantee of protection and contributing to facilitate the reading of the architectural spaces that they define. This was performed with identical characteristics of the existing construction: concerted masonry received with red and lime sand mortar, always separating the intervention provided by interposing a mesh between the original wall and the new.

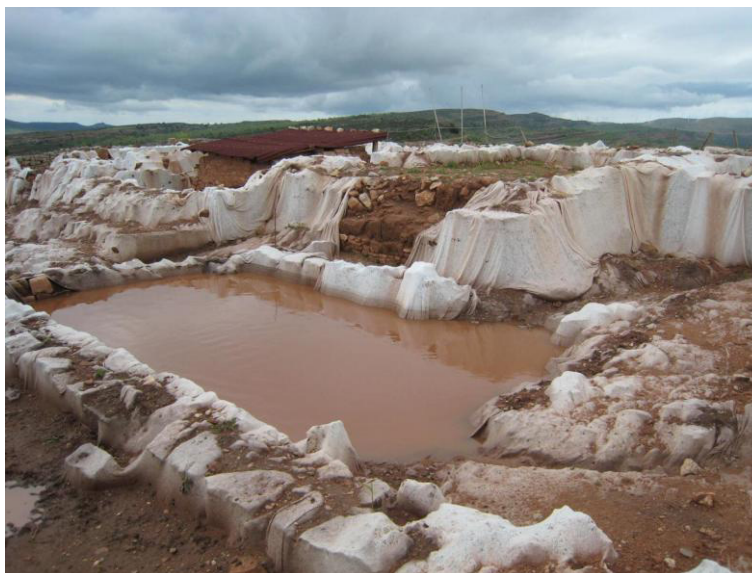
Fig. 2. Archaeological site, previous state. Water accumulation on the geotextile mesh and obsolete protections.

Eliminating standing water has been solved by placing drainage pipes at points where the slope was allowed to discharge outside the complex or by filling the large cavities with filter gravel, provided on a layer of geotextile, using large diameter bolus deeper in the spaces, in order to increase drainage capacity and coarse gravel in the more superficial dimensions. For its part, the mechanism used to protect land courts has been broken up, placing galvanized steel gabions filled with bowls and gravel, avoiding deterioration by the circulation of water runoff.

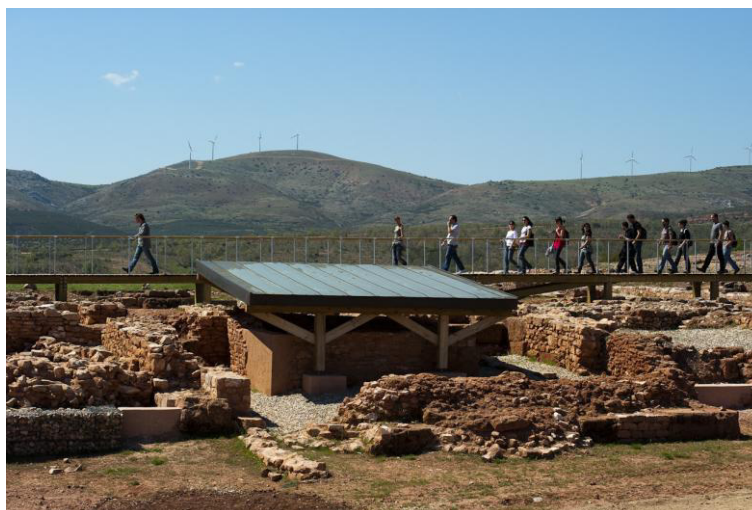
Fig. 3. Joint Forum, reformed state. The consolidation of the north area, with a new protection for the *opus signinum* tank, made of wood and copper coat. Behind, the wooden bridge.

The presence in the north of the Forum of a space functioning as a tanker kept part of its *opus signinum* coating in a state of serious deterioration, demanding a restoration intervention, carried out under the supervision of Numantino Museum's Restoration Service. Moreover, its provisional protection covering the passenger compartment was eliminated, in order to proceed with its substitution by a more stable one, made of treated wood and copper coat, which rests on four small lime concrete footings. Thus a cabin was achieved, where all the restore process takes place, ensuring the same way conservation later on.

b) Gateway: In the upper area of the Forum a wooden bridge (pillars, beams and wooden double) was built, supported by on-site concrete pads placed on the ground, without need of excavation, which allows visits without having to go into the interior of the murarias structures, to better safeguard the remains and to provide better

Its construction system uses wooden pillars formed by two planks of 7,5 x 20 cm plugs, interconnected by wooden beams consisting of wooden planks of the same dimensions, and small plank non-slip floor grooving with blunt edge, 5 x 15 cm. All the wood used is national, dried and autoclaved pine.

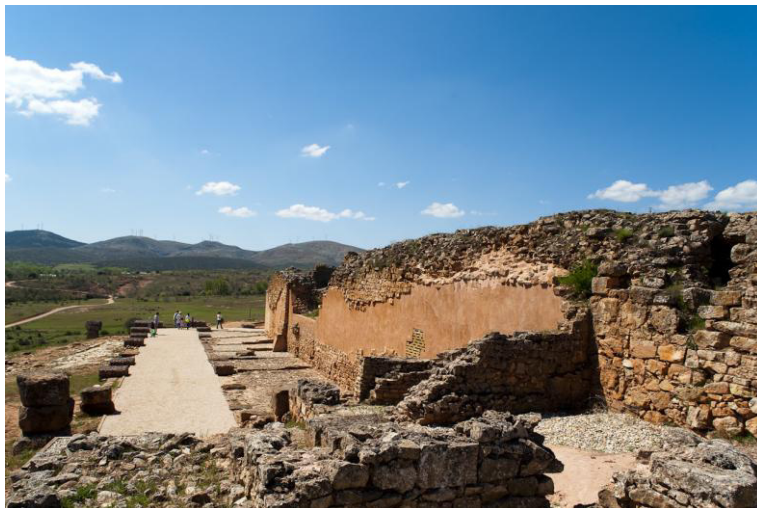
Fig. 4. Joint Forum, reformed state. Landscape view from the north stair. Streets and taverns after the restoration.

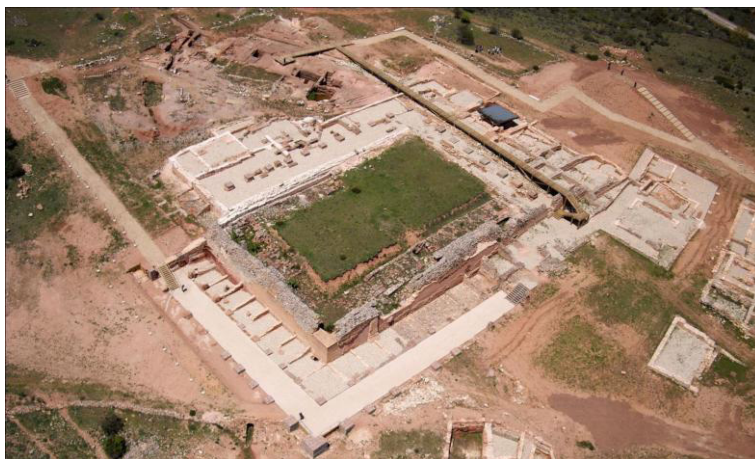
Fig. 6. Joint Forum, reformed state. Aerial view from southeast.
